Manhole Inspection Report

Date:	04/10/2018	Weather:		Coding:	RZMACP
MH#:	M-708-106	Owner:	NA	Len. Surveyed:	8.1
P.O.#:		Surveyor:	John Kuglmaier	Rim to Invert:	8.5
Customer:		Cert. #:	U-1215-07002349	Wall Material:	Concrete (reinforced)

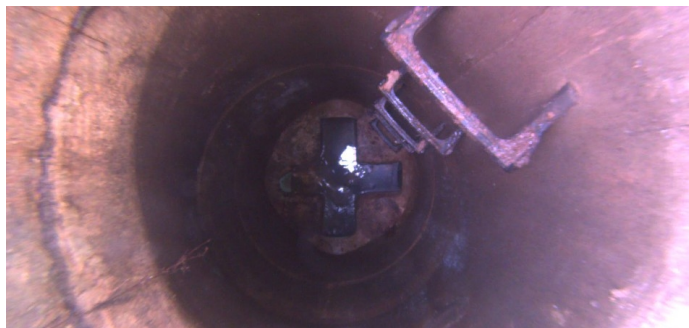
Code: **MGP**
Description: **General Photo**

Distance (ft): **.0**
Structural Grade: **0**
O&M Grade: **0**
Clock Start/From:
Clock To:
1st Value:
2nd Value:
Value Percent:
Step: **NO**
Remarks:

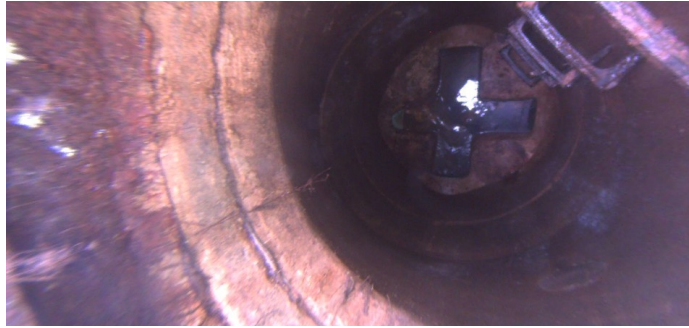
Code: **RFJ**
Description: **Roots Fine Joint**

Distance (ft): **.0**
Structural Grade: **0**
O&M Grade: **1**
Clock Start/From: **8**
Clock To:
1st Value:
2nd Value:
Value Percent:
Step: **NO**
Remarks:

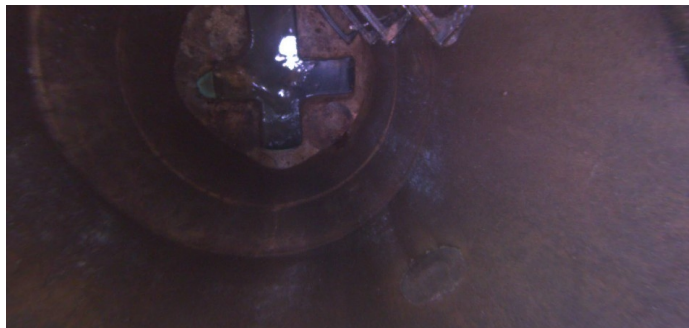
Code: **IS**
Description: **Infil Stain**

Distance (ft): **1.3**
Structural Grade: **0**
O&M Grade: **0**
Clock Start/From: **5**
Clock To:
1st Value:
2nd Value:
Value Percent:
Step: **NO**
Remarks:

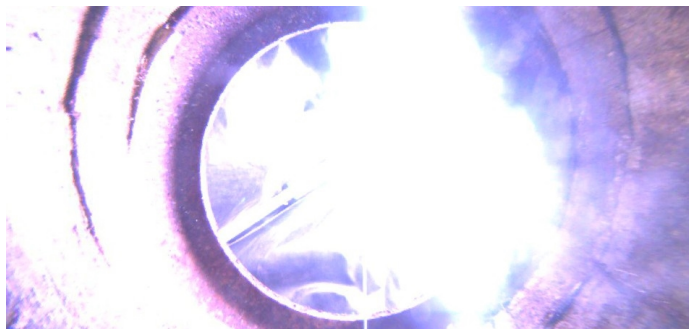
Code: **MGP**
Description: **General Photo**

Distance (ft): **2.2**
Structural Grade: **0**
O&M Grade: **0**
Clock Start/From:
Clock To:
1st Value:
2nd Value:
Value Percent:
Step: **NO**
Remarks:

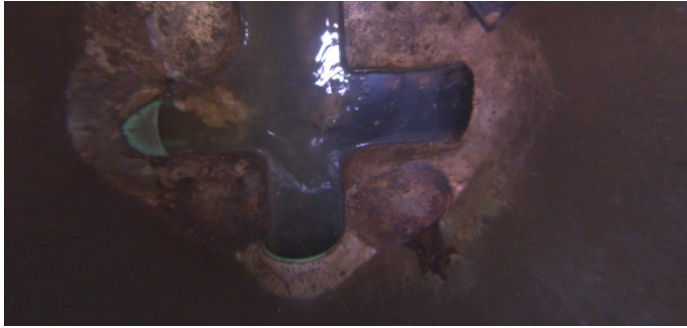
Code: **IS**
Description: **Infil Stain**

Distance (ft): **5.3**
Structural Grade: **0**
O&M Grade: **0**
Clock Start/From: **5**
Clock To:
1st Value:
2nd Value:
Value Percent:
Step: **NO**
Remarks:

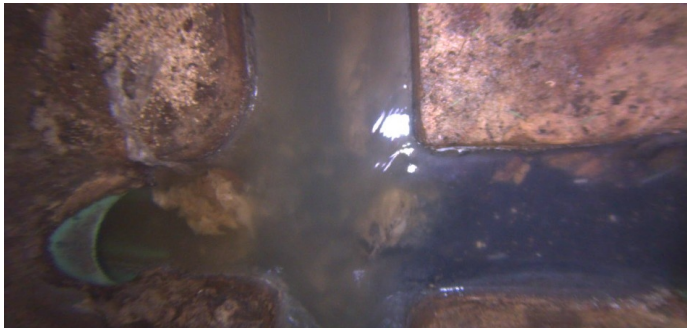
Code: **MGO**
Description: **General Observation**

Distance (ft): **6.9**
Structural Grade: **0**
O&M Grade: **0**
Clock Start/From:
Clock To:
1st Value:
2nd Value:
Value Percent:
Step: **NO**
Remarks: **Ins. Comp.**
