Manhole Inspection Report

Date:	04/10/2018	Weather:		Coding:	RZMACP
MH#:	M-708-121	Owner:	NA	Len. Surveyed:	7.1
P.O.#:		Surveyor:	John Kuglmaier	Rim to Invert:	7.7
Customer:		Cert. #:	U-1215-07002349	Wall Material:	Concrete (reinforced)

Street:	Tamarack Dr. 113' West of Magnolia	Project:	Hobart, IN
City:	Hobart, IN	GPS Northing:	2905549.713
Location:		GPS Easting:	2905549.713
Drain Area:	Southwest	GPS Accuracy:	Sub-Meter
Cover Shape:	Circular	Evidence of Surcharge:	No
Cover Size:	22.5	Potential for Runoff:	None
Comments:

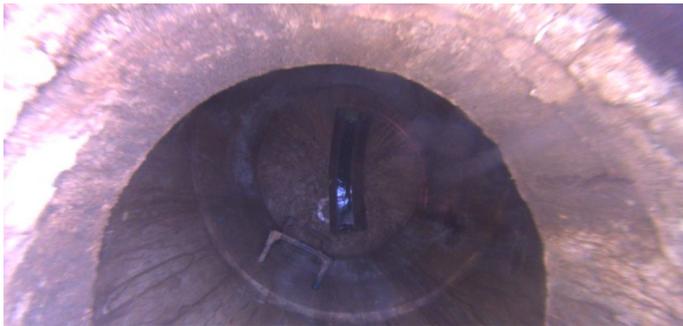
Code: **MGP**
Description: **General Photo**

Distance (ft): **.0**
Structural Grade: **0**
O&M Grade: **0**
Clock Start/From:
Clock To:
1st Value:
2nd Value:
Value Percent:
Step: **NO**
Remarks:

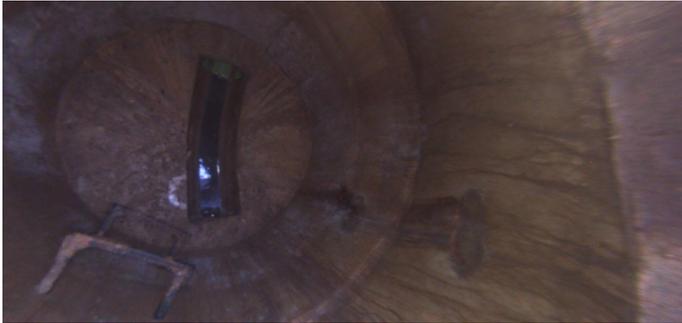
Code: **IS**
Description: **Infil Stain**

Distance (ft): **1.2**
Structural Grade: **0**
O&M Grade: **0**
Clock Start/From: **4**
Clock To:
1st Value:
2nd Value:
Value Percent:
Step: **NO**
Remarks:

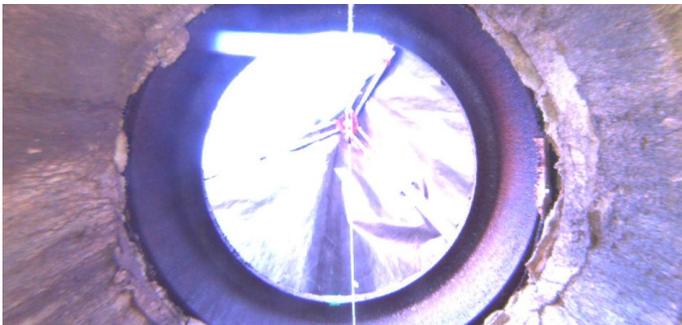
Code: **MGP**
Description: **General Photo**

Distance (ft): **2.3**
Structural Grade: **0**
O&M Grade: **0**
Clock Start/From:
Clock To:
1st Value:
2nd Value:
Value Percent:
Step: **NO**
Remarks:

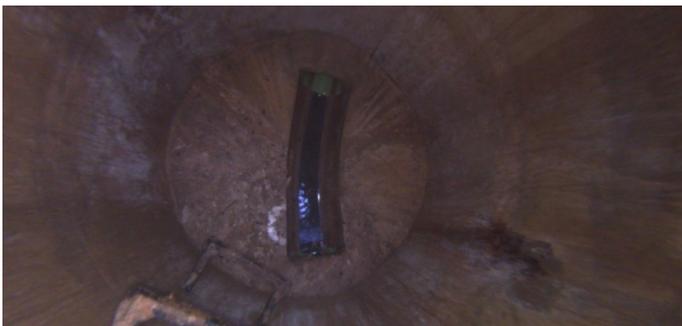
Code: **IS**
Description: **Infil Stain**

Distance (ft): **2.6**
Structural Grade: **0**
O&M Grade: **0**
Clock Start/From: **4**
Clock To:
1st Value:
2nd Value:
Value Percent:
Step: **NO**
Remarks:

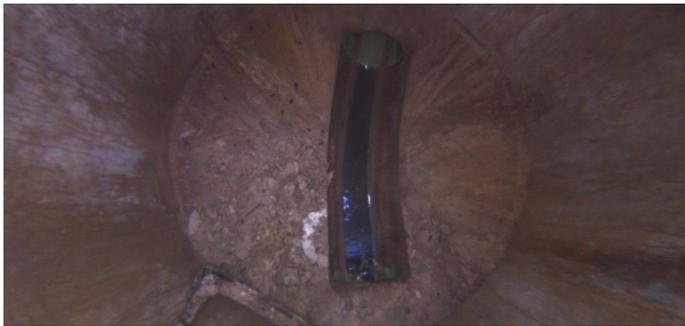
Code: **DSGV**
Description: **Deposits Settled Gravel**

Distance (ft): **3.9**
Structural Grade: **0**
O&M Grade: **2**
Clock Start/From: **6**
Clock To: **10**
1st Value:
2nd Value:
Value Percent: **5.000**
Step: **NO**
Remarks:

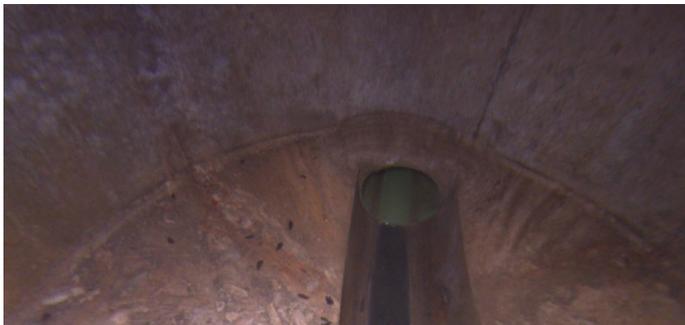
Code: **IS**
Description: **Infil Stain**

Distance (ft): **5.5**
Structural Grade: **0**
O&M Grade: **0**
Clock Start/From: **11**
Clock To:
1st Value:
2nd Value:
Value Percent:
Step: **NO**
Remarks:

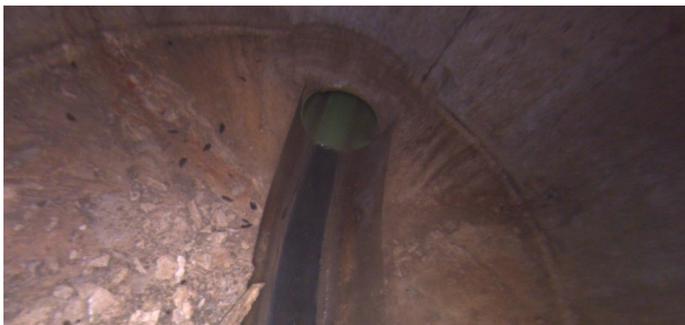
Code: **IS**
Description: **Infil Stain**

Distance (ft): **5.5**
Structural Grade: **0**
O&M Grade: **0**
Clock Start/From: **2**
Clock To:
1st Value:
2nd Value:
Value Percent:
Step: **NO**
Remarks:

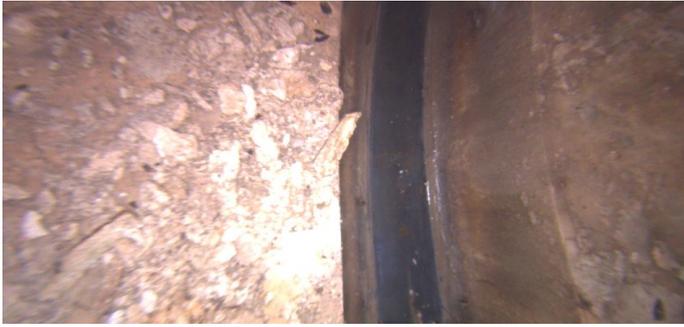
Code: **MGO**
Description: **General Observation**

Distance (ft): **6.2**
Structural Grade: **0**
O&M Grade: **0**
Clock Start/From:
Clock To:
1st Value:
2nd Value:
Value Percent:
Step: **NO**
Remarks: **Ins. Comp.**
