Manhole Inspection Report

Date:	11/07/2022	Weather:		Coding:	RZMACP
MH#:	M-708-134	Owner:	NA	Len. Surveyed:	5.3
P.O.#:		Surveyor:	Jen Costello	Rim to Invert:	6.2
Customer:		Cert. #:	U-907-5518	Wall Material:	Concrete (non-reinforced)

Street:	Magnolia Dr. 253' North of Azalea D	Project:	Missing GPS
City:	Hobart, IN	GPS Northing:	2280588.388
Location:		GPS Easting:	2906027.233
Drain Area:	Southwest	GPS Accuracy:	Sub-Meter
Cover Shape:	Circular	Evidence of Surcharge:	No
Cover Size:	24.0	Potential for Runoff:	None
Comments:

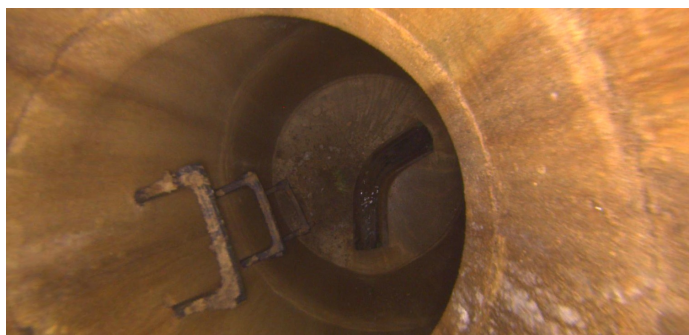
Code: **MGO**
Description: **General Observation**

Distance (ft): **.0**
Structural Grade: **0**
O&M Grade: **0**
Clock Start/From:
Clock To:
1st Value:
2nd Value:
Value Percent:
Step: **NO**
Remarks: **access mh**

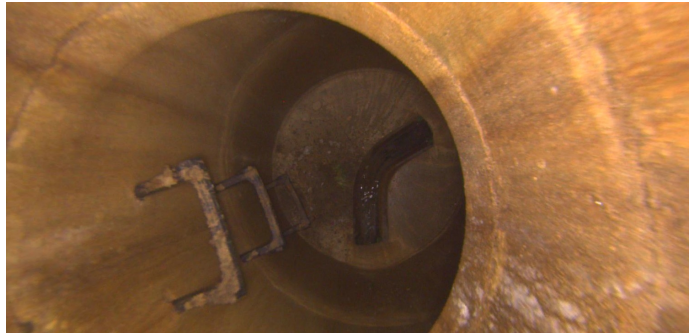
Code: **SRI**
Description: **Surface Roughness Increased**

Distance (ft): **.0**
Structural Grade: **1**
O&M Grade: **0**
Clock Start/From: **12**
Clock To: **12**
1st Value:
2nd Value:
Value Percent:
Step: **NO**
Remarks:

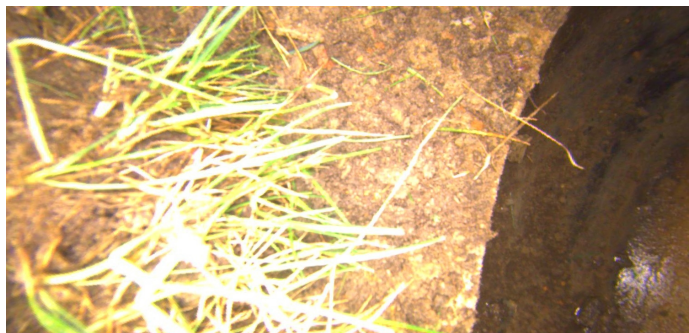
Code: **SRI**
Description: **Surface Roughness Increased**

Distance (ft): **5.3**
Structural Grade: **1**
O&M Grade: **0**
Clock Start/From: **3**
Clock To: **9**
1st Value:
2nd Value:
Value Percent:
Step: **NO**
Remarks:

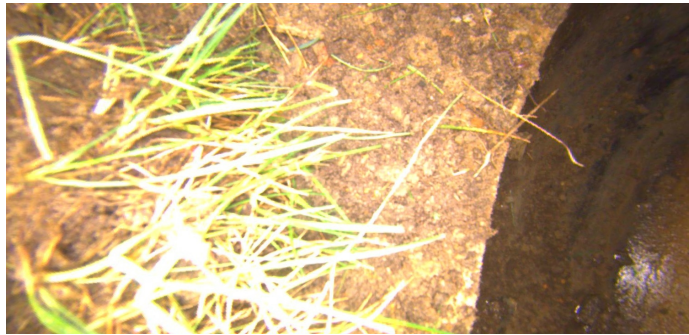
Code: **MGO**
Description: **General Observation**

Distance (ft): **5.3**
Structural Grade: **0**
O&M Grade: **0**
Clock Start/From:
Clock To:
1st Value:
2nd Value:
Value Percent:
Step: **NO**
Remarks: **end of survey**

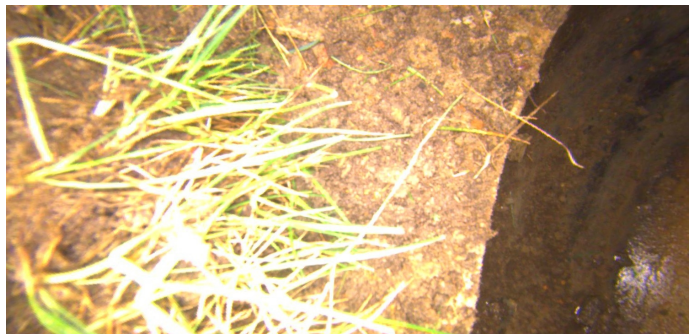
Code: **SRI**
Description: **Surface Roughness Increased**

Distance (ft): **5.3**
Structural Grade: **1**
O&M Grade: **0**
Clock Start/From: **12**
Clock To: **12**
1st Value:
2nd Value:
Value Percent:
Step: **NO**
Remarks:

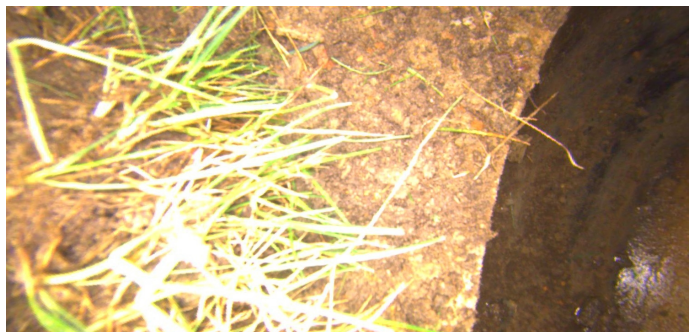
Code: **DSF**
Description: **Deposits Settled Fine**

Distance (ft): **5.3**
Structural Grade: **0**
O&M Grade: **2**
Clock Start/From: **12**
Clock To: **12**
1st Value:
2nd Value:
Value Percent: **5.000**
Step: **NO**
Remarks:
