Manhole Inspection Report

Date:	11/07/2022	Weather:		Coding:	RZMACP
MH#:	M-708-142	Owner:	NA	Len. Surveyed:	5.8
P.O.#:		Surveyor:	Jen Costello	Rim to Invert:	7.0
Customer:		Cert. #:	U-907-5518	Wall Material:	Concrete (non-reinforced)

Street:	Lake St. 214' South of Coral Cove.	Project:	Missing GPS
City:	Hobart, IN	GPS Northing:	2281607.803
Location:		GPS Easting:	2905855.702
Drain Area:	Southwest	GPS Accuracy:	Sub-Meter
Cover Shape:	Circular	Evidence of Surcharge:	No
Cover Size:	24.0	Potential for Runoff:	None
Comments:

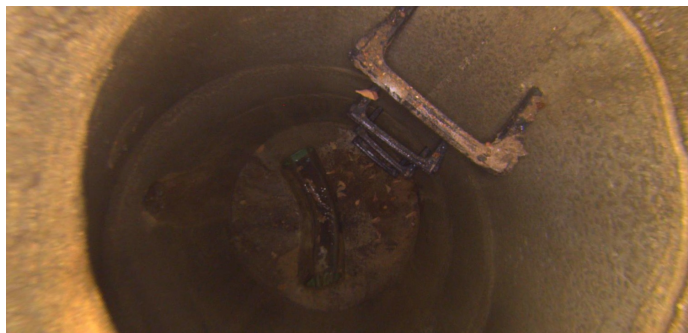
Code: **SRI**
Description: **Surface Roughness Increased**

Distance (ft): **.0**
Structural Grade: **1**
O&M Grade: **0**
Clock Start/From: **12**
Clock To: **12**
1st Value:
2nd Value:
Value Percent:
Step: **NO**
Remarks:

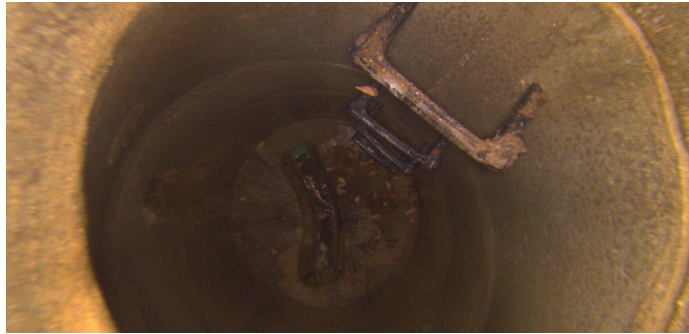
Code: **MGO**
Description: **General Observation**

Distance (ft): **.0**
Structural Grade: **0**
O&M Grade: **0**
Clock Start/From:
Clock To:
1st Value:
2nd Value:
Value Percent:
Step: **NO**
Remarks: **access mh**

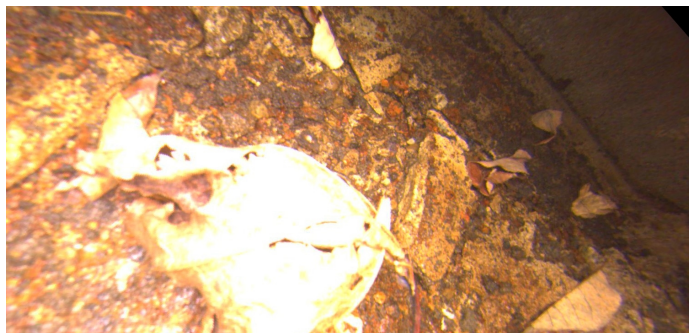
Code: **SRI**
Description: **Surface Roughness Increased**

Distance (ft): **5.8**
Structural Grade: **1**
O&M Grade: **0**
Clock Start/From: **12**
Clock To: **12**
1st Value:
2nd Value:
Value Percent:
Step: **NO**
Remarks:

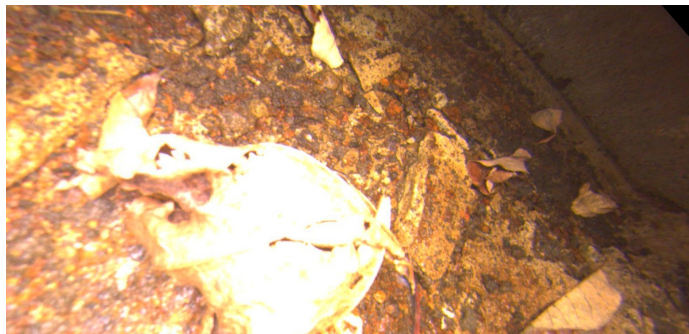
Code:	MGO
Description:	General Observation
Distance (ft):	5.8
Structural Grade:	0
O&M Grade:	0
Clock Start/From:	
Clock To:	
1st Value:	
2nd Value:	
Value Percent:	
Step:	NO
Remarks:	end of survey
