Manhole Inspection Report

Date:	04/18/2018	Weather:		Coding:	RZMACP
MH#:	M-708-161	Owner:	NA	Len. Surveyed:	4.6
P.O.#:		Surveyor:	John Kuglmaier	Rim to Invert:	4.8
Customer:		Cert. #:	U-1215-07002349	Wall Material:	Concrete (reinforced)

Street:	Intersection of 16th St. and Hidden	Project:	Hobart, IN
City:	Hobart, IN	GPS Northing:	0.0
Location:		GPS Easting:	0.0
Drain Area:	Southwest	GPS Accuracy:	Nearest Meter
Cover Shape:	Circular	Evidence of Surcharge:	No
Cover Size:	22.5	Potential for Runoff:	None
Comments:

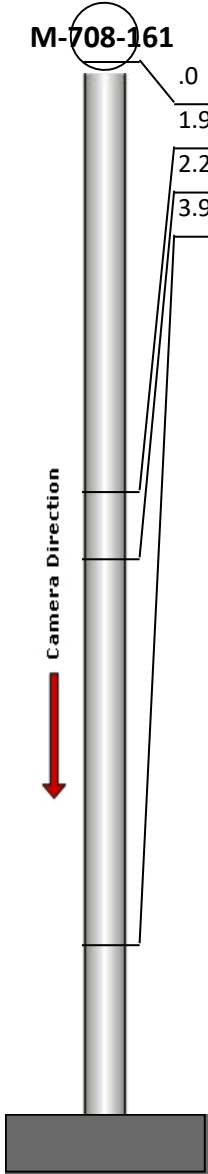
.0	MGP	General Photo	10	NA
	1.9	DSF	Deposits Settled Fine	26	M 2
	2.2	MGP	General Photo	40	NA
	3.9	MGO	General Observation	57	NA

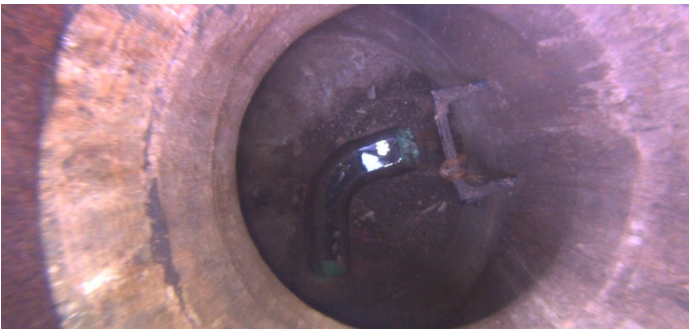
Code: **MGP**
Description: **General Photo**

Distance (ft): **.0**
Structural Grade: **0**
O&M Grade: **0**
Clock Start/From:
Clock To:
1st Value:
2nd Value:
Value Percent:
Step: **NO**
Remarks:

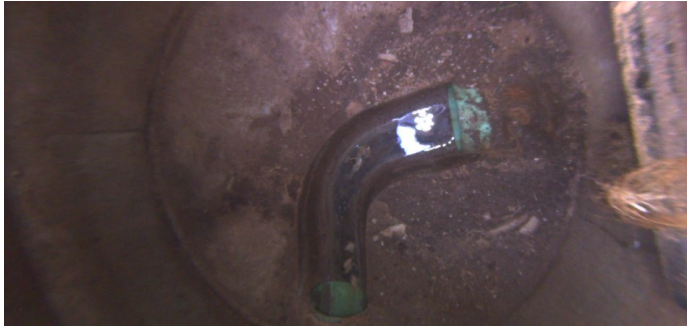
Code: **DSF**
Description: **Deposits Settled Fine**

Distance (ft): **1.9**
Structural Grade: **0**
O&M Grade: **2**
Clock Start/From: **2**
Clock To: **6**
1st Value:
2nd Value:
Value Percent: **5.000**
Step: **NO**
Remarks:

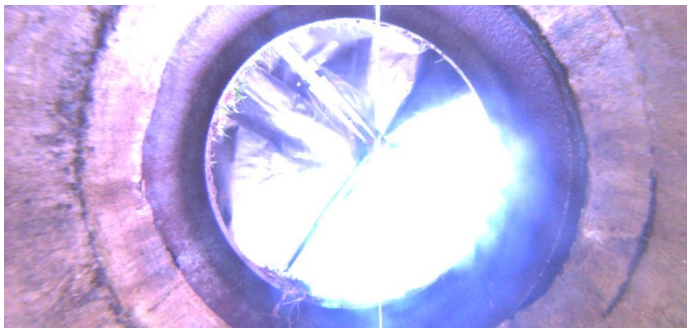
Code: **MGP**
Description: **General Photo**

Distance (ft): **2.2**
Structural Grade: **0**
O&M Grade: **0**
Clock Start/From:
Clock To:
1st Value:
2nd Value:
Value Percent:
Step: **NO**
Remarks:

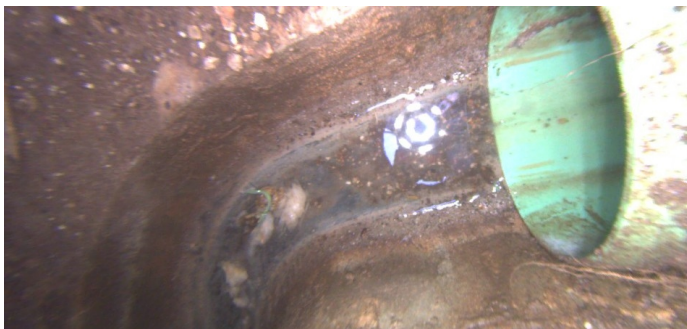
Code: **MGO**
Description: **General Observation**

Distance (ft): **3.9**
Structural Grade: **0**
O&M Grade: **0**
Clock Start/From:
Clock To:
1st Value:
2nd Value:
Value Percent:
Step: **NO**
Remarks: **Ins. Comp.**
