Manhole Inspection Report

Date:	11/07/2022	Weather:		Coding:	RZMACP
MH#:	M-708-162	Owner:	Hobart, IN	Len. Surveyed:	4.0
P.O.#:		Surveyor:	Jen Costello	Rim to Invert:	4.7
Customer:		Cert. #:	U-907-5518	Wall Material:	Concrete (non-reinforced)

Street:	Hidden Oak Dr. 16th St. to the South	Project:	Missing GPS
City:	Hobart, IN	GPS Northing:	2281008.502
Location:		GPS Easting:	2906092.948
Drain Area:	Southwest	GPS Accuracy:	Sub-Meter
Cover Shape:	Circular	Evidence of Surcharge:	No
Cover Size:	24.0	Potential for Runoff:	None
Comments:

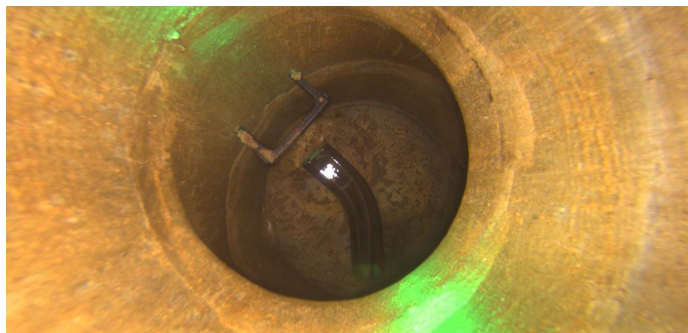
Code: **MGO**
Description: **General Observation**

Distance (ft): **.0**
Structural Grade: **0**
O&M Grade: **0**
Clock Start/From:
Clock To:
1st Value:
2nd Value:
Value Percent:
Step: **NO**
Remarks: **access mh**

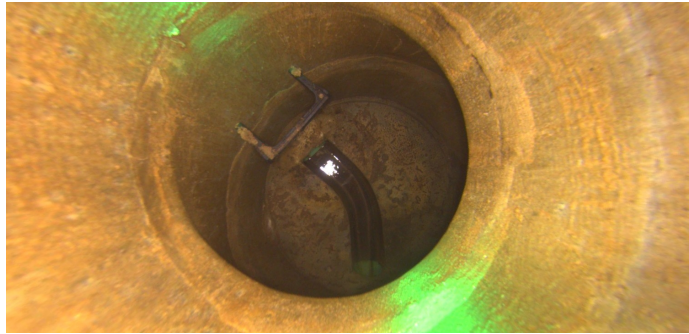
Code: **SRI**
Description: **Surface Roughness Increased**

Distance (ft): **.0**
Structural Grade: **1**
O&M Grade: **0**
Clock Start/From: **12**
Clock To: **12**
1st Value:
2nd Value:
Value Percent:
Step: **NO**
Remarks:

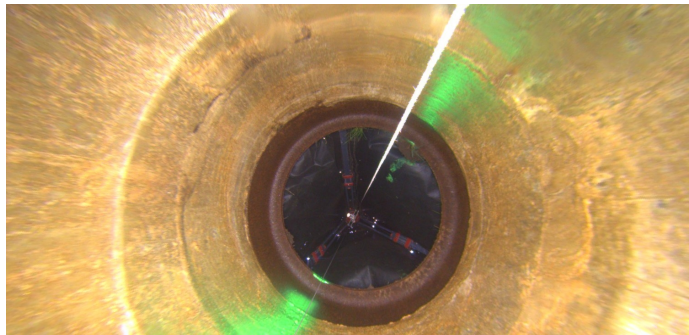
Code: **MGO**
Description: **General Observation**

Distance (ft): **2.2**
Structural Grade: **0**
O&M Grade: **0**
Clock Start/From:
Clock To:
1st Value:
2nd Value:
Value Percent:
Step: **NO**
Remarks: **underside of frame**

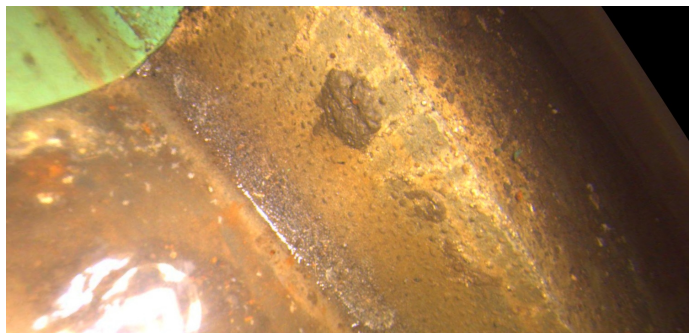
Code: **SAV**
Description: **Surface Aggregate Visible**

Distance (ft): **4.0**
Structural Grade: **3**
O&M Grade: **0**
Clock Start/From: **12**
Clock To: **12**
1st Value:
2nd Value:
Value Percent:
Step: **NO**
Remarks:

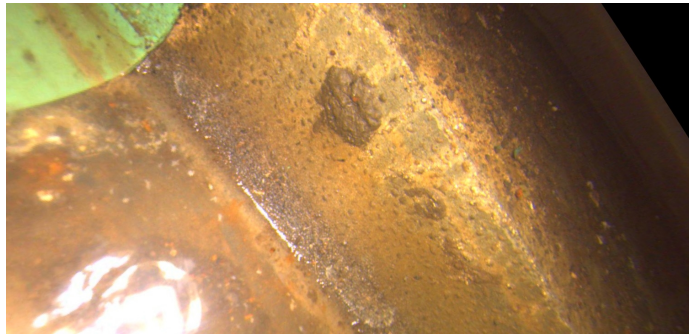
Code:	SAV
Description:	Surface Aggregate Visible
Distance (ft):	4.0
Structural Grade:	3
O&M Grade:	0
Clock Start/From:	3
Clock To:	9
1st Value:	
2nd Value:	
Value Percent:	
Step:	NO
Remarks:

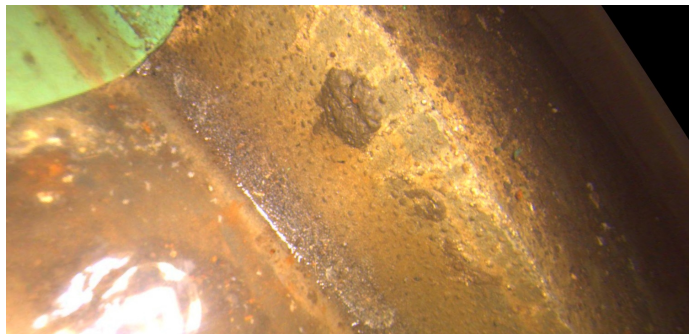
Code:	SRI
Description:	Surface Roughness Increased
Distance (ft):	4.0
Structural Grade:	1
O&M Grade:	0
Clock Start/From:	12
Clock To:	12
1st Value:	
2nd Value:	
Value Percent:	
Step:	NO
Remarks:

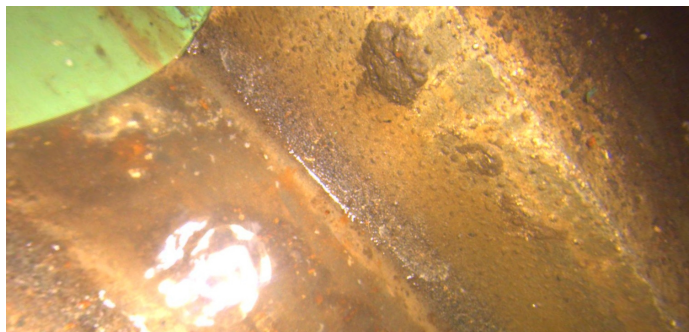
Code:	MGO
Description:	General Observation
Distance (ft):	4.0
Structural Grade:	0
O&M Grade:	0
Clock Start/From:	
Clock To:	
1st Value:	
2nd Value:	
Value Percent:	
Step:	NO
Remarks:	end of survey
