# Manhole Inspection Report

Date:	11/02/2022	Weather:		Coding:	RZMACP
MH#:	M-708-164	Owner:	NA	Len. Surveyed:	3.9
P.O.#:		Surveyor:	Jen Costello	Rim to Invert:	4.5
Customer:		Cert. #:	U-907-5518	Wall Material:	Concrete (non-reinforced)

Street:	Hidden Oak Dr. 116' West of Lincoln	Project:	Missing GPS
City:	Hobart, IN	GPS Northing:	2280962.039
Location:		GPS Easting:	2906469.837
Drain Area:	Southwest	GPS Accuracy:	Sub-Meter
Cover Shape:	Circular	Evidence of Surcharge:	No
Cover Size:	24.0	Potential for Runoff:	None
Comments:

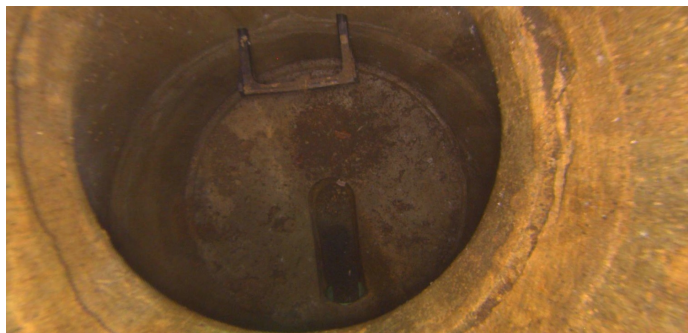
Code: **SRI**  
Description: **Surface Roughness Increased**

Distance (ft): **.0**  
Structural Grade: **1**  
O&M Grade: **0**  
Clock Start/From: **12**  
Clock To: **12**  
1st Value:  
2nd Value:  
Value Percent:  
Step: **NO**  
Remarks:

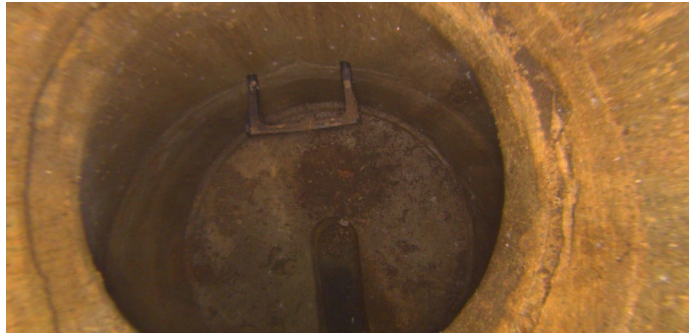
Code: **MGO**  
Description: **General Observation**

Distance (ft): **.0**  
Structural Grade: **0**  
O&M Grade: **0**  
Clock Start/From:  
Clock To:  
1st Value:  
2nd Value:  
Value Percent:  
Step: **NO**  
Remarks: **access mh**

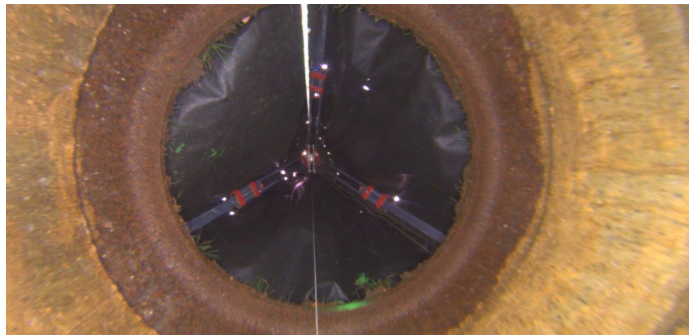
Code: **MGO**  
Description: **General Observation**

Distance (ft): **1.7**  
Structural Grade: **0**  
O&M Grade: **0**  
Clock Start/From:  
Clock To:  
1st Value:  
2nd Value:  
Value Percent:  
Step: **NO**  
Remarks: **underside of frame**

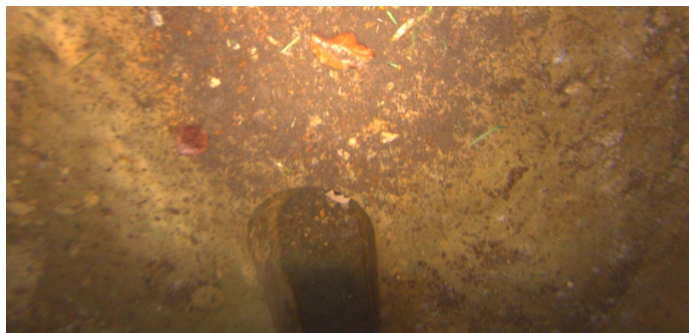
Code: **DSF**  
Description: **Deposits Settled Fine**

Distance (ft): **3.0**  
Structural Grade: **0**  
O&M Grade: **3**  
Clock Start/From: **4**  
Clock To: **8**  
1st Value:  
2nd Value:  
Value Percent: **20.000**  
Step: **NO**  
Remarks:

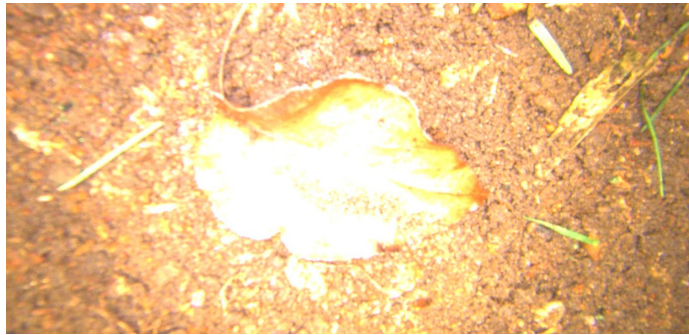
Code: **DSF**  
Description: **Deposits Settled Fine**

Distance (ft): **3.9**  
Structural Grade: **0**  
O&M Grade: **2**  
Clock Start/From: **12**  
Clock To: **12**  
1st Value:  
2nd Value:  
Value Percent: **5.000**  
Step: **NO**  
Remarks:

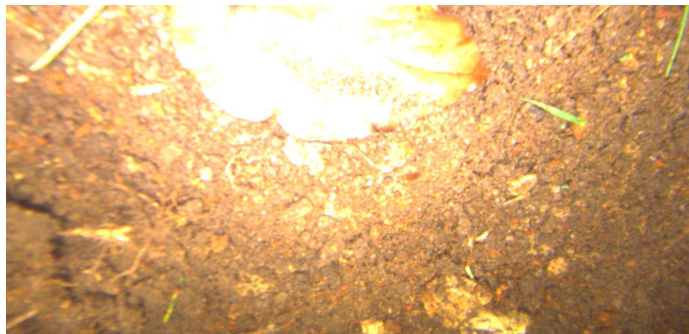
Code: **MGO**  
Description: **General Observation**

Distance (ft): **3.9**  
Structural Grade: **0**  
O&M Grade: **0**  
Clock Start/From:  
Clock To:  
1st Value:  
2nd Value:  
Value Percent:  
Step: **NO**  
Remarks: **end of survey**

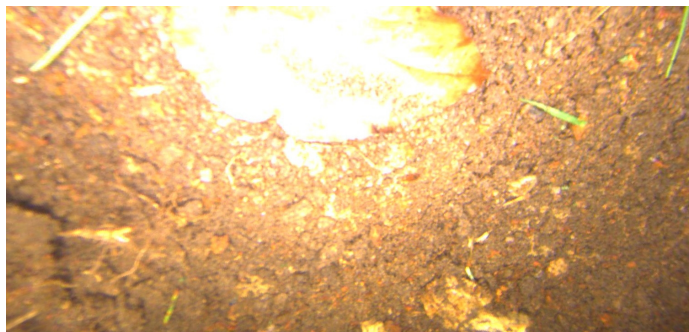
Code: **SRI**  
Description: **Surface Roughness Increased**

Distance (ft): **3.9**  
Structural Grade: **1**  
O&M Grade: **0**  
Clock Start/From: **12**  
Clock To: **12**  
1st Value:  
2nd Value:  
Value Percent:  
Step: **NO**  
Remarks:
