Manhole Inspection Report

Date:	11/02/2022	Weather:		Coding:	RZMACP
MH#:	M-708-167	Owner:	NA	Len. Surveyed:	4.7
P.O.#:		Surveyor:	Jen Costello	Rim to Invert:	5.7
Customer:		Cert. #:	U-907-5518	Wall Material:	Concrete (non-reinforced)

Street:	Capitol Dr. 242' West of Bracken Par	Project:	Missing GPS
City:	Hobart, IN	GPS Northing:	2280299.154
Location:		GPS Easting:	2906750.805
Drain Area:	Southwest	GPS Accuracy:	Sub-Meter
Cover Shape:	Circular	Evidence of Surcharge:	No
Cover Size:	24.0	Potential for Runoff:	None
Comments:

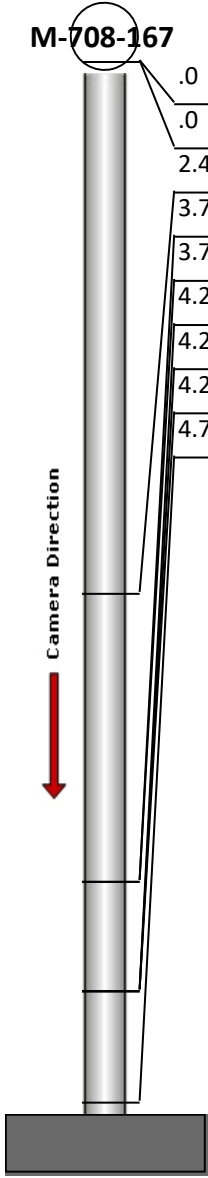
.0	MGO	General Observation	31	NA
	.0	SRI	Surface Roughness Increased	31	S 1
	2.4	MGO	General Observation	16	NA
	3.7	IW	Infil Weeper	8	M 2
	3.7	IW	Infil Weeper	8	M 2
	4.2	IW	Infil Weeper	4	M 2
	4.2	DSF	Deposits Settled Fine	4	M 2
	4.2	SRI	Surface Roughness Increased	4	S 1
	4.7	MGO	General Observation	0	NA

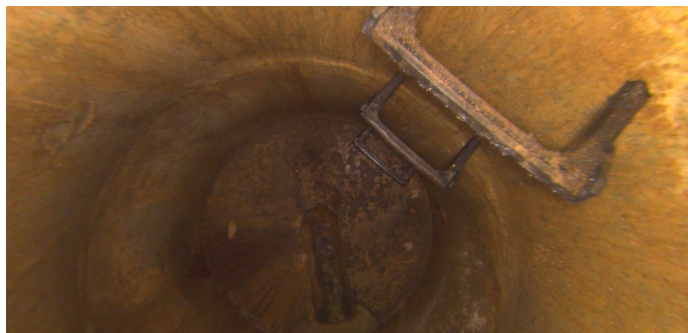
Code: **MGO**
Description: **General Observation**

Distance (ft): **.0**
Structural Grade: **0**
O&M Grade: **0**
Clock Start/From:
Clock To:
1st Value:
2nd Value:
Value Percent:
Step: **NO**
Remarks: **access mh**

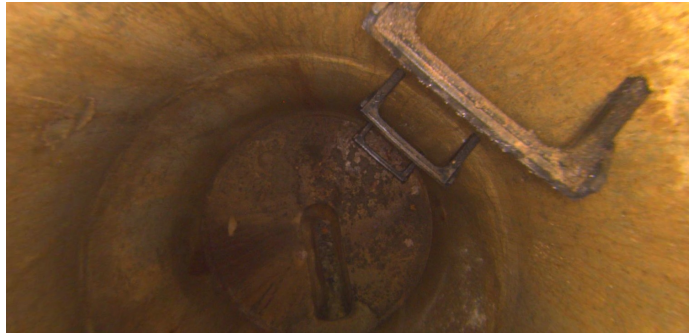
Code: **SRI**
Description: **Surface Roughness Increased**

Distance (ft): **.0**
Structural Grade: **1**
O&M Grade: **0**
Clock Start/From: **12**
Clock To: **12**
1st Value:
2nd Value:
Value Percent:
Step: **NO**
Remarks:

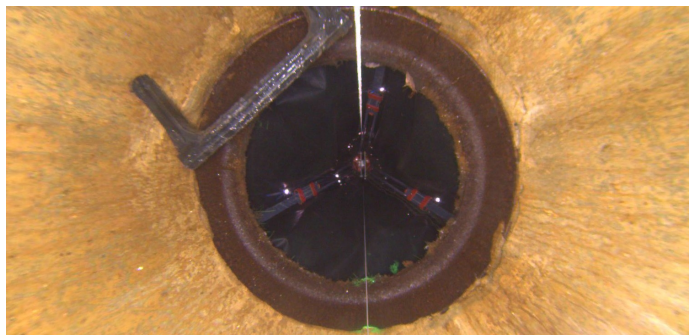
Code: **MGO**
Description: **General Observation**

Distance (ft): **2.4**
Structural Grade: **0**
O&M Grade: **0**
Clock Start/From:
Clock To:
1st Value:
2nd Value:
Value Percent:
Step: **NO**
Remarks: **underside of frame**

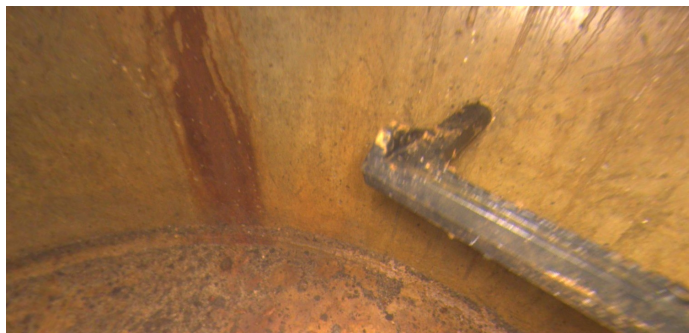
Code: **IW**
Description: **Infil Weeper**

Distance (ft): **3.7**
Structural Grade: **0**
O&M Grade: **2**
Clock Start/From: **12**
Clock To:
1st Value:
2nd Value:
Value Percent:
Step: **NO**
Remarks:

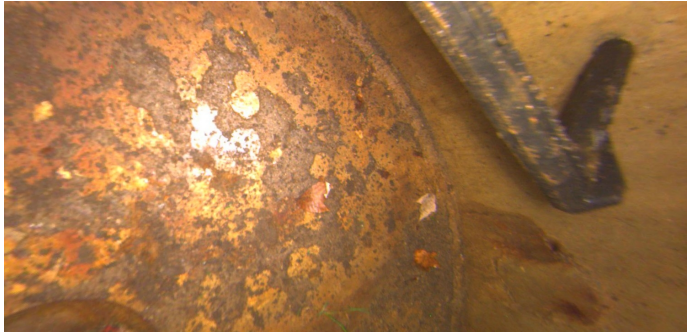
Code: **IW**
Description: **Infil Weeper**

Distance (ft): **3.7**
Structural Grade: **0**
O&M Grade: **2**
Clock Start/From: **3**
Clock To:
1st Value:
2nd Value:
Value Percent:
Step: **NO**
Remarks:

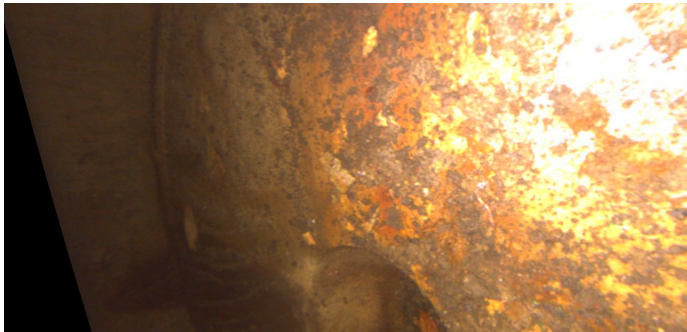
Code: **IW**
Description: **Infil Weeper**

Distance (ft): **4.2**
Structural Grade: **0**
O&M Grade: **2**
Clock Start/From: **9**
Clock To:
1st Value:
2nd Value:
Value Percent:
Step: **NO**
Remarks:

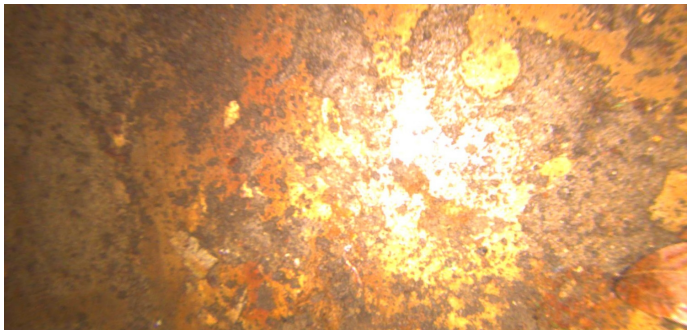
Code: **DSF**
Description: **Deposits Settled Fine**

Distance (ft): **4.2**
Structural Grade: **0**
O&M Grade: **2**
Clock Start/From: **12**
Clock To: **12**
1st Value:
2nd Value:
Value Percent: **5.000**
Step: **NO**
Remarks:

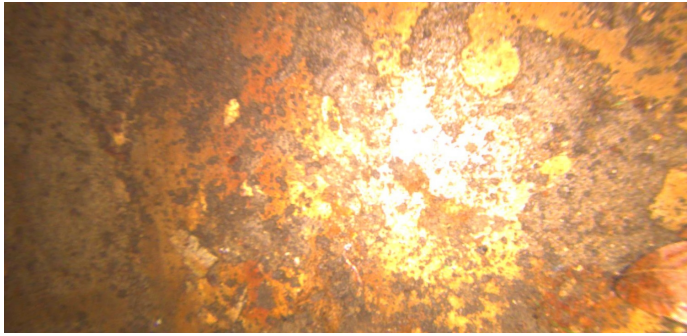
Code: **SRI**
Description: **Surface Roughness Increased**

Distance (ft): **4.2**
Structural Grade: **1**
O&M Grade: **0**
Clock Start/From: **12**
Clock To: **12**
1st Value:
2nd Value:
Value Percent:
Step: **NO**
Remarks:

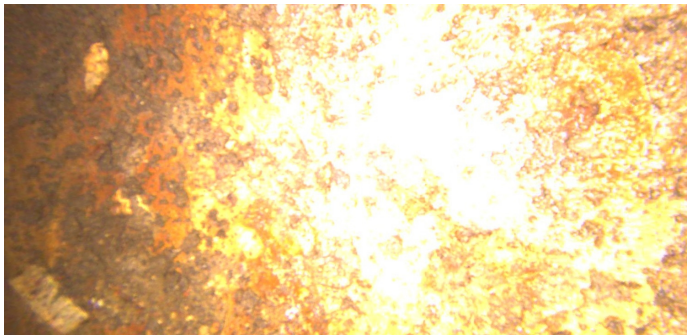
Code: **MGO**
Description: **General Observation**

Distance (ft): **4.7**
Structural Grade: **0**
O&M Grade: **0**
Clock Start/From:
Clock To:
1st Value:
2nd Value:
Value Percent:
Step: **NO**
Remarks: **end of survey**
