# Manhole Inspection Report

Date:	<b>04/10/2018</b>	Weather:		Coding:	<b>RZMACP</b>
MH#:	<b>M-708-169</b>	Owner:	<b>NA</b>	Len. Surveyed:	<b>6.4</b>
P.O.#:		Surveyor:	<b>John Kuglmaier</b>	Rim to Invert:	<b>7.4</b>
Customer:		Cert. #:	<b>U-1215-07002349</b>	Wall Material:	<b>Concrete (reinforced)</b>

Street:	<b>Azalea Dr. and Magnolia Dr.</b>	Project:	<b>Hobart, IN</b>
City:	<b>Hobart, IN</b>	GPS Northing:	<b>2906032.773</b>
Location:		GPS Easting:	<b>2906032.773</b>
Drain Area:	<b>Southwest</b>	GPS Accuracy:	<b>Sub-Meter</b>
Cover Shape:	<b>Circular</b>	Evidence of Surcharge:	<b>No</b>
Cover Size:	<b>22.5</b>	Potential for Runoff:	<b>None</b>
Comments:

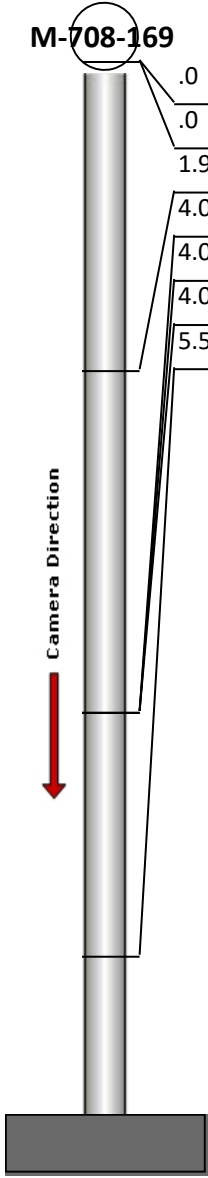
.0	MGP	General Photo	10	NA
	.0	RFJ	Roots Fine Joint	22	M 1
	1.9	MGP	General Photo	40	NA
	4.0	IS	Infil Stain	58	NA
	4.0	IS	Infil Stain	70	NA
	4.0	IS	Infil Stain	81	NA
	5.5	MGO	General Observation	96	NA

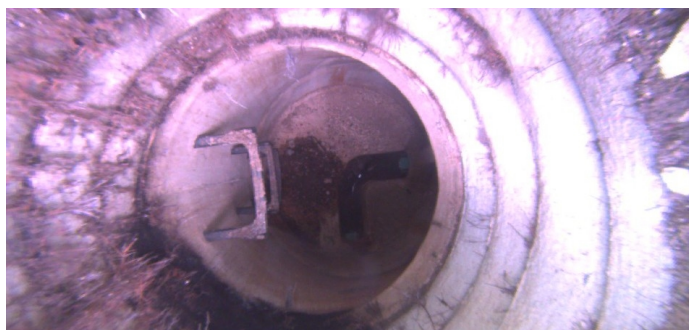
Code: **MGP**  
Description: **General Photo**

Distance (ft): **.0**  
Structural Grade: **0**  
O&M Grade: **0**  
Clock Start/From:  
Clock To:  
1st Value:  
2nd Value:  
Value Percent:  
Step: **NO**  
Remarks:

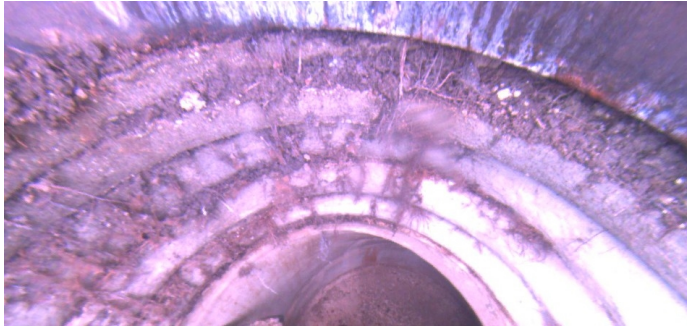
Code:	RFJ
Description:	Roots Fine Joint
Distance (ft):	.0
Structural Grade:	0
O&M Grade:	1
Clock Start/From:	12
Clock To:	12
1st Value:	
2nd Value:	
Value Percent:	
Step:	NO
Remarks:

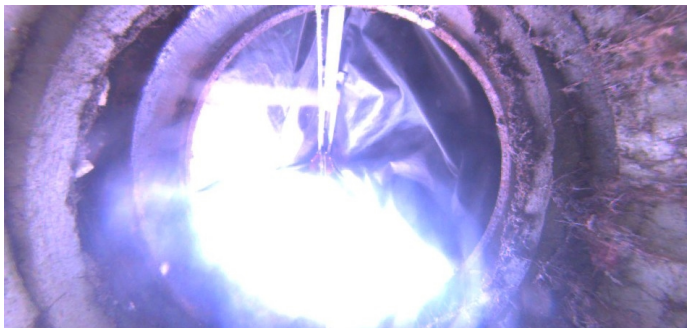
Code:	MGP
Description:	General Photo
Distance (ft):	1.9
Structural Grade:	0
O&M Grade:	0
Clock Start/From:	
Clock To:	
1st Value:	
2nd Value:	
Value Percent:	
Step:	NO
Remarks:

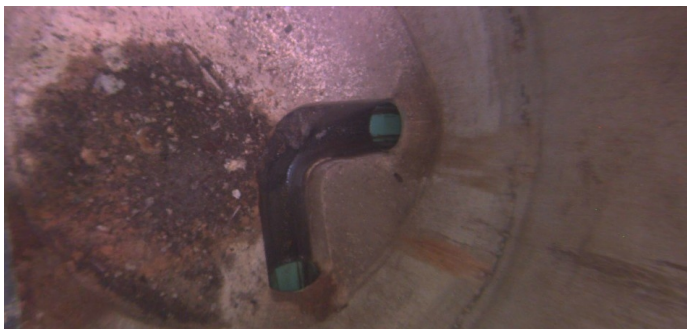
Code:	IS
Description:	Infil Stain
Distance (ft):	4.0
Structural Grade:	0
O&M Grade:	0
Clock Start/From:	3
Clock To:	4
1st Value:	
2nd Value:	
Value Percent:	
Step:	NO
Remarks:

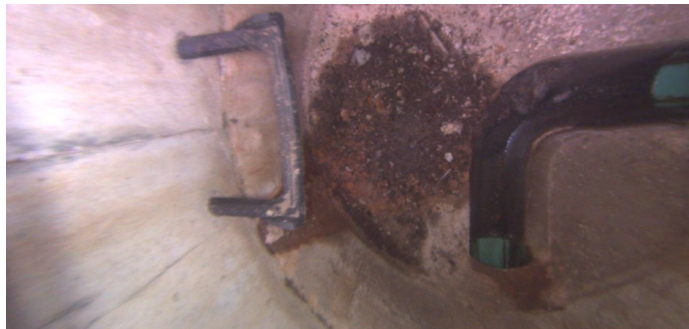
Code: **IS**  
Description: **Infil Stain**

Distance (ft): **4.0**  
Structural Grade: **0**  
O&M Grade: **0**  
Clock Start/From: **8**  
Clock To:  
1st Value:  
2nd Value:  
Value Percent:  
Step: **NO**  
Remarks:

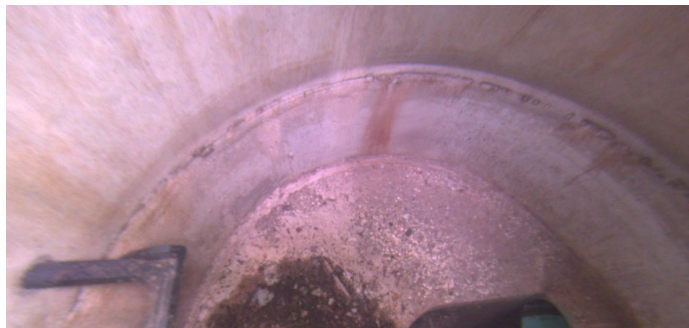
Code: **IS**  
Description: **Infil Stain**

Distance (ft): **4.0**  
Structural Grade: **0**  
O&M Grade: **0**  
Clock Start/From: **12**  
Clock To:  
1st Value:  
2nd Value:  
Value Percent:  
Step: **NO**  
Remarks:

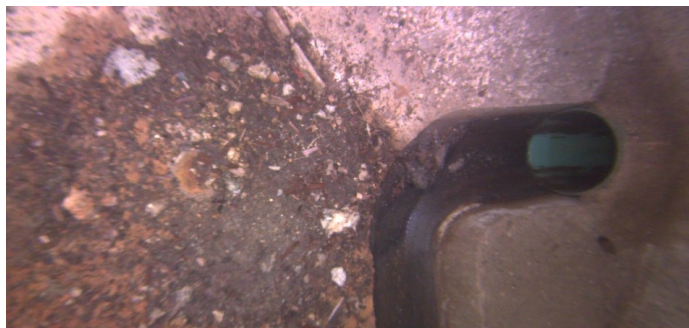
Code: **MGO**  
Description: **General Observation**

Distance (ft): **5.5**  
Structural Grade: **0**  
O&M Grade: **0**  
Clock Start/From:  
Clock To:  
1st Value:  
2nd Value:  
Value Percent:  
Step: **NO**  
Remarks: **Ins. Comp.**
