# Manhole Inspection Report

Date:	<b>04/19/2018</b>	Weather:		Coding:	<b>RZMACP</b>
MH#:	<b>M-708-198</b>	Owner:	<b>NA</b>	Len. Surveyed:	<b>5.9</b>
P.O.#:		Surveyor:	<b>John Kuglmaier</b>	Rim to Invert:	<b>6.5</b>
Customer:		Cert. #:	<b>U-1215-07002349</b>	Wall Material:	<b>Concrete (reinforced)</b>

Street:	<b>644' East of 14th St. and Hwy 51.</b>	Project:	<b>Hobart, IN</b>
City:	<b>Hobart, IN</b>	GPS Northing:	<b>2905302.263</b>
Location:		GPS Easting:	<b>2905302.263</b>
Drain Area:	<b>Southwest</b>	GPS Accuracy:	<b>Sub-Meter</b>
Cover Shape:	<b>Circular</b>	Evidence of Surcharge:	<b>No</b>
Cover Size:	<b>22.5</b>	Potential for Runoff:	<b>None</b>
Comments:

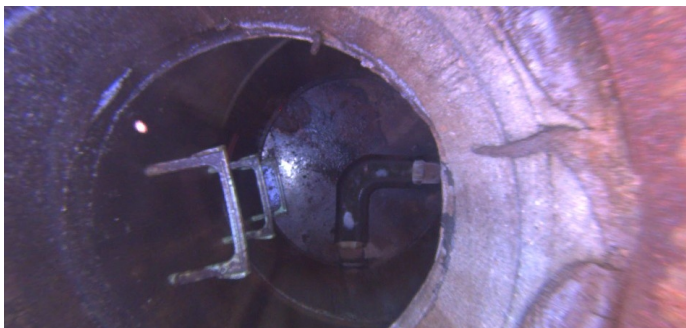
Code:	<b>MGP</b>
Description:	<b>General Photo</b>

Distance (ft):	.0
Structural Grade:	0
O&M Grade:	0
Clock Start/From:	
Clock To:	
1st Value:	
2nd Value:	
Value Percent:	
Step:	NO
Remarks:

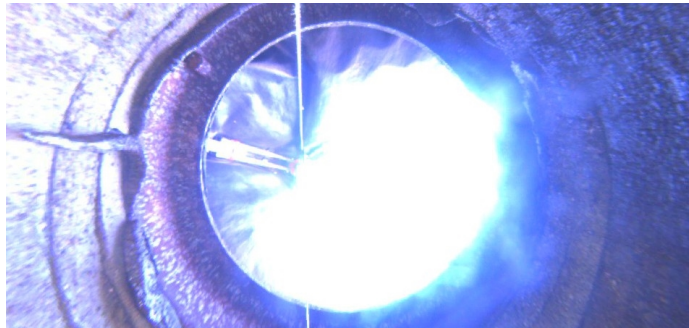
Code:	<b>MGP</b>
Description:	<b>General Photo</b>
Distance (ft):	<b>2.2</b>
Structural Grade:	<b>0</b>
O&M Grade:	<b>0</b>
Clock Start/From:	
Clock To:	
1st Value:	
2nd Value:	
Value Percent:	
Step:	<b>NO</b>
Remarks:

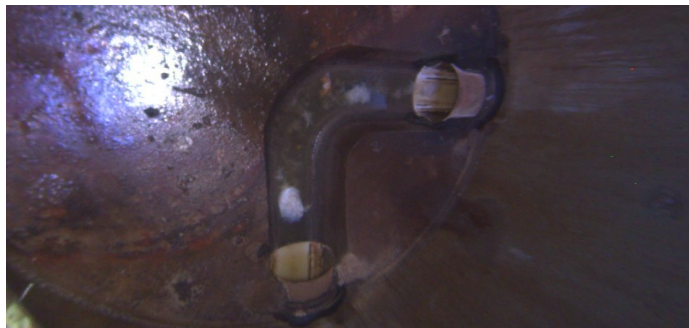
Code:	<b>IS</b>
Description:	<b>Infil Stain</b>
Distance (ft):	<b>4.0</b>
Structural Grade:	<b>0</b>
O&M Grade:	<b>0</b>
Clock Start/From:	<b>4</b>
Clock To:	
1st Value:	
2nd Value:	
Value Percent:	
Step:	<b>NO</b>
Remarks:

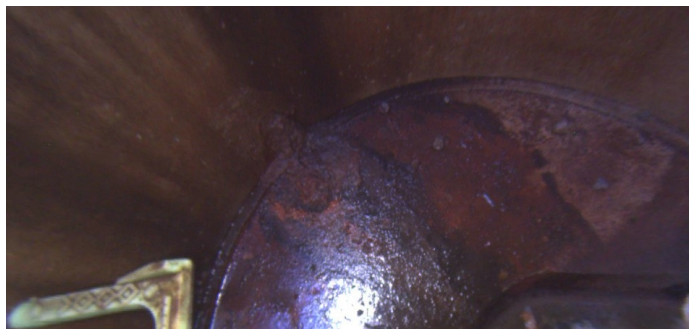
Code:	<b>IS</b>
Description:	<b>Infil Stain</b>
Distance (ft):	<b>4.0</b>
Structural Grade:	<b>0</b>
O&M Grade:	<b>0</b>
Clock Start/From:	<b>11</b>
Clock To:	
1st Value:	
2nd Value:	
Value Percent:	
Step:	<b>NO</b>
Remarks:

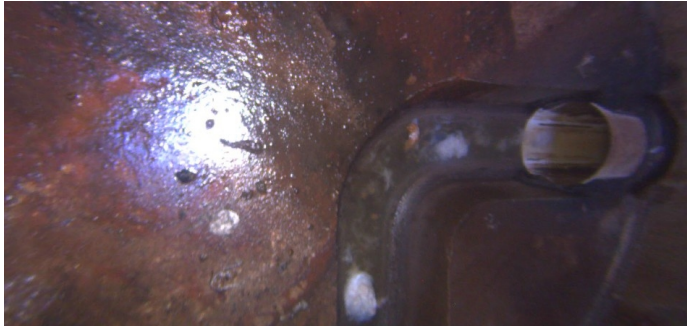
Code:	<b>MGO</b>
Description:	<b>General Observation</b>
Distance (ft):	<b>4.9</b>
Structural Grade:	<b>0</b>
O&M Grade:	<b>0</b>
Clock Start/From:	
Clock To:	
1st Value:	
2nd Value:	
Value Percent:	
Step:	<b>NO</b>
Remarks:	<b>Ins. Comp.</b>
