Manhole Inspection Report

Date:	04/09/2018	Weather:		Coding:	RZMACP
MH#:	M-708-202	Owner:	NA	Len. Surveyed:	15.4
P.O.#:		Surveyor:	John Kuglmaier	Rim to Invert:	16.0
Customer:		Cert. #:	U-1215-07002349	Wall Material:	Concrete (reinforced)

Street:	Bracken Pky. and Capitol Dr.	Project:	Hobart, IN
City:	Hobart, IN	GPS Northing:	2907058.577
Location:		GPS Easting:	2907058.577
Drain Area:	Southwest	GPS Accuracy:	Sub-Meter
Cover Shape:	Circular	Evidence of Surcharge:	No
Cover Size:	22.5	Potential for Runoff:	None
Comments:

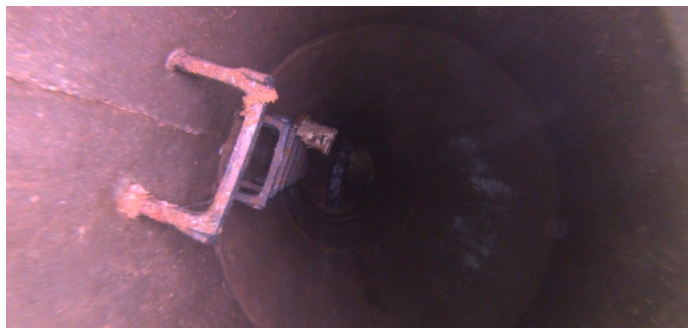
Code: **MGP**
Description: **General Photo**

Distance (ft): **.0**
Structural Grade: **0**
O&M Grade: **0**
Clock Start/From:
Clock To:
1st Value:
2nd Value:
Value Percent:
Step: **NO**
Remarks:

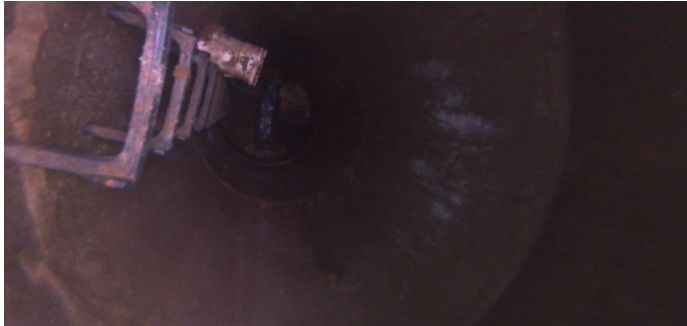
Code: **IS**
Description: **Infil Stain**

Distance (ft): **1.6**
Structural Grade: **0**
O&M Grade: **0**
Clock Start/From: **6**
Clock To:
1st Value:
2nd Value:
Value Percent:
Step: **NO**
Remarks:

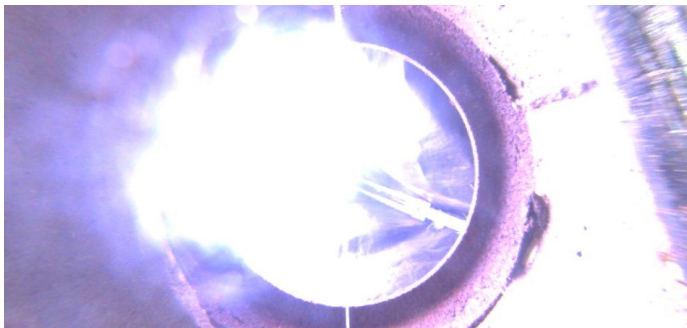
Code: **MGP**
Description: **General Photo**

Distance (ft): **2.3**
Structural Grade: **0**
O&M Grade: **0**
Clock Start/From:
Clock To:
1st Value:
2nd Value:
Value Percent:
Step: **NO**
Remarks:

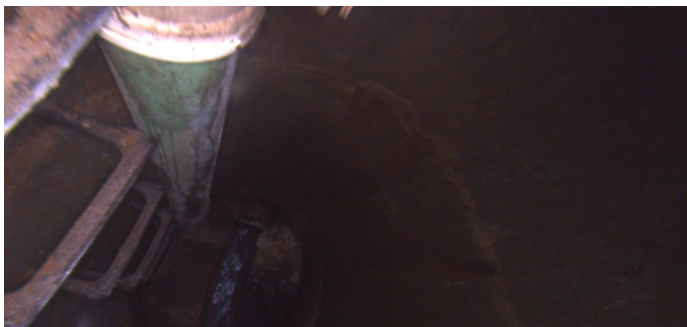
Code: **IS**
Description: **Infil Stain**

Distance (ft): **6.4**
Structural Grade: **0**
O&M Grade: **0**
Clock Start/From: **2**
Clock To: **3**
1st Value:
2nd Value:
Value Percent:
Step: **NO**
Remarks:

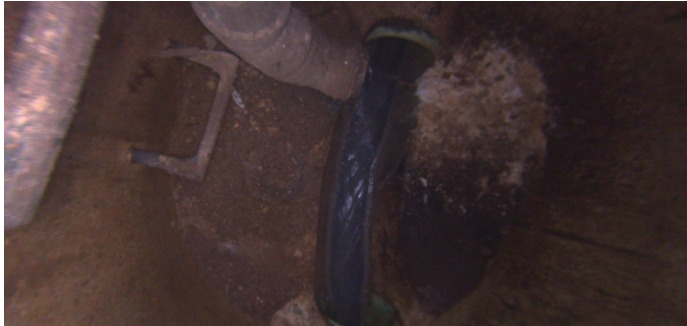
Code:	DAZ
Description:	Deposits Attached Other
Distance (ft):	12.5
Structural Grade:	0
O&M Grade:	2
Clock Start/From:	12
Clock To:	12
1st Value:	
2nd Value:	
Value Percent:	10.000
Step:	NO
Remarks:	Mixed materials

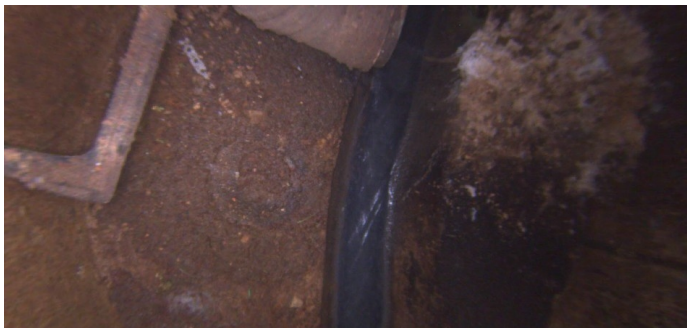
Code:	MGO
Description:	General Observation
Distance (ft):	13.8
Structural Grade:	0
O&M Grade:	0
Clock Start/From:	
Clock To:	
1st Value:	
2nd Value:	
Value Percent:	
Step:	NO
Remarks:	Ins. Comp.
