Manhole Inspection Report

Date:	09/21/2022	Weather:		Coding:	RZMACP
MH#:	M-709-002	Owner:	NA	Len. Surveyed:	9.9
P.O.#:		Surveyor:	Jen Costello	Rim to Invert:	11.1
Customer:		Cert. #:	U-907-5518	Wall Material:	Concrete (cast in place)

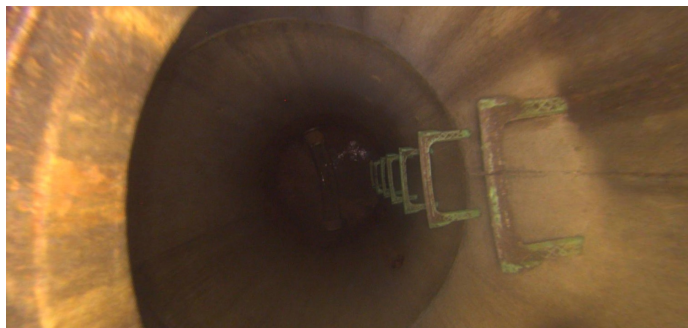
Code: **MGO**
Description: **General Observation**

Distance (ft): **.0**
Structural Grade: **0**
O&M Grade: **0**
Clock Start/From:
Clock To:
1st Value:
2nd Value:
Value Percent:
Step: **NO**
Remarks: **access mh**

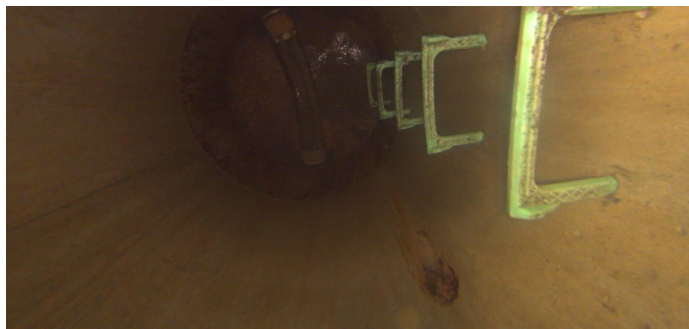
Code: **IW**
Description: **Infil Weeper**

Distance (ft): **3.1**
Structural Grade: **0**
O&M Grade: **2**
Clock Start/From: **5**
Clock To:
1st Value:
2nd Value:
Value Percent:
Step: **NO**
Remarks:

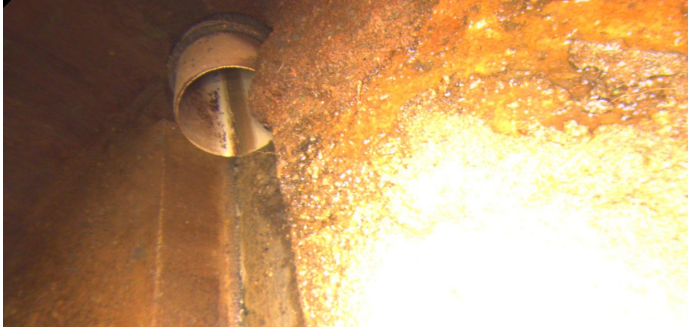
Code:	MGO
Description:	General Observation
Distance (ft):	9.9
Structural Grade:	0
O&M Grade:	0
Clock Start/From:	
Clock To:	
1st Value:	
2nd Value:	
Value Percent:	
Step:	NO
Remarks:	end of survey
