# Manhole Inspection Report

Date:	<b>04/10/2018</b>	Weather:		Coding:	<b>RZMACP</b>
MH#:	<b>M-709-004</b>	Owner:	<b>NA</b>	Len. Surveyed:	<b>13.3</b>
P.O.#:		Surveyor:	<b>John Kuglmaier</b>	Rim to Invert:	<b>13.7</b>
Customer:		Cert. #:	<b>U-1215-07002349</b>	Wall Material:	<b>Concrete (reinforced)</b>

Street:	<b>Bracken Parkway. 195' Southeast of</b>	Project:	<b>Hobart, IN</b>
City:	<b>Hobart, IN</b>	GPS Northing:	<b>2907090.383</b>
Location:		GPS Easting:	<b>2907090.383</b>
Drain Area:	<b>Southwest</b>	GPS Accuracy:	<b>Sub-Meter</b>
Cover Shape:	<b>Circular</b>	Evidence of Surcharge:	<b>No</b>
Cover Size:	<b>22.5</b>	Potential for Runoff:	<b>None</b>
Comments:

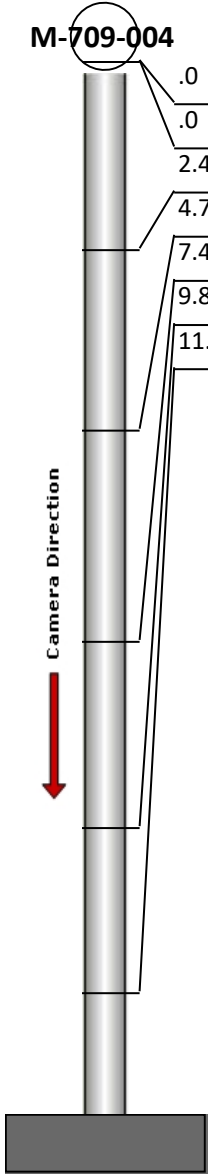
.0	MGP	General Photo	10	NA
	.0	ISSRH	Intruding Sealing Ring Hanging	22	M 2
	2.4	MGP	General Photo	41	NA
	4.7	IS	Infil Stain	59	NA
	7.4	IS	Infil Stain	76	NA
	9.8	DSF	Deposits Settled Fine	92	M 2
	11.9	MGO	General Observation	108	NA

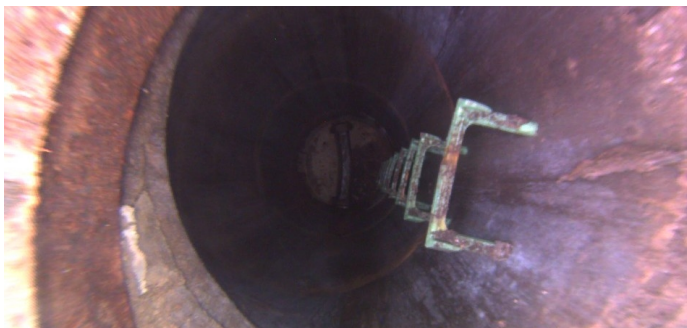
Code: **MGP**  
Description: **General Photo**

Distance (ft): **.0**  
Structural Grade: **0**  
O&M Grade: **0**  
Clock Start/From:  
Clock To:  
1st Value:  
2nd Value:  
Value Percent:  
Step: **NO**  
Remarks:

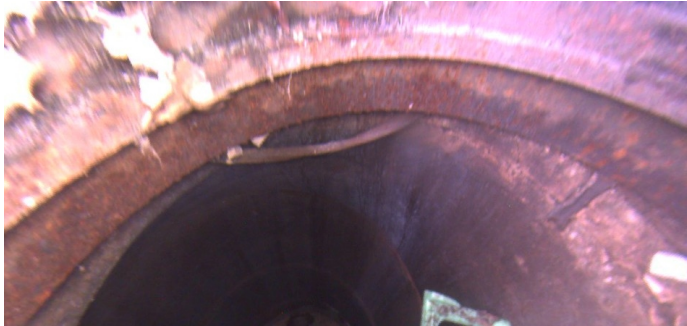
Code:	<b>ISSRH</b>
Description:	<b>Intruding Sealing Ring Hanging</b>
Distance (ft):	<b>.0</b>
Structural Grade:	<b>0</b>
O&M Grade:	<b>2</b>
Clock Start/From:	<b>11</b>
Clock To:	<b>12</b>
1st Value:	
2nd Value:	
Value Percent:	<b>5.000</b>
Step:	<b>NO</b>
Remarks:

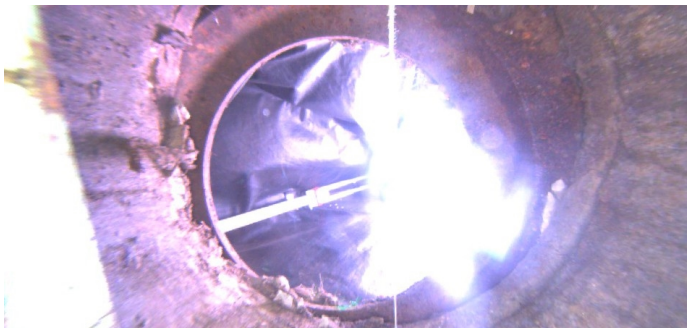
Code:	<b>MGP</b>
Description:	<b>General Photo</b>
Distance (ft):	<b>2.4</b>
Structural Grade:	<b>0</b>
O&M Grade:	<b>0</b>
Clock Start/From:	
Clock To:	
1st Value:	
2nd Value:	
Value Percent:	
Step:	<b>NO</b>
Remarks:

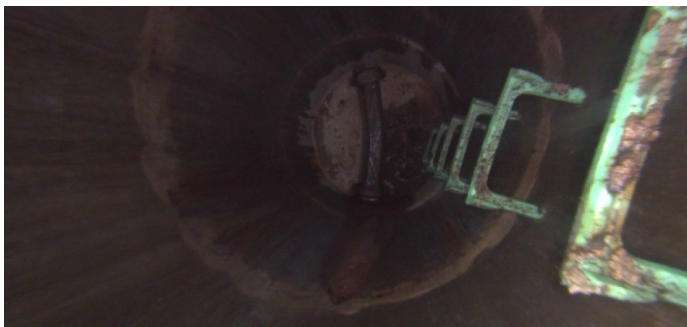
Code:	<b>IS</b>
Description:	<b>Infil Stain</b>
Distance (ft):	<b>4.7</b>
Structural Grade:	<b>0</b>
O&M Grade:	<b>0</b>
Clock Start/From:	<b>6</b>
Clock To:	
1st Value:	
2nd Value:	
Value Percent:	
Step:	<b>NO</b>
Remarks:

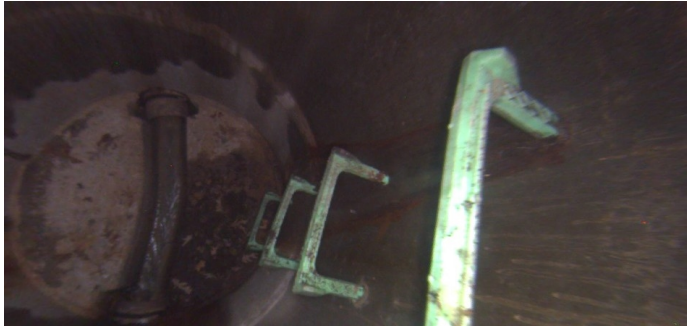
Code: **IS**  
Description: **Infil Stain**

Distance (ft): **7.4**  
Structural Grade: **0**  
O&M Grade: **0**  
Clock Start/From: **2**  
Clock To:  
1st Value:  
2nd Value:  
Value Percent:  
Step: **NO**  
Remarks:

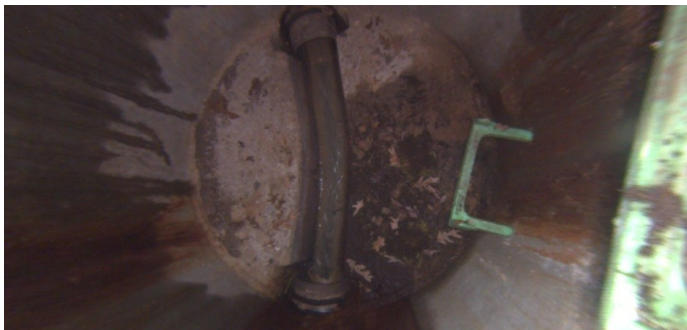
Code: **DSF**  
Description: **Deposits Settled Fine**

Distance (ft): **9.8**  
Structural Grade: **0**  
O&M Grade: **2**  
Clock Start/From: **2**  
Clock To: **5**  
1st Value:  
2nd Value:  
Value Percent: **5.000**  
Step: **NO**  
Remarks:

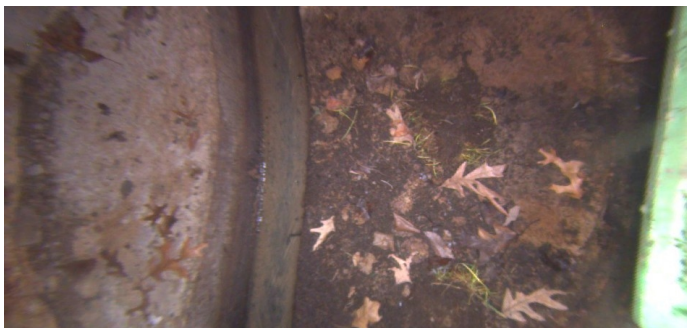
Code: **MGO**  
Description: **General Observation**

Distance (ft): **11.9**  
Structural Grade: **0**  
O&M Grade: **0**  
Clock Start/From:  
Clock To:  
1st Value:  
2nd Value:  
Value Percent:  
Step: **NO**  
Remarks: **Ins. Comp.**
