# Manhole Inspection Report

Date:	<b>04/10/2018</b>	Weather:		Coding:	<b>RZMACP</b>
MH#:	<b>M-709-005</b>	Owner:	<b>NA</b>	Len. Surveyed:	<b>7.2</b>
P.O.#:		Surveyor:	<b>John Kuglmaier</b>	Rim to Invert:	<b>14.8</b>
Customer:		Cert. #:	<b>U-1215-07002349</b>	Wall Material:	<b>Concrete (reinforced)</b>

Street:	<b>Intersection of Dunlin Ct. and Brack</b>	Project:	<b>Hobart, IN</b>
City:	<b>Hobart, IN</b>	GPS Northing:	<b>2906996.698</b>
Location:		GPS Easting:	<b>2906996.698</b>
Drain Area:	<b>Southwest</b>	GPS Accuracy:	<b>Sub-Meter</b>
Cover Shape:	<b>Circular</b>	Evidence of Surcharge:	<b>No</b>
Cover Size:	<b>22.5</b>	Potential for Runoff:	<b>None</b>
Comments:

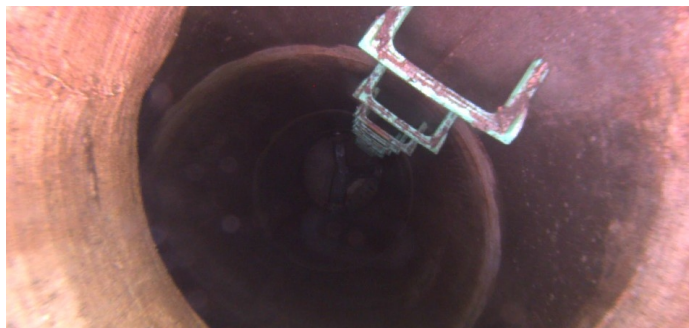
Code: **MGP**  
Description: **General Photo**

Distance (ft): **.0**  
Structural Grade: **0**  
O&M Grade: **0**  
Clock Start/From:  
Clock To:  
1st Value:  
2nd Value:  
Value Percent:  
Step: **NO**  
Remarks:

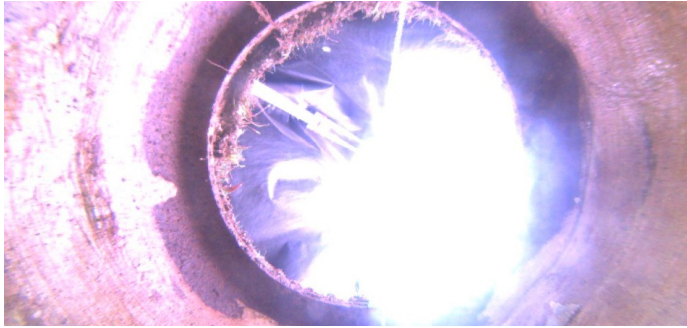
Code: **MGP**  
Description: **General Photo**

Distance (ft): **2.3**  
Structural Grade: **0**  
O&M Grade: **0**  
Clock Start/From:  
Clock To:  
1st Value:  
2nd Value:  
Value Percent:  
Step: **NO**  
Remarks:

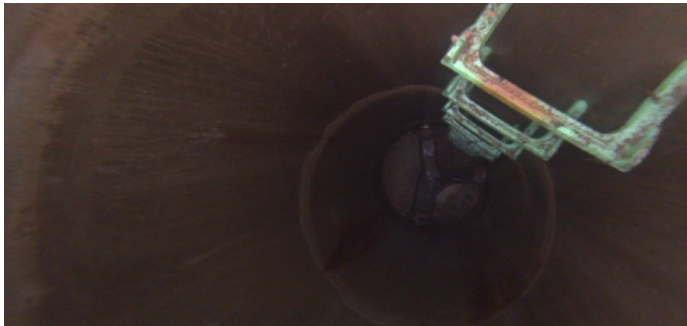
Code: **IS**  
Description: **Infil Stain**

Distance (ft): **2.6**  
Structural Grade: **0**  
O&M Grade: **0**  
Clock Start/From: **10**  
Clock To:  
1st Value:  
2nd Value:  
Value Percent:  
Step: **NO**  
Remarks:

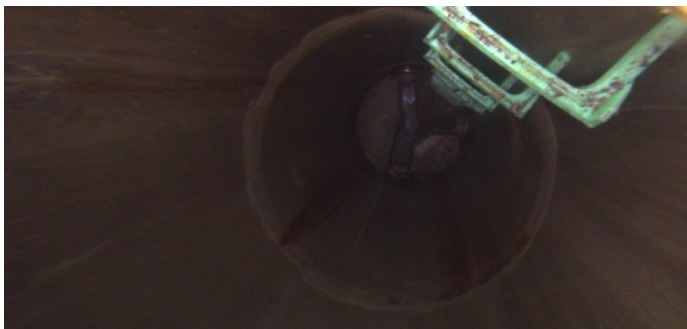
Code: **IS**  
Description: **Infil Stain**

Distance (ft): **3.7**  
Structural Grade: **0**  
O&M Grade: **0**  
Clock Start/From: **4**  
Clock To: **5**  
1st Value:  
2nd Value:  
Value Percent:  
Step: **NO**  
Remarks:

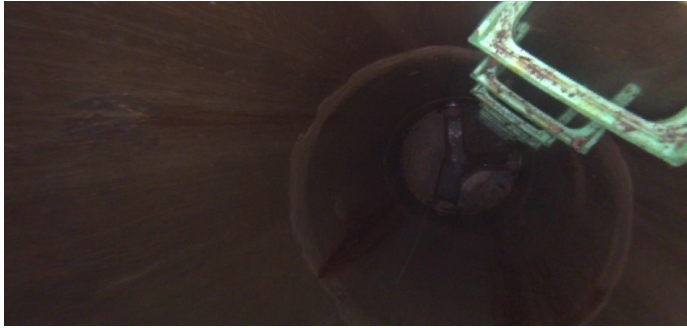
Code: **IS**  
Description: **Infil Stain**

Distance (ft): **3.7**  
Structural Grade: **0**  
O&M Grade: **0**  
Clock Start/From: **7**  
Clock To:  
1st Value:  
2nd Value:  
Value Percent:  
Step: **NO**  
Remarks:

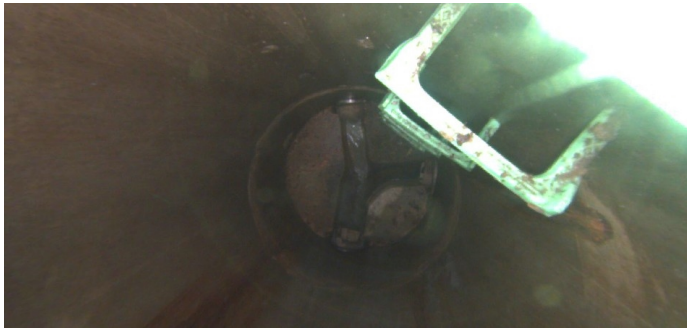
Code: **MGO**  
Description: **General Observation**

Distance (ft): **7.2**  
Structural Grade: **0**  
O&M Grade: **0**  
Clock Start/From:  
Clock To:  
1st Value:  
2nd Value:  
Value Percent:  
Step: **NO**  
Remarks: **Ins. Comp.**
