# Manhole Inspection Report

Date:	<b>04/10/2018</b>	Weather:		Coding:	<b>RZMACP</b>
MH#:	<b>M-709-006</b>	Owner:	<b>NA</b>	Len. Surveyed:	<b>15.0</b>
P.O.#:		Surveyor:	<b>John Kuglmaier</b>	Rim to Invert:	<b>15.3</b>
Customer:		Cert. #:	<b>U-1215-07002349</b>	Wall Material:	<b>Concrete (reinforced)</b>

Street:	<b>Bracken Parkway. 103' South of Mer</b>	Project:	<b>Hobart, IN</b>
City:	<b>Hobart, IN</b>	GPS Northing:	<b>2906948.668</b>
Location:		GPS Easting:	<b>2906948.668</b>
Drain Area:	<b>Southwest</b>	GPS Accuracy:	<b>Sub-Meter</b>
Cover Shape:	<b>Circular</b>	Evidence of Surcharge:	<b>No</b>
Cover Size:	<b>22.5</b>	Potential for Runoff:	<b>None</b>
Comments:

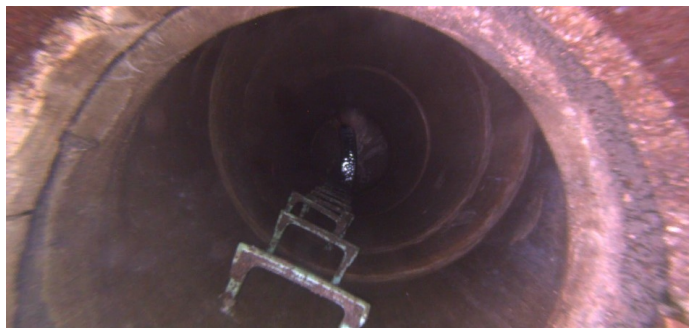
Code: **MGP**  
 Description: **General Photo**

Distance (ft): **.0**  
 Structural Grade: **0**  
 O&M Grade: **0**  
 Clock Start/From:  
 Clock To:  
 1st Value:  
 2nd Value:  
 Value Percent:  
 Step: **NO**  
 Remarks:

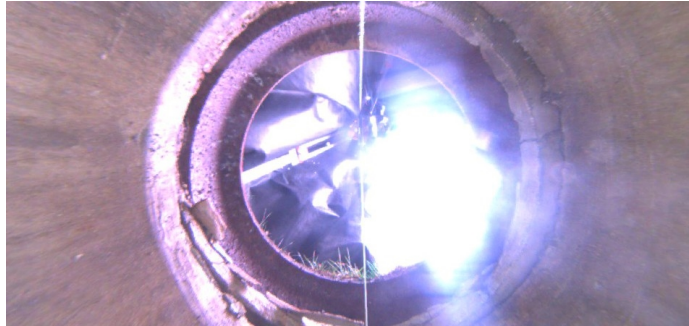
Code: **MGP**  
Description: **General Photo**

Distance (ft): **2.6**  
Structural Grade: **0**  
O&M Grade: **0**  
Clock Start/From:  
Clock To:  
1st Value:  
2nd Value:  
Value Percent:  
Step: **NO**  
Remarks:

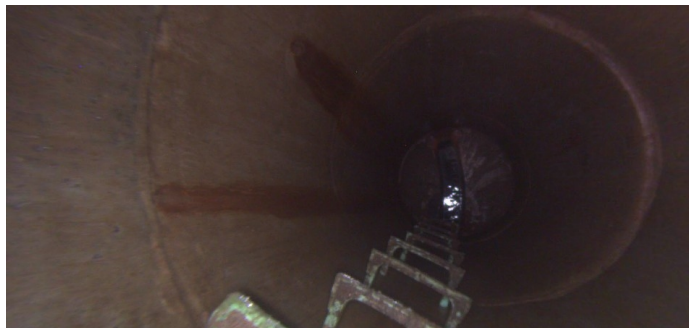
Code: **IS**  
Description: **Infil Stain**

Distance (ft): **3.5**  
Structural Grade: **0**  
O&M Grade: **0**  
Clock Start/From: **8**  
Clock To:  
1st Value:  
2nd Value:  
Value Percent:  
Step: **NO**  
Remarks:

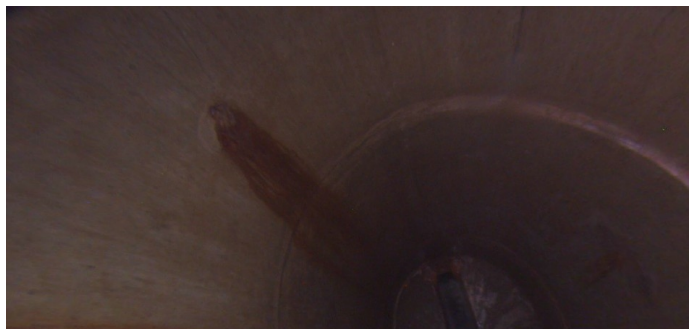
Code: **IS**  
Description: **Infil Stain**

Distance (ft): **4.9**  
Structural Grade: **0**  
O&M Grade: **0**  
Clock Start/From: **10**  
Clock To:  
1st Value:  
2nd Value:  
Value Percent:  
Step: **NO**  
Remarks:

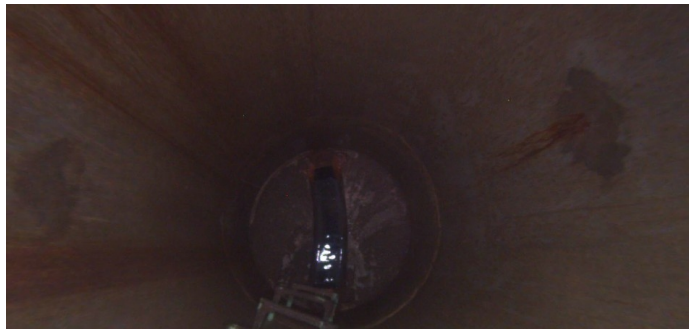
Code: **IS**  
Description: **Infil Stain**

Distance (ft): **7.6**  
Structural Grade: **0**  
O&M Grade: **0**  
Clock Start/From: **2**  
Clock To:  
1st Value:  
2nd Value:  
Value Percent:  
Step: **NO**  
Remarks:

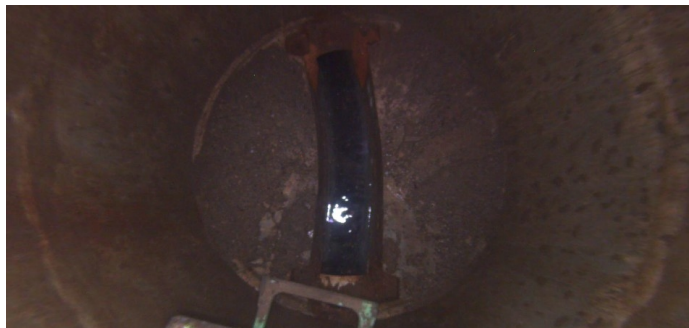
Code: **DSF**  
Description: **Deposits Settled Fine**

Distance (ft): **11.2**  
Structural Grade: **0**  
O&M Grade: **2**  
Clock Start/From: **12**  
Clock To: **12**  
1st Value:  
2nd Value:  
Value Percent: **10.000**  
Step: **NO**  
Remarks:

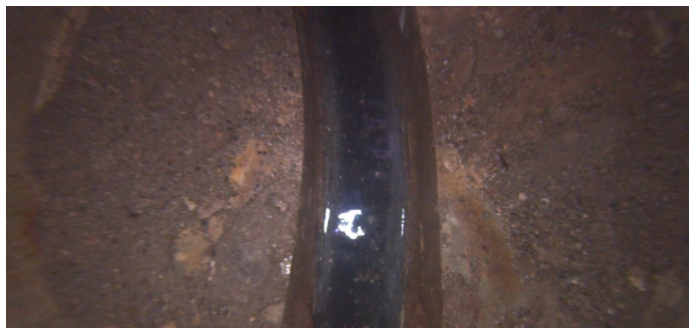
Code: **MGO**  
Description: **General Observation**

Distance (ft): **13.2**  
Structural Grade: **0**  
O&M Grade: **0**  
Clock Start/From:  
Clock To:  
1st Value:  
2nd Value:  
Value Percent:  
Step: **NO**  
Remarks: **Ins. Comp.**
