# Manhole Inspection Report

Date:	<b>04/10/2018</b>	Weather:		Coding:	<b>RZMACP</b>
MH#:	<b>M-709-007</b>	Owner:	<b>NA</b>	Len. Surveyed:	<b>14.8</b>
P.O.#:		Surveyor:	<b>John Kuglmaier</b>	Rim to Invert:	<b>15.1</b>
Customer:		Cert. #:	<b>U-1215-07002349</b>	Wall Material:	<b>Concrete (reinforced)</b>

Street:	<b>Bracken Parkway. and Merganser St.</b>	Project:	<b>Hobart, IN</b>
City:	<b>Hobart, IN</b>	GPS Northing:	<b>2906946.089</b>
Location:		GPS Easting:	<b>2906946.089</b>
Drain Area:	<b>Southwest</b>	GPS Accuracy:	<b>Sub-Meter</b>
Cover Shape:	<b>Circular</b>	Evidence of Surcharge:	<b>No</b>
Cover Size:	<b>22.5</b>	Potential for Runoff:	<b>None</b>
Comments:

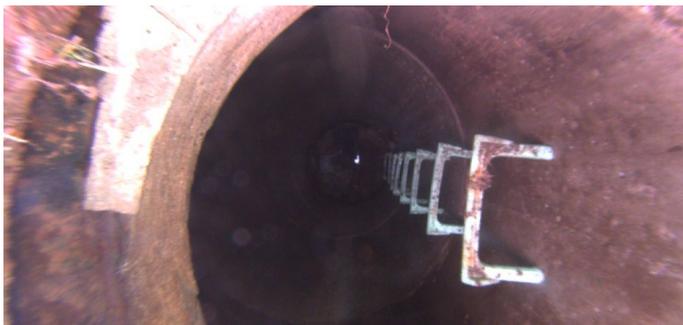
Code: **MGP**  
Description: **General Photo**

Distance (ft): **.0**  
Structural Grade: **0**  
O&M Grade: **0**  
Clock Start/From:  
Clock To:  
1st Value:  
2nd Value:  
Value Percent:  
Step: **NO**  
Remarks:

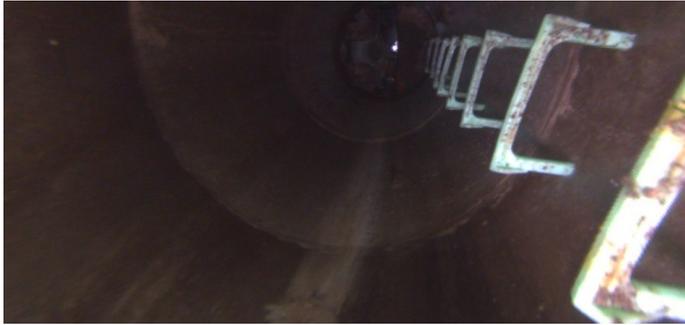
Code: **IS**  
Description: **Infil Stain**

Distance (ft): **1.0**  
Structural Grade: **0**  
O&M Grade: **0**  
Clock Start/From: **6**  
Clock To:  
1st Value:  
2nd Value:  
Value Percent:  
Step: **NO**  
Remarks:

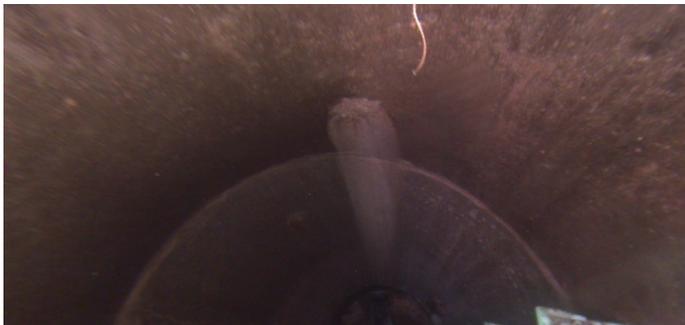
Code: **IS**  
Description: **Infil Stain**

Distance (ft): **1.0**  
Structural Grade: **0**  
O&M Grade: **0**  
Clock Start/From: **12**  
Clock To:  
1st Value:  
2nd Value:  
Value Percent:  
Step: **NO**  
Remarks:

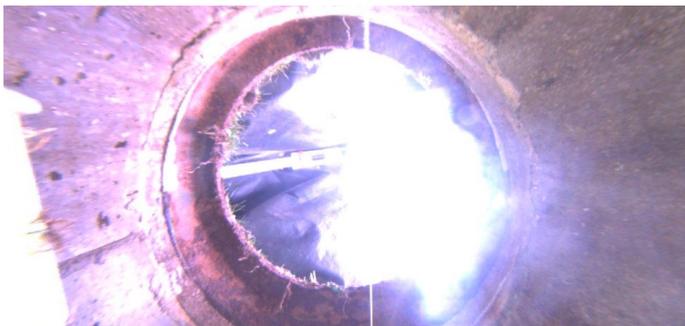
Code: **MGP**  
Description: **General Photo**

Distance (ft): **2.6**  
Structural Grade: **0**  
O&M Grade: **0**  
Clock Start/From:  
Clock To:  
1st Value:  
2nd Value:  
Value Percent:  
Step: **NO**  
Remarks:

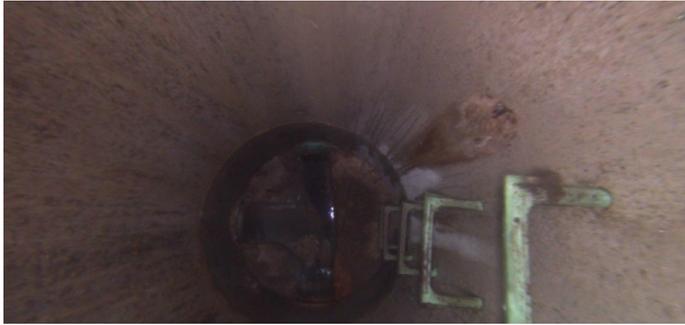
Code: **IS**  
Description: **Infil Stain**

Distance (ft): **7.5**  
Structural Grade: **0**  
O&M Grade: **0**  
Clock Start/From: **2**  
Clock To:  
1st Value:  
2nd Value:  
Value Percent:  
Step: **NO**  
Remarks:

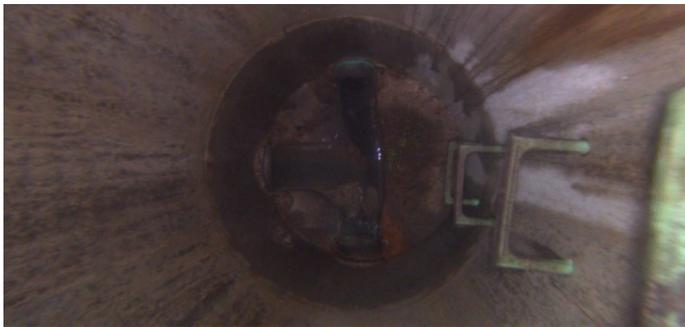
Code: **IS**  
Description: **Infil Stain**

Distance (ft): **9.3**  
Structural Grade: **0**  
O&M Grade: **0**  
Clock Start/From: **12**  
Clock To: **12**  
1st Value:  
2nd Value:  
Value Percent:  
Step: **NO**  
Remarks:

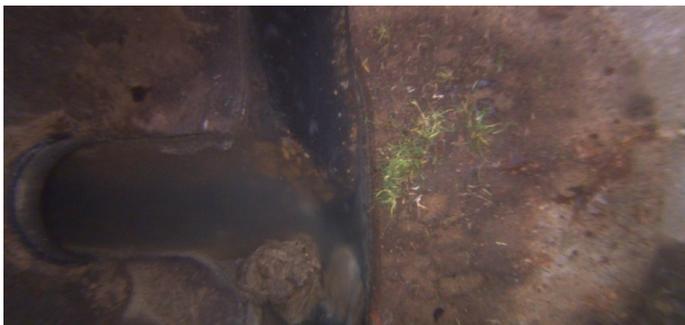
Code: **MGO**  
Description: **General Observation**

Distance (ft): **13.3**  
Structural Grade: **0**  
O&M Grade: **0**  
Clock Start/From:  
Clock To:  
1st Value:  
2nd Value:  
Value Percent:  
Step: **NO**  
Remarks: **Ins. Comp.**
