# Manhole Inspection Report

Date:	<b>04/10/2018</b>	Weather:		Coding:	<b>RZMACP</b>
MH#:	<b>M-709-011</b>	Owner:	<b>NA</b>	Len. Surveyed:	<b>13.4</b>
P.O.#:		Surveyor:	<b>John Kuglmaier</b>	Rim to Invert:	<b>13.8</b>
Customer:		Cert. #:	<b>U-1215-07002349</b>	Wall Material:	<b>Concrete (reinforced)</b>

Street:	<b>Dunlin Circle. 75' East of Waxwing Ci</b>	Project:	<b>Hobart, IN</b>
City:	<b>Hobart, IN</b>	GPS Northing:	<b>2906830.171</b>
Location:		GPS Easting:	<b>2906830.171</b>
Drain Area:	<b>Southwest</b>	GPS Accuracy:	<b>Sub-Meter</b>
Cover Shape:	<b>Circular</b>	Evidence of Surcharge:	<b>No</b>
Cover Size:	<b>22.5</b>	Potential for Runoff:	<b>None</b>
Comments:

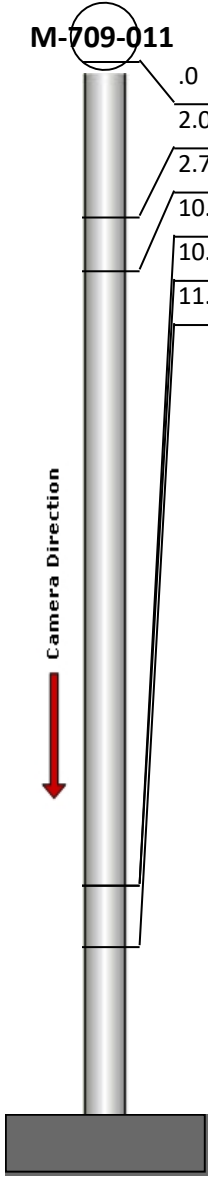
Position	Code	Observation	Video (sec)	Grade

.0	MGP	General Photo	10	NA
	2.0	IS	Infil Stain	26	NA
	2.7	MGP	General Photo	41	NA
	10.6	DAZ	Deposits Attached Other	70	M 2
	10.6	IS	Infil Stain	82	NA
	11.4	MGO	General Observation	95	NA

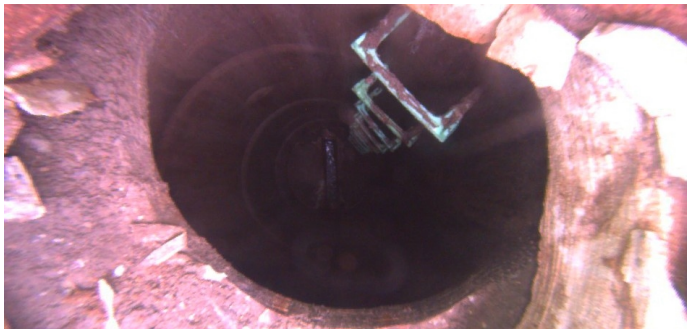
Code: **MGP**  
Description: **General Photo**

Distance (ft): **.0**  
Structural Grade: **0**  
O&M Grade: **0**  
Clock Start/From:  
Clock To:  
1st Value:  
2nd Value:  
Value Percent:  
Step: **NO**  
Remarks:

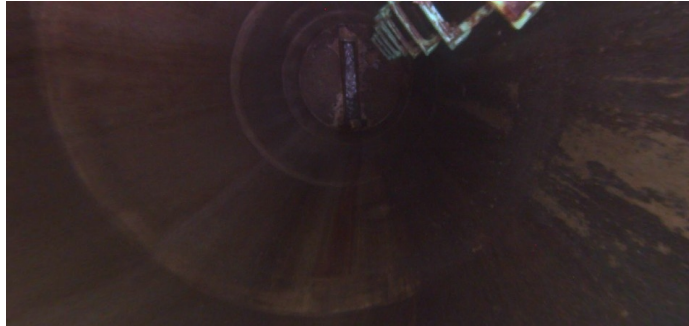
Code: **IS**  
Description: **Infil Stain**

Distance (ft): **2.0**  
Structural Grade: **0**  
O&M Grade: **0**  
Clock Start/From: **6**  
Clock To:  
1st Value:  
2nd Value:  
Value Percent:  
Step: **NO**  
Remarks:

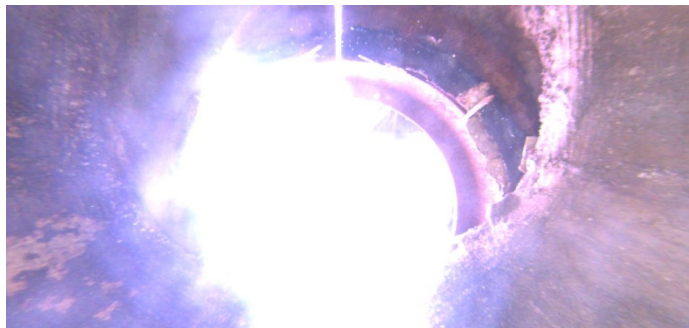
Code: **MGP**  
Description: **General Photo**

Distance (ft): **2.7**  
Structural Grade: **0**  
O&M Grade: **0**  
Clock Start/From:  
Clock To:  
1st Value:  
2nd Value:  
Value Percent:  
Step: **NO**  
Remarks:

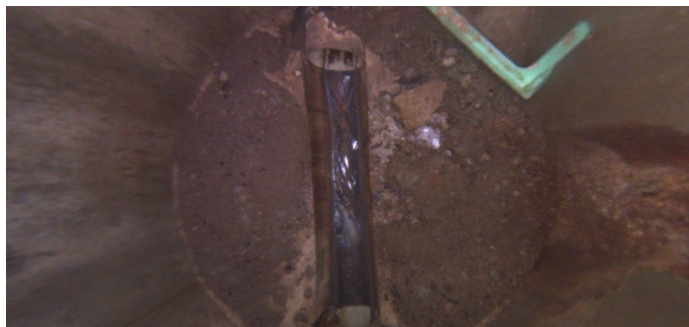
Code: **DAZ**  
Description: **Deposits Attached Other**

Distance (ft): **10.6**  
Structural Grade: **0**  
O&M Grade: **2**  
Clock Start/From: **12**  
Clock To: **12**  
1st Value:  
2nd Value:  
Value Percent: **10.000**  
Step: **NO**  
Remarks: **Mixed materials**

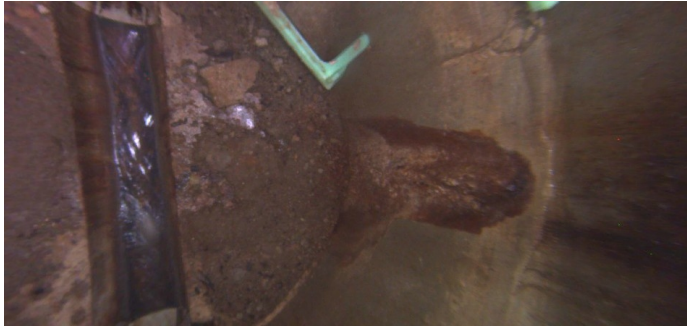
Code: **IS**  
Description: **Infil Stain**

Distance (ft): **10.6**  
Structural Grade: **0**  
O&M Grade: **0**  
Clock Start/From: **4**  
Clock To:  
1st Value:  
2nd Value:  
Value Percent:  
Step: **NO**  
Remarks:

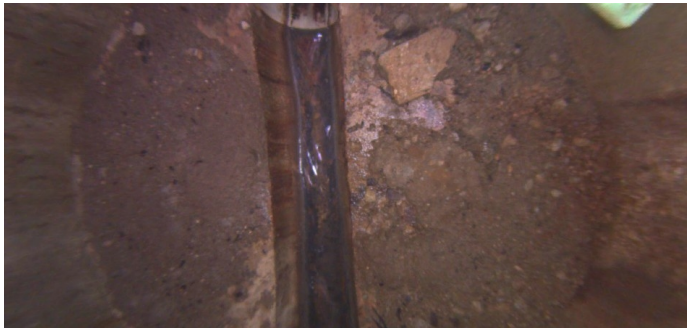
Code: **MGO**  
Description: **General Observation**

Distance (ft): **11.4**  
Structural Grade: **0**  
O&M Grade: **0**  
Clock Start/From:  
Clock To:  
1st Value:  
2nd Value:  
Value Percent:  
Step: **NO**  
Remarks: **Ins. Comp.**
