# Manhole Inspection Report

Date:	<b>04/12/2018</b>	Weather:		Coding:	<b>RZMACP</b>
MH#:	<b>M-709-020</b>	Owner:	<b>NA</b>	Len. Surveyed:	<b>7.6</b>
P.O.#:		Surveyor:	<b>John Kuglmaier</b>	Rim to Invert:	<b>8.1</b>
Customer:		Cert. #:	<b>U-1215-07002349</b>	Wall Material:	<b>Concrete (reinforced)</b>

Street:	<b>Avocet Circle. Southwest Corner.</b>	Project:	<b>Hobart, IN</b>
City:	<b>Hobart, IN</b>	GPS Northing:	<b>2906141.786</b>
Location:		GPS Easting:	<b>2906141.786</b>
Drain Area:	<b>Southwest</b>	GPS Accuracy:	<b>Sub-Meter</b>
Cover Shape:	<b>Circular</b>	Evidence of Surcharge:	<b>No</b>
Cover Size:	<b>22.5</b>	Potential for Runoff:	<b>None</b>
Comments:

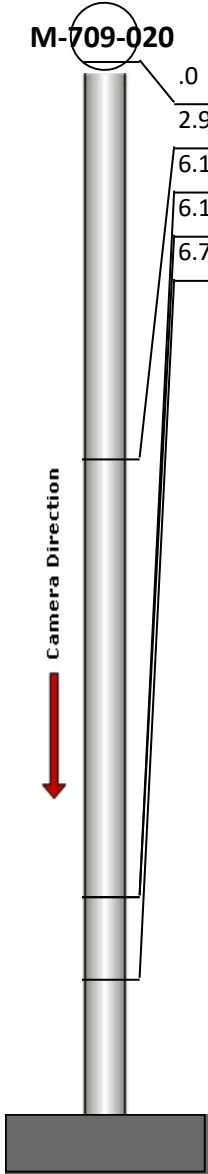
.0	MGP	General Photo	10	NA
	2.9	MGP	General Photo	30	NA
	6.1	IS	Infil Stain	50	NA
	6.1	IS	Infil Stain	62	NA
	6.7	MGO	General Observation	75	NA

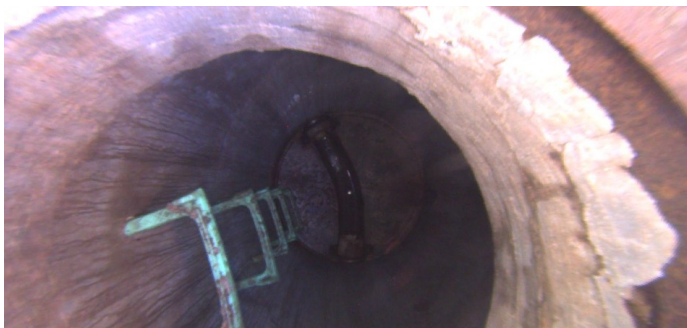
Code: **MGP**  
Description: **General Photo**

Distance (ft): **.0**  
Structural Grade: **0**  
O&M Grade: **0**  
Clock Start/From:  
Clock To:  
1st Value:  
2nd Value:  
Value Percent:  
Step: **NO**  
Remarks:

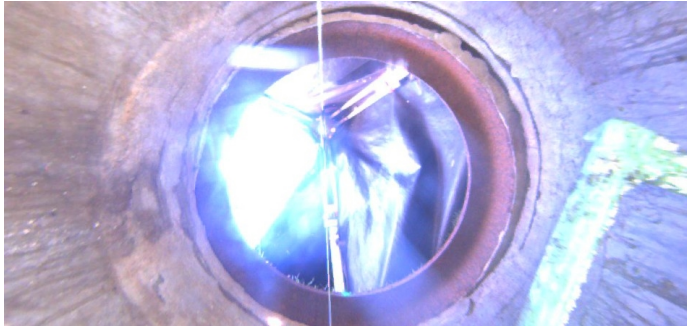
Code:	<b>MGP</b>
Description:	<b>General Photo</b>
Distance (ft):	<b>2.9</b>
Structural Grade:	<b>0</b>
O&M Grade:	<b>0</b>
Clock Start/From:	
Clock To:	
1st Value:	
2nd Value:	
Value Percent:	
Step:	<b>NO</b>
Remarks:

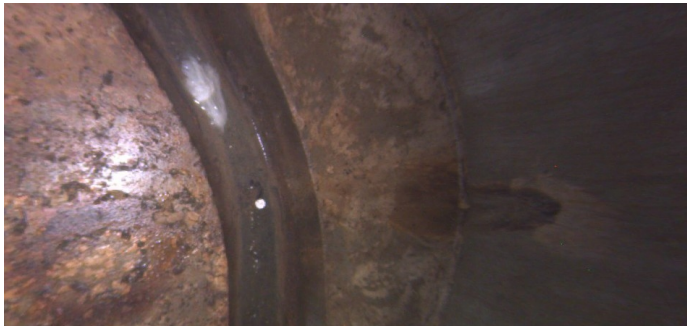
Code:	<b>IS</b>
Description:	<b>Infil Stain</b>
Distance (ft):	<b>6.1</b>
Structural Grade:	<b>0</b>
O&M Grade:	<b>0</b>
Clock Start/From:	<b>3</b>
Clock To:	
1st Value:	
2nd Value:	
Value Percent:	
Step:	<b>NO</b>
Remarks:

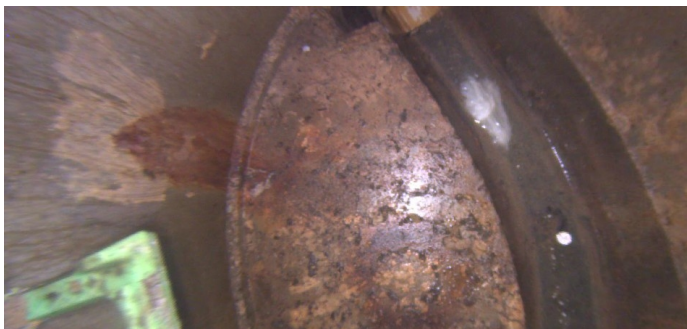
Code:	<b>IS</b>
Description:	<b>Infil Stain</b>
Distance (ft):	<b>6.1</b>
Structural Grade:	<b>0</b>
O&M Grade:	<b>0</b>
Clock Start/From:	<b>10</b>
Clock To:	
1st Value:	
2nd Value:	
Value Percent:	
Step:	<b>NO</b>
Remarks:

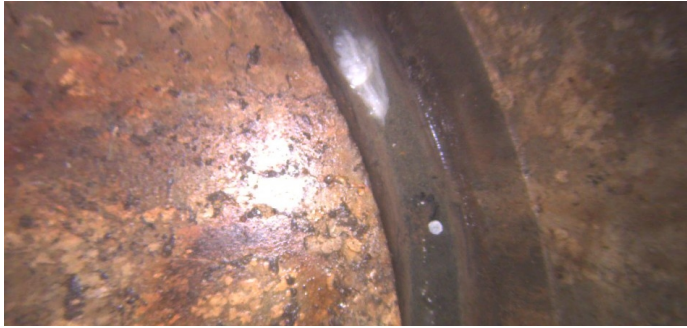
Code:	<b>MGO</b>
Description:	<b>General Observation</b>
Distance (ft):	<b>6.7</b>
Structural Grade:	<b>0</b>
O&M Grade:	<b>0</b>
Clock Start/From:	
Clock To:	
1st Value:	
2nd Value:	
Value Percent:	
Step:	<b>NO</b>
Remarks:	<b>Ins. Comp.</b>
