Manhole Inspection Report

Date:	11/02/2022	Weather:		Coding:	RZMACP
MH#:	M-709-024	Owner:	NA	Len. Surveyed:	6.4
P.O.#:		Surveyor:	Jen Costello	Rim to Invert:	7.4
Customer:		Cert. #:	U-907-5518	Wall Material:	Concrete (non-reinforced)

Street:	Avocet Circle. North Side in Middle.	Project:	Missing GPS
City:	Hobart, IN	GPS Northing:	2279545.762
Location:		GPS Easting:	2906485.049
Drain Area:	Southwest	GPS Accuracy:	Sub-Meter
Cover Shape:	Circular	Evidence of Surcharge:	No
Cover Size:	24.0	Potential for Runoff:	None
Comments:

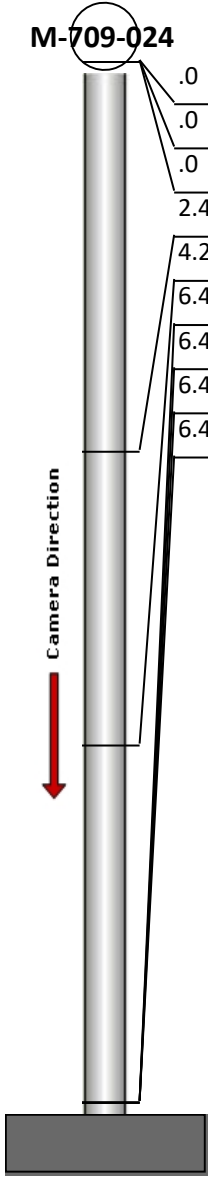
M-709-024				
	.0	RFJ	Roots Fine Joint	10	M 1
	.0	SRI	Surface Roughness Increased	21	S 1
	.0	MGO	General Observation	32	NA
	2.4	MGO	General Observation	51	NA
	4.2	IW	Infil Weeper	68	M 2
	6.4	SAV	Surface Aggregate Visible	85	S 3
	6.4	MGO	General Observation	96	NA
	6.4	DSF	Deposits Settled Fine	107	M 2
	6.4	SRI	Surface Roughness Increased	118	S 1

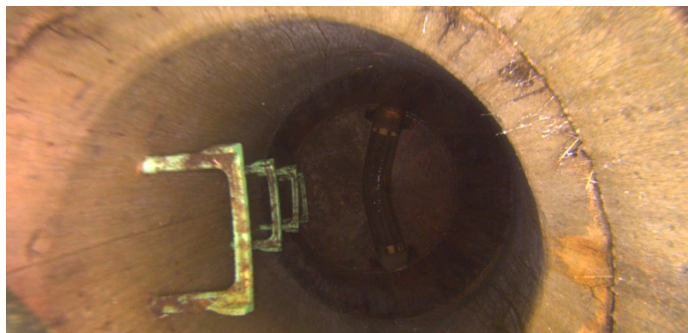
Code: **RFJ**
Description: **Roots Fine Joint**

Distance (ft): **.0**
Structural Grade: **0**
O&M Grade: **1**
Clock Start/From: **12**
Clock To: **4**
1st Value:
2nd Value:
Value Percent:
Step: **NO**
Remarks:

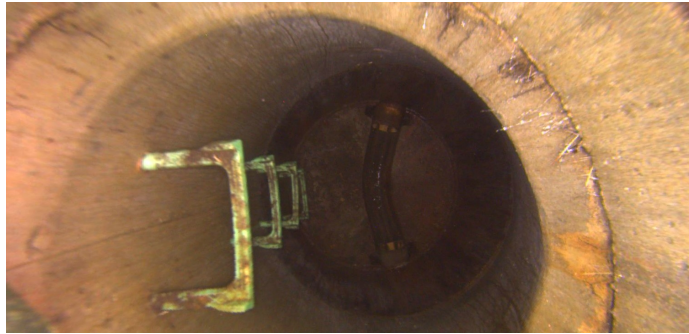
Code: **SRI**
Description: **Surface Roughness Increased**

Distance (ft): **.0**
Structural Grade: **1**
O&M Grade: **0**
Clock Start/From: **12**
Clock To: **12**
1st Value:
2nd Value:
Value Percent:
Step: **NO**
Remarks:

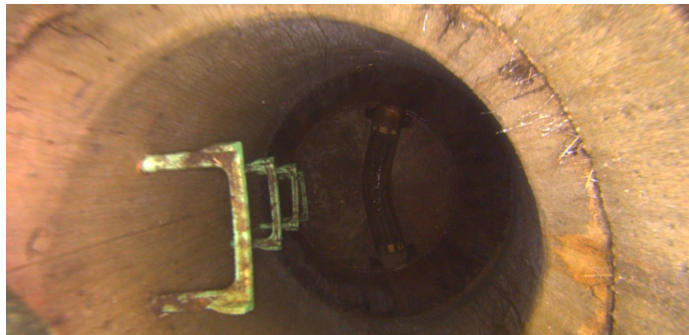
Code: **MGO**
Description: **General Observation**

Distance (ft): **.0**
Structural Grade: **0**
O&M Grade: **0**
Clock Start/From:
Clock To:
1st Value:
2nd Value:
Value Percent:
Step: **NO**
Remarks: **access mh**

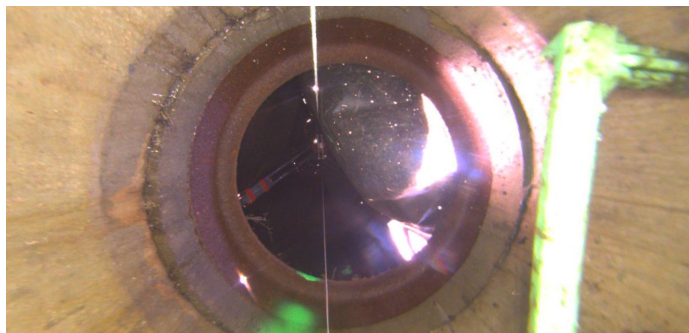
Code: **MGO**
Description: **General Observation**

Distance (ft): **2.4**
Structural Grade: **0**
O&M Grade: **0**
Clock Start/From:
Clock To:
1st Value:
2nd Value:
Value Percent:
Step: **NO**
Remarks: **underside of frame**

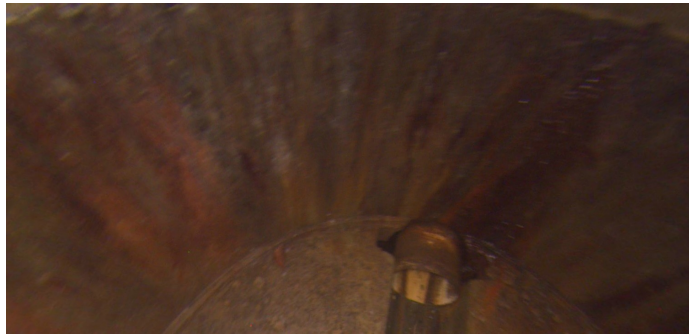
Code: **IW**
Description: **Infil Weeper**

Distance (ft): **4.2**
Structural Grade: **0**
O&M Grade: **2**
Clock Start/From: **12**
Clock To: **12**
1st Value:
2nd Value:
Value Percent:
Step: **NO**
Remarks:

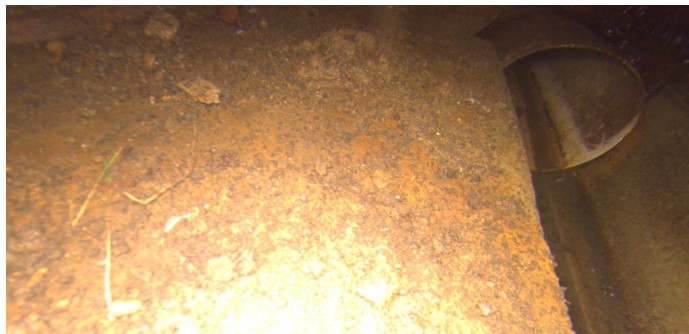
Code: **SAV**
Description: **Surface Aggregate Visible**

Distance (ft): **6.4**
Structural Grade: **3**
O&M Grade: **0**
Clock Start/From: **3**
Clock To: **9**
1st Value:
2nd Value:
Value Percent:
Step: **NO**
Remarks:

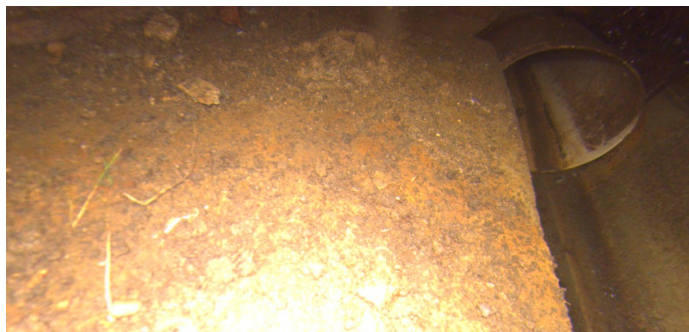
Code: **MGO**
Description: **General Observation**

Distance (ft): **6.4**
Structural Grade: **0**
O&M Grade: **0**
Clock Start/From:
Clock To:
1st Value:
2nd Value:
Value Percent:
Step: **NO**
Remarks: **end of survey**

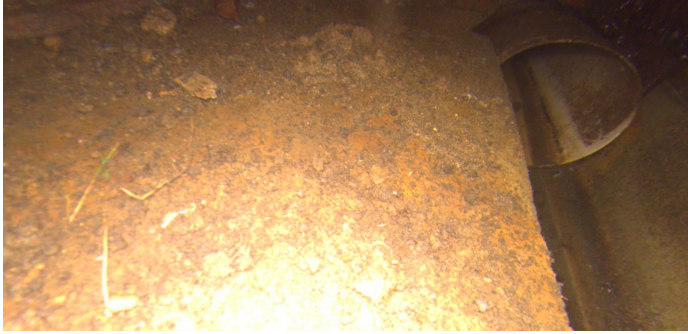
Code: **DSF**
Description: **Deposits Settled Fine**

Distance (ft): **6.4**
Structural Grade: **0**
O&M Grade: **2**
Clock Start/From: **12**
Clock To: **12**
1st Value:
2nd Value:
Value Percent: **5.000**
Step: **NO**
Remarks:

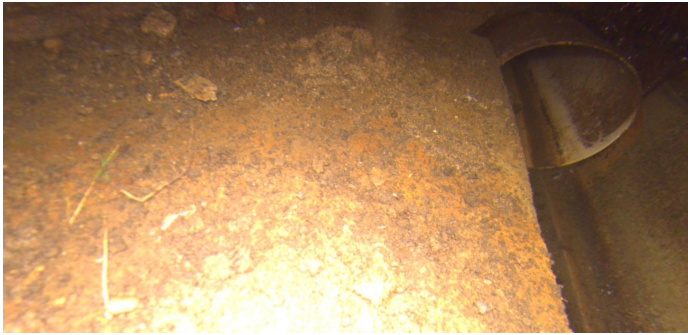
Code: **SRI**
Description: **Surface Roughness Increased**

Distance (ft): **6.4**
Structural Grade: **1**
O&M Grade: **0**
Clock Start/From: **12**
Clock To: **12**
1st Value:
2nd Value:
Value Percent:
Step: **NO**
Remarks:
