# Manhole Inspection Report

| MH#: | M-709-025 | Owner: | NA | Len. Surveyed: | 7.5 |

| Street: | Avocet Circle. 1 Manhole East of Nor | Project: | Hobart, IN |

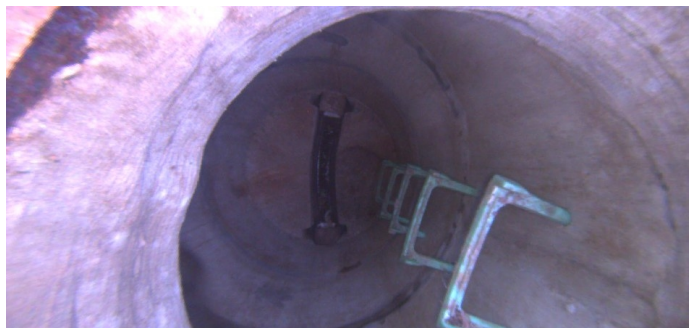
Code: **MGP**  
 Description: **General Photo**

Distance (ft): **.0**  
 Structural Grade: **0**  
 O&M Grade: **0**  
 Clock Start/From:  
 Clock To:  
 1st Value:  
 2nd Value:  
 Value Percent:  
 Step: **NO**  
 Remarks:

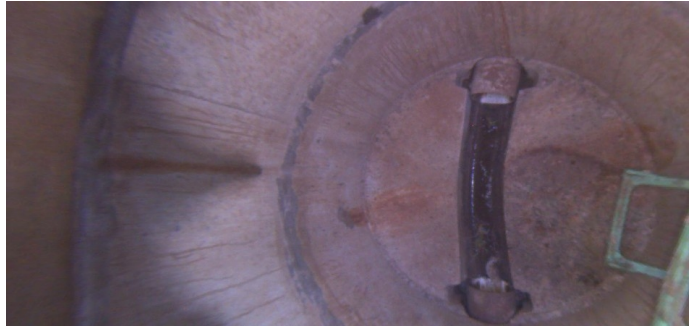
Code: **IS**  
Description: **Infil Stain**

Distance (ft): **2.7**  
Structural Grade: **0**  
O&M Grade: **0**  
Clock Start/From: **9**  
Clock To:  
1st Value:  
2nd Value:  
Value Percent:  
Step: **NO**  
Remarks:

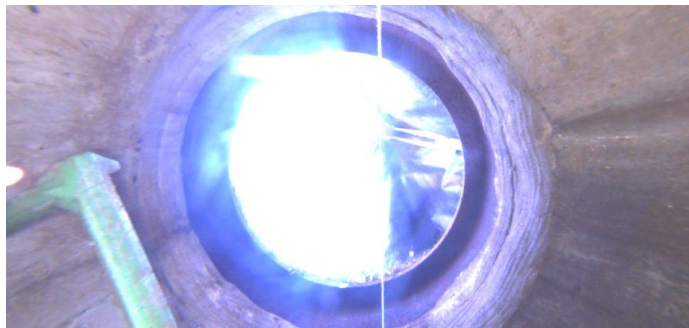
Code: **MGP**  
Description: **General Photo**

Distance (ft): **2.7**  
Structural Grade: **0**  
O&M Grade: **0**  
Clock Start/From:  
Clock To:  
1st Value:  
2nd Value:  
Value Percent:  
Step: **NO**  
Remarks:

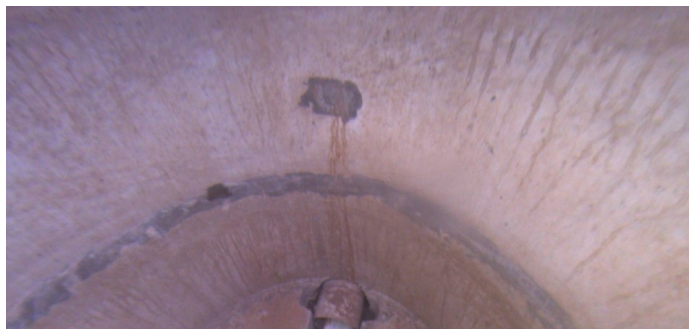
Code: **IS**  
Description: **Infil Stain**

Distance (ft): **3.4**  
Structural Grade: **0**  
O&M Grade: **0**  
Clock Start/From: **12**  
Clock To:  
1st Value:  
2nd Value:  
Value Percent:  
Step: **NO**  
Remarks:

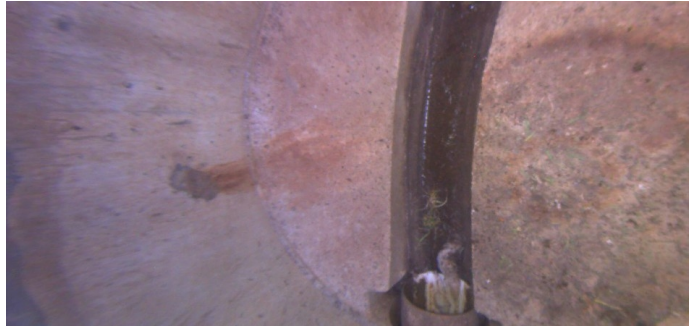
Code: **IS**  
Description: **Infil Stain**

Distance (ft): **5.2**  
Structural Grade: **0**  
O&M Grade: **0**  
Clock Start/From: **8**  
Clock To:  
1st Value:  
2nd Value:  
Value Percent:  
Step: **NO**  
Remarks:

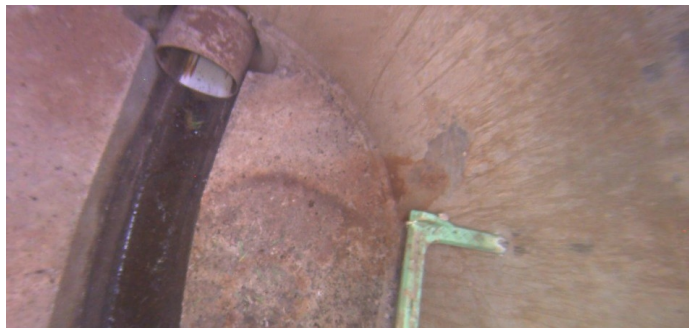
Code: **IS**  
Description: **Infil Stain**

Distance (ft): **5.2**  
Structural Grade: **0**  
O&M Grade: **0**  
Clock Start/From: **2**  
Clock To:  
1st Value:  
2nd Value:  
Value Percent:  
Step: **NO**  
Remarks:

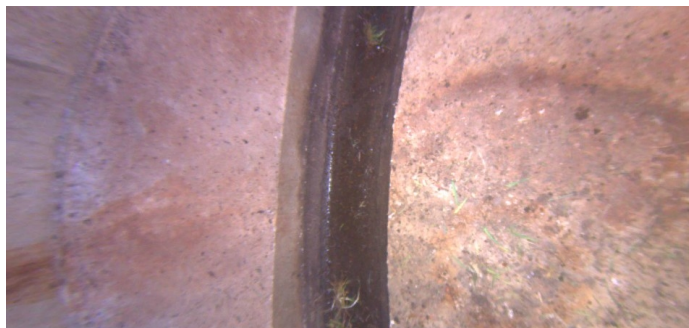
Code: **MGO**  
Description: **General Observation**

Distance (ft): **6.2**  
Structural Grade: **0**  
O&M Grade: **0**  
Clock Start/From:  
Clock To:  
1st Value:  
2nd Value:  
Value Percent:  
Step: **NO**  
Remarks: **Ins. Comp.**
