Manhole Inspection Report

Date:	04/12/2018	Weather:		Coding:	RZMACP
MH#:	M-709-031	Owner:	NA	Len. Surveyed:	8.8
P.O.#:		Surveyor:	John Kuglmaier	Rim to Invert:	9.5
Customer:		Cert. #:	U-1215-07002349	Wall Material:	Concrete (reinforced)

Street:	Waxwing Circle. Southeast Corner.	Project:	Hobart, IN
City:	Hobart, IN	GPS Northing:	2906803.646
Location:		GPS Easting:	2906803.646
Drain Area:	Southwest	GPS Accuracy:	Sub-Meter
Cover Shape:	Circular	Evidence of Surcharge:	No
Cover Size:	22.5	Potential for Runoff:	None
Comments:

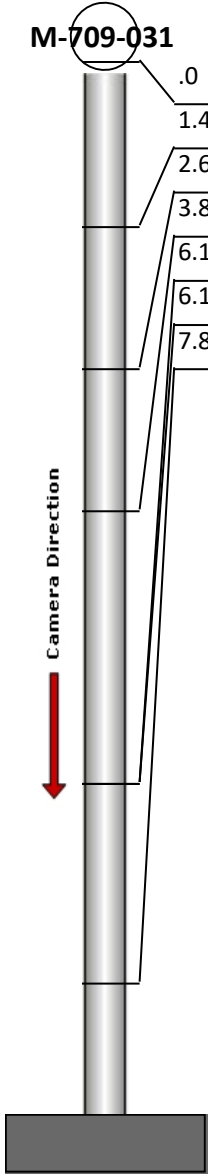
.0	MGP	General Photo	10	NA
	1.4	IS	Infil Stain	25	NA
	2.6	MGP	General Photo	41	NA
	3.8	IS	Infil Stain	57	NA
	6.1	DAZ	Deposits Attached Other	73	M 2
	6.1	IS	Infil Stain	85	NA
	7.8	MGO	General Observation	100	NA

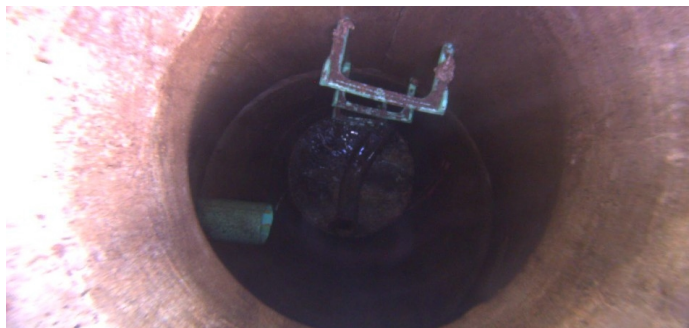
Code: **MGP**
Description: **General Photo**

Distance (ft): **.0**
Structural Grade: **0**
O&M Grade: **0**
Clock Start/From:
Clock To:
1st Value:
2nd Value:
Value Percent:
Step: **NO**
Remarks:

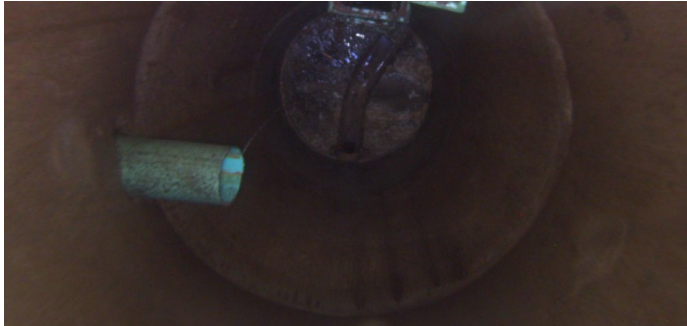
Code: **IS**
Description: **Infil Stain**

Distance (ft): **1.4**
Structural Grade: **0**
O&M Grade: **0**
Clock Start/From: **5**
Clock To: **6**
1st Value:
2nd Value:
Value Percent:
Step: **NO**
Remarks:

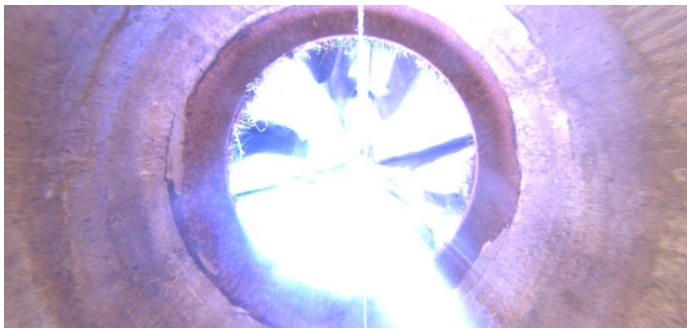
Code: **MGP**
Description: **General Photo**

Distance (ft): **2.6**
Structural Grade: **0**
O&M Grade: **0**
Clock Start/From:
Clock To:
1st Value:
2nd Value:
Value Percent:
Step: **NO**
Remarks:

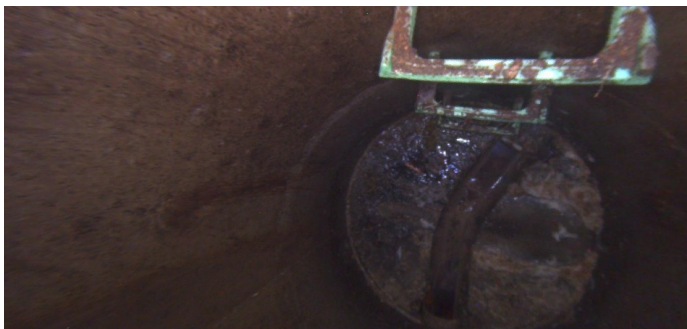
Code: **IS**
Description: **Infil Stain**

Distance (ft): **3.8**
Structural Grade: **0**
O&M Grade: **0**
Clock Start/From: **9**
Clock To:
1st Value:
2nd Value:
Value Percent:
Step: **NO**
Remarks:

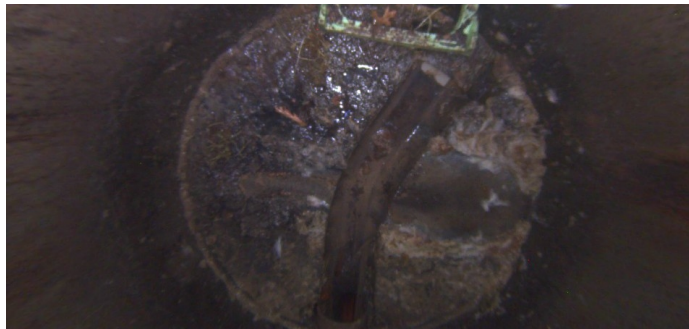
Code: **DAZ**
Description: **Deposits Attached Other**

Distance (ft): **6.1**
Structural Grade: **0**
O&M Grade: **2**
Clock Start/From: **12**
Clock To: **12**
1st Value:
2nd Value:
Value Percent: **10.000**
Step: **NO**
Remarks: **Mixed materials**

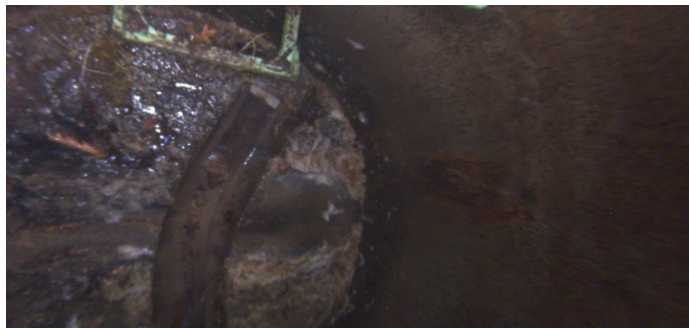
Code: **IS**
Description: **Infil Stain**

Distance (ft): **6.1**
Structural Grade: **0**
O&M Grade: **0**
Clock Start/From: **3**
Clock To:
1st Value:
2nd Value:
Value Percent:
Step: **NO**
Remarks:

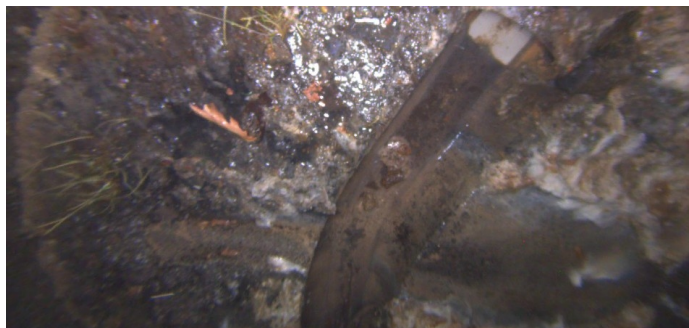
Code: **MGO**
Description: **General Observation**

Distance (ft): **7.8**
Structural Grade: **0**
O&M Grade: **0**
Clock Start/From:
Clock To:
1st Value:
2nd Value:
Value Percent:
Step: **NO**
Remarks: **Ins. Comp.**
