Manhole Inspection Report

Date:	11/01/2022	Weather:		Coding:	RZMACP
MH#:	M-709-032	Owner:	NA	Len. Surveyed:	7.6
P.O.#:		Surveyor:	Jen Costello	Rim to Invert:	9.2
Customer:		Cert. #:	U-907-5518	Wall Material:	Concrete (non-reinforced)

Street:	Waxwing Circle. Southeast Corner.	Project:	Missing GPS
City:	Hobart, IN	GPS Northing:	2278621.217
Location:		GPS Easting:	2906800.283
Drain Area:	Southwest	GPS Accuracy:	Sub-Meter
Cover Shape:	Circular	Evidence of Surcharge:	No
Cover Size:	24.0	Potential for Runoff:	None
Comments:

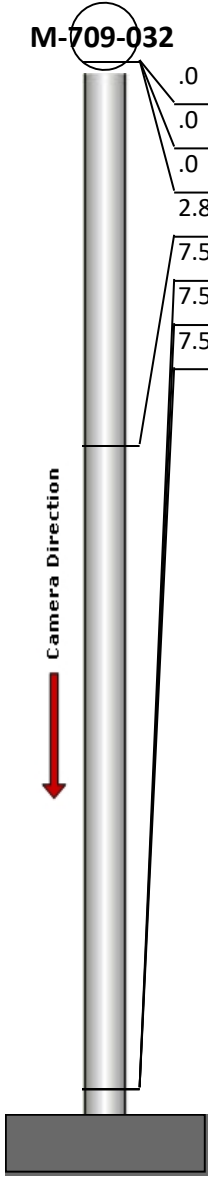
Position	Code	Observation	Video (sec)	Grade

.0	SRI	Surface Roughness Increased	10	S 1
	.0	MGO	General Observation	21	NA
	.0	RFJ	Roots Fine Joint	32	M 1
	2.8	MGO	General Observation	51	NA
	7.5	SRI	Surface Roughness Increased	74	S 1
	7.5	DSGV	Deposits Settled Gravel	85	M 2
	7.5	MGO	General Observation	96	NA

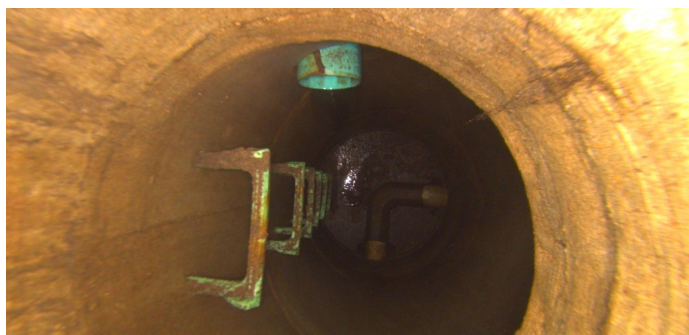
Code: **SRI**
Description: **Surface Roughness Increased**

Distance (ft): **.0**
Structural Grade: **1**
O&M Grade: **0**
Clock Start/From: **12**
Clock To: **12**
1st Value:
2nd Value:
Value Percent:
Step: **NO**
Remarks:

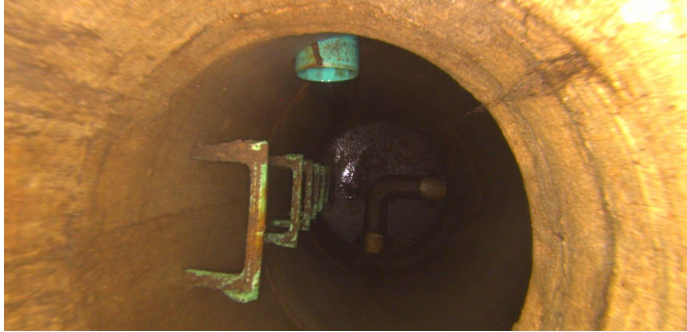
Code: **MGO**
Description: **General Observation**

Distance (ft): **.0**
Structural Grade: **0**
O&M Grade: **0**
Clock Start/From:
Clock To:
1st Value:
2nd Value:
Value Percent:
Step: **NO**
Remarks: **access mh**

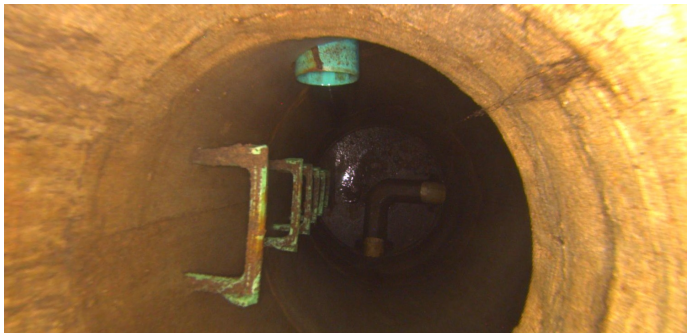
Code: **RFJ**
Description: **Roots Fine Joint**

Distance (ft): **.0**
Structural Grade: **0**
O&M Grade: **1**
Clock Start/From: **2**
Clock To:
1st Value:
2nd Value:
Value Percent:
Step: **NO**
Remarks:

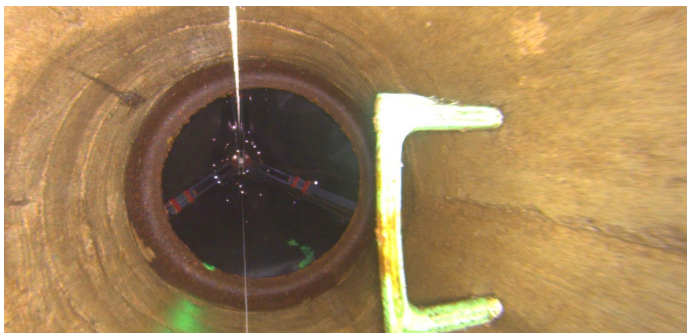
Code: **MGO**
Description: **General Observation**

Distance (ft): **2.8**
Structural Grade: **0**
O&M Grade: **0**
Clock Start/From:
Clock To:
1st Value:
2nd Value:
Value Percent:
Step: **NO**
Remarks: **underside of frame**

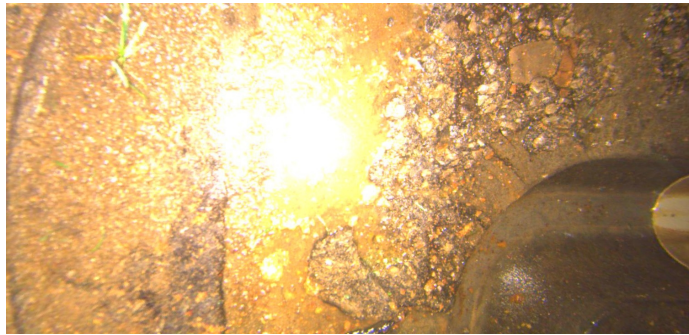
Code: **SRI**
Description: **Surface Roughness Increased**

Distance (ft): **7.5**
Structural Grade: **1**
O&M Grade: **0**
Clock Start/From: **12**
Clock To: **12**
1st Value:
2nd Value:
Value Percent:
Step: **NO**
Remarks:

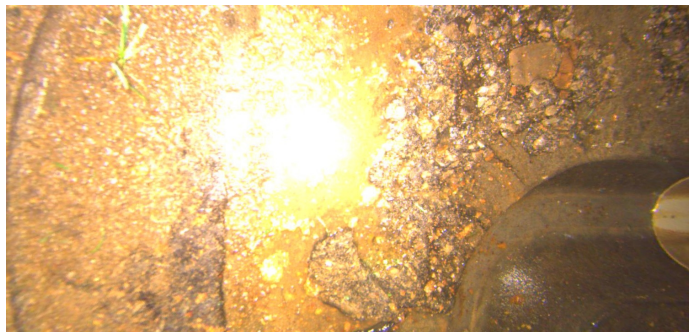
Code: **DSGV**
Description: **Deposits Settled Gravel**

Distance (ft): **7.5**
Structural Grade: **0**
O&M Grade: **2**
Clock Start/From: **12**
Clock To: **12**
1st Value:
2nd Value:
Value Percent: **5.000**
Step: **NO**
Remarks:

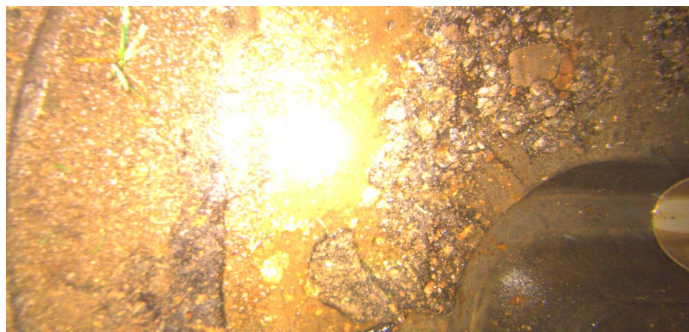
Code: **MGO**
Description: **General Observation**

Distance (ft): **7.5**
Structural Grade: **0**
O&M Grade: **0**
Clock Start/From:
Clock To:
1st Value:
2nd Value:
Value Percent:
Step: **NO**
Remarks: **end of survey**
