# Manhole Inspection Report

Date:	<b>04/11/2018</b>	Weather:		Coding:	<b>RZMACP</b>
MH#:	<b>M-709-036</b>	Owner:	<b>NA</b>	Len. Surveyed:	<b>13.6</b>
P.O.#:		Surveyor:	<b>John Kuglmaier</b>	Rim to Invert:	<b>14.0</b>
Customer:		Cert. #:	<b>U-1215-07002349</b>	Wall Material:	<b>Concrete (reinforced)</b>

Street:	<b>Merganser St. and Kestrel St.</b>	Project:	<b>Hobart, IN</b>
City:	<b>Hobart, IN</b>	GPS Northing:	<b>2907295.831</b>
Location:		GPS Easting:	<b>2907295.831</b>
Drain Area:	<b>Southwest</b>	GPS Accuracy:	<b>Sub-Meter</b>
Cover Shape:	<b>Circular</b>	Evidence of Surcharge:	<b>No</b>
Cover Size:	<b>22.5</b>	Potential for Runoff:	<b>None</b>
Comments:

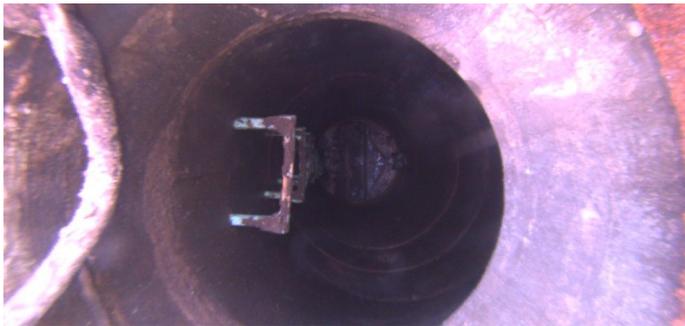
Code: **MGP**  
Description: **General Photo**

Distance (ft): **.0**  
Structural Grade: **0**  
O&M Grade: **0**  
Clock Start/From:  
Clock To:  
1st Value:  
2nd Value:  
Value Percent:  
Step: **NO**  
Remarks:

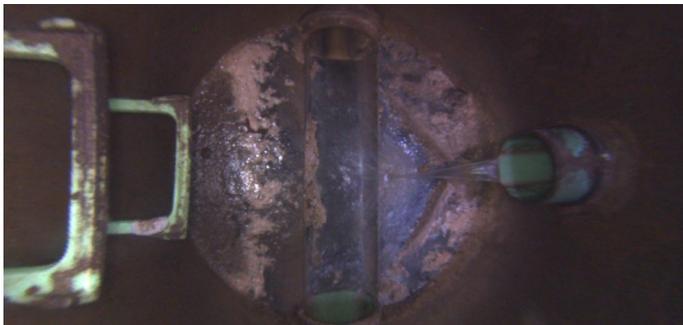
Code: **DAZ**  
Description: **Deposits Attached Other**

Distance (ft): **10.0**  
Structural Grade: **0**  
O&M Grade: **2**  
Clock Start/From: **12**  
Clock To: **12**  
1st Value:  
2nd Value:  
Value Percent: **5.000**  
Step: **NO**  
Remarks: **Mixed materials**

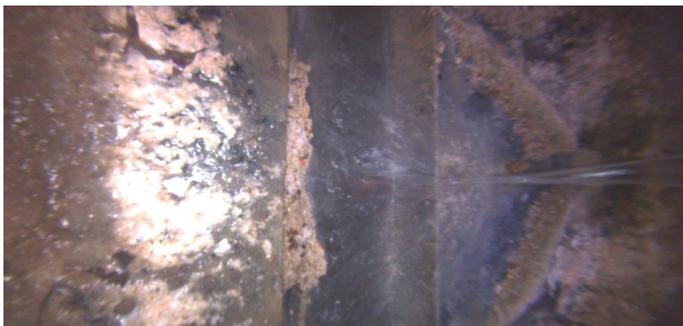
Code: **MGO**  
Description: **General Observation**

Distance (ft): **12.3**  
Structural Grade: **0**  
O&M Grade: **0**  
Clock Start/From:  
Clock To:  
1st Value:  
2nd Value:  
Value Percent:  
Step: **NO**  
Remarks: **Ins. Comp.**
