# Manhole Inspection Report

Date:	<b>03/21/2018</b>	Weather:		Coding:	<b>RZMACP</b>
MH#:	<b>M-802-025</b>	Owner:	<b>NA</b>	Len. Surveyed:	<b>2.1</b>
P.O.#:		Surveyor:	<b>John Kuglmaier</b>	Rim to Invert:	<b>3.0</b>
Customer:		Cert. #:	<b>U-1215-07002349</b>	Wall Material:	<b>Concrete (reinforced)</b>

Street:	<b>177' North of Hwy 6. 97' West of No</b>	Project:	<b>Hobart, IN</b>
City:	<b>Hobart, IN</b>	GPS Northing:	<b>0.0</b>
Location:		GPS Easting:	<b>0.0</b>
Drain Area:	<b>Northeast</b>	GPS Accuracy:	<b>Nearest Meter</b>
Cover Shape:	<b>Circular</b>	Evidence of Surcharge:	<b>Yes</b>
Cover Size:	<b>23.0</b>	Potential for Runoff:	<b>None</b>
Comments:

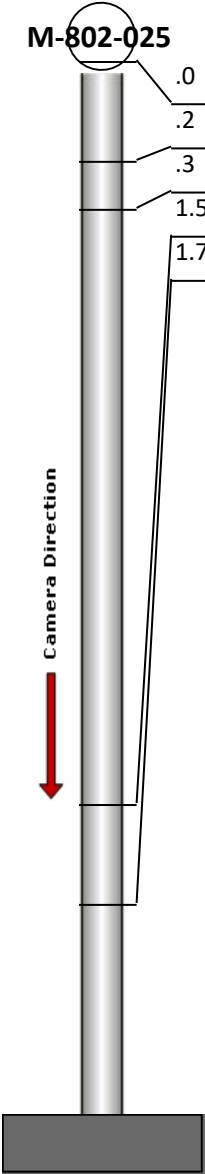
M-802-025				
	.0	MGP	General Photo	10	NA
	.2	DAZ	Deposits Attached Other	22	M 2
	.3	DAZ	Deposits Attached Other	34	M 2
	1.5	DAZ	Deposits Attached Other	48	M 2
	1.7	MGO	General Observation	61	NA

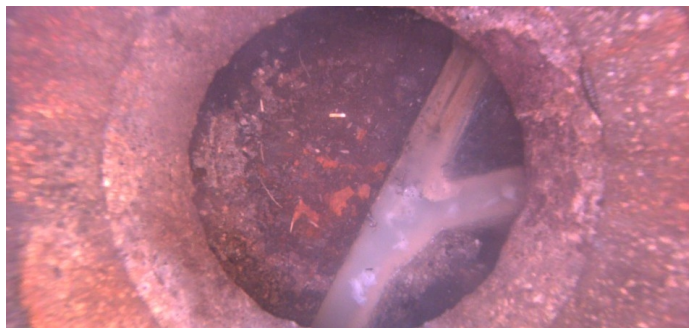
Code: **MGP**  
Description: **General Photo**

Distance (ft): **.0**  
Structural Grade: **0**  
O&M Grade: **0**  
Clock Start/From:  
Clock To:  
1st Value:  
2nd Value:  
Value Percent:  
Step: **NO**  
Remarks:

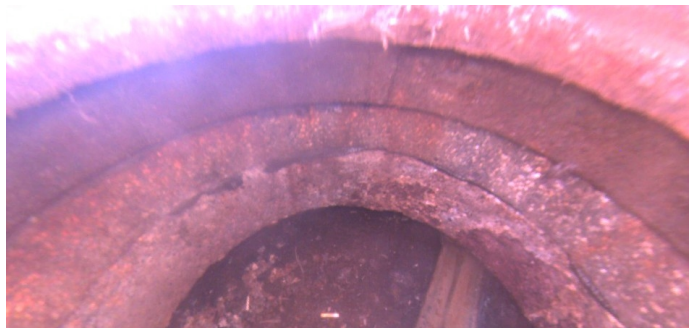
Code:	<b>DAZ</b>
Description:	<b>Deposits Attached Other</b>
Distance (ft):	<b>.2</b>
Structural Grade:	<b>0</b>
O&M Grade:	<b>2</b>
Clock Start/From:	<b>12</b>
Clock To:	<b>12</b>
1st Value:	
2nd Value:	
Value Percent:	<b>10.000</b>
Step:	<b>NO</b>
Remarks:	<b>Mixed materials</b>

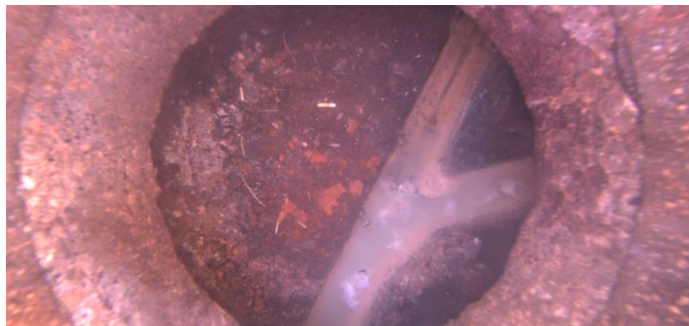
Code:	<b>DAZ</b>
Description:	<b>Deposits Attached Other</b>
Distance (ft):	<b>.3</b>
Structural Grade:	<b>0</b>
O&M Grade:	<b>2</b>
Clock Start/From:	<b>12</b>
Clock To:	<b>12</b>
1st Value:	
2nd Value:	
Value Percent:	<b>10.000</b>
Step:	<b>NO</b>
Remarks:	<b>Mixed materials</b>

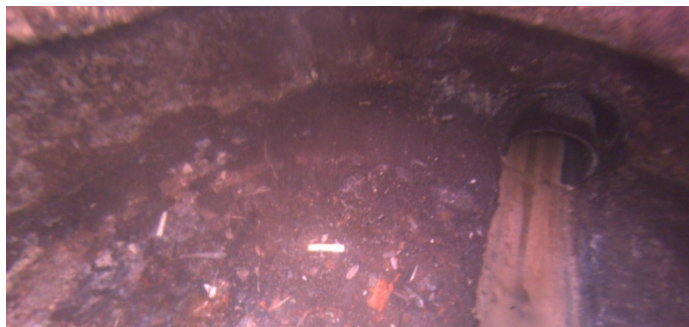
Code:	<b>DAZ</b>
Description:	<b>Deposits Attached Other</b>
Distance (ft):	<b>1.5</b>
Structural Grade:	<b>0</b>
O&M Grade:	<b>2</b>
Clock Start/From:	<b>12</b>
Clock To:	<b>12</b>
1st Value:	
2nd Value:	
Value Percent:	<b>10.000</b>
Step:	<b>NO</b>
Remarks:	<b>Mixed materials</b>

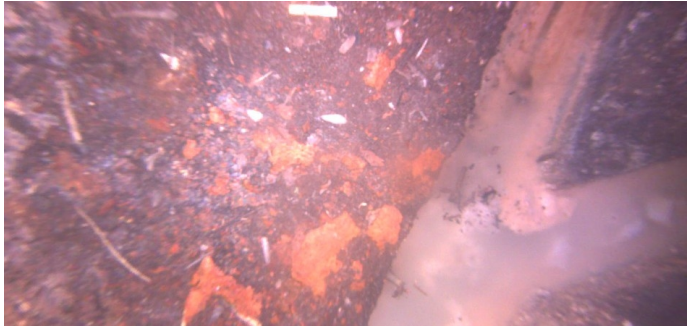
Code:	<b>MGO</b>
Description:	<b>General Observation</b>
Distance (ft):	<b>1.7</b>
Structural Grade:	<b>0</b>
O&M Grade:	<b>0</b>
Clock Start/From:	
Clock To:	
1st Value:	
2nd Value:	
Value Percent:	
Step:	<b>NO</b>
Remarks:	<b>Ins. Comp.</b>
