# Manhole Inspection Report

Date:	<b>03/28/2018</b>	Weather:		Coding:	<b>RZMACP</b>
MH#:	<b>M-803-002</b>	Owner:	<b>NA</b>	Len. Surveyed:	<b>13.7</b>
P.O.#:		Surveyor:	<b>John Kuglmaier</b>	Rim to Invert:	<b>15.7</b>
Customer:		Cert. #:	<b>U-1215-07002349</b>	Wall Material:	<b>Concrete (reinforced)</b>

Street:	<b>164' South of North St. 163' West of</b>	Project:	<b>Hobart, IN</b>
City:	<b>Hobart, IN</b>	GPS Northing:	<b>0.0</b>
Location:		GPS Easting:	<b>0.0</b>
Drain Area:	<b>Northeast</b>	GPS Accuracy:	<b>Nearest Meter</b>
Cover Shape:	<b>Circular</b>	Evidence of Surcharge:	<b>Yes</b>
Cover Size:	<b>23.0</b>	Potential for Runoff:	<b>None</b>
Comments:

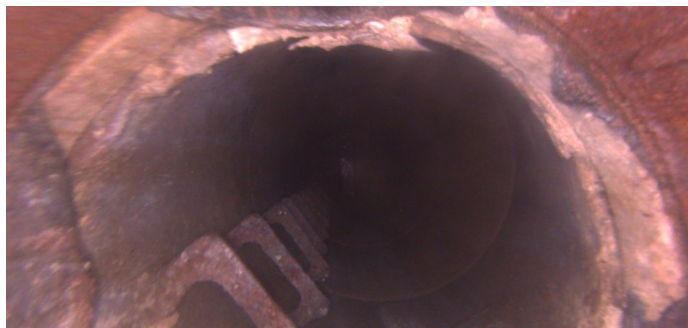
Code: **MGP**  
Description: **General Photo**

Distance (ft): **.0**  
Structural Grade: **0**  
O&M Grade: **0**  
Clock Start/From:  
Clock To:  
1st Value:  
2nd Value:  
Value Percent:  
Step: **NO**  
Remarks:

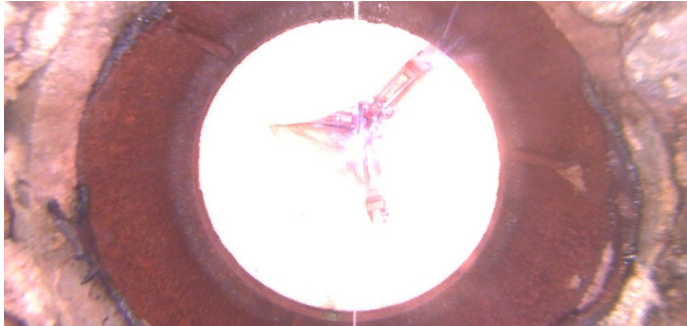
Code: **MGP**  
Description: **General Photo**

Distance (ft): **1.7**  
Structural Grade: **0**  
O&M Grade: **0**  
Clock Start/From:  
Clock To:  
1st Value:  
2nd Value:  
Value Percent:  
Step: **NO**  
Remarks:

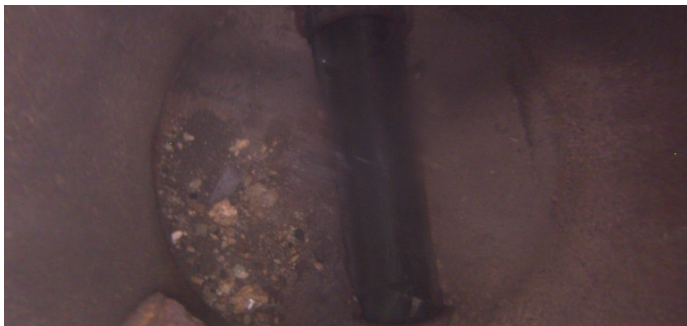
Code: **DSGV**  
Description: **Deposits Settled Gravel**

Distance (ft): **11.9**  
Structural Grade: **0**  
O&M Grade: **2**  
Clock Start/From: **7**  
Clock To: **10**  
1st Value:  
2nd Value:  
Value Percent: **5.000**  
Step: **NO**  
Remarks:

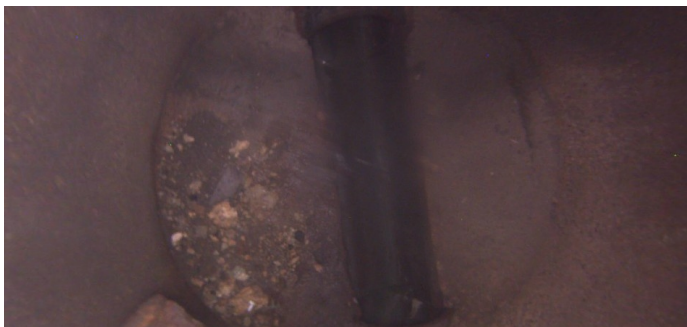
Code: **DSF**  
Description: **Deposits Settled Fine**

Distance (ft): **11.9**  
Structural Grade: **0**  
O&M Grade: **2**  
Clock Start/From: **10**  
Clock To: **6**  
1st Value:  
2nd Value:  
Value Percent: **5.000**  
Step: **NO**  
Remarks:

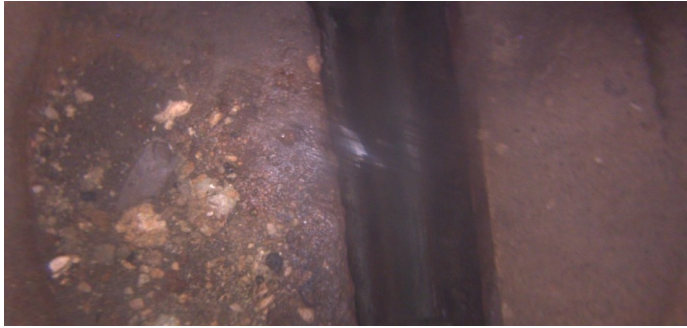
Code:	<b>MGO</b>
Description:	<b>General Observation</b>
Distance (ft):	<b>12.8</b>
Structural Grade:	<b>0</b>
O&M Grade:	<b>0</b>
Clock Start/From:	
Clock To:	
1st Value:	
2nd Value:	
Value Percent:	
Step:	<b>NO</b>
Remarks:	<b>Ins. Comp.</b>
