Manhole Inspection Report

Date:	10/08/2022	Weather:		Coding:	RZMACP
MH#:	M-803-004	Owner:	NA	Len. Surveyed:	8.3
P.O.#:		Surveyor:	Jen Costello	Rim to Invert:	10.0
Customer:		Cert. #:	U-907-5518	Wall Material:	Concrete (cast in place)

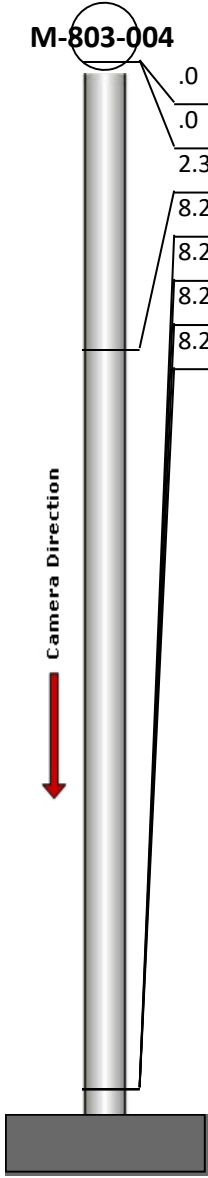
.0	MGO	General Observation	10	NA
	.0	SAV	Surface Aggregate Visible	21	S 3
	2.3	MGO	General Observation	39	NA
	8.2	DSF	Deposits Settled Fine	65	M 2
	8.2	B	Broken	76	S 5
	8.2	SAV	Surface Aggregate Visible	87	S 3
	8.2	MGO	General Observation	98	NA

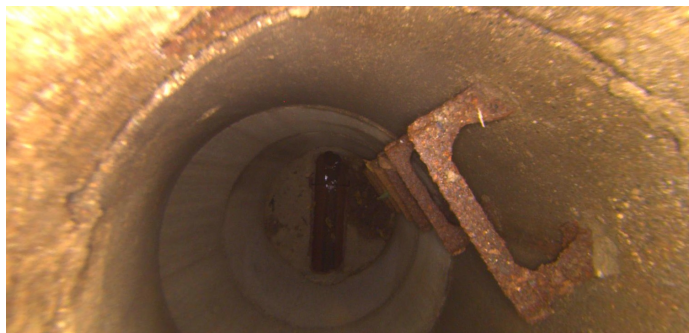
Code: **MGO**
Description: **General Observation**

Distance (ft): **.0**
Structural Grade: **0**
O&M Grade: **0**
Clock Start/From:
Clock To:
1st Value:
2nd Value:
Value Percent:
Step: **NO**
Remarks: **access mh**

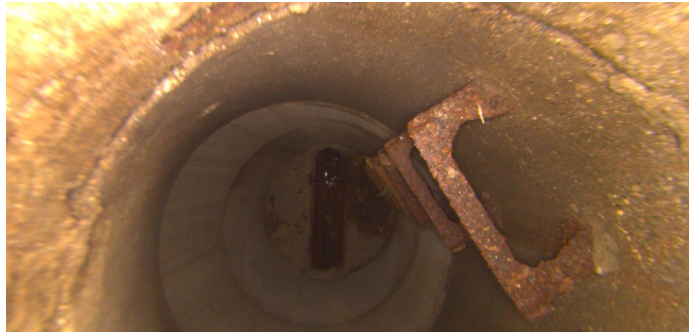
Code: **SAV**
Description: **Surface Aggregate Visible**

Distance (ft): **.0**
Structural Grade: **3**
O&M Grade: **0**
Clock Start/From: **12**
Clock To: **12**
1st Value:
2nd Value:
Value Percent:
Step: **NO**
Remarks:

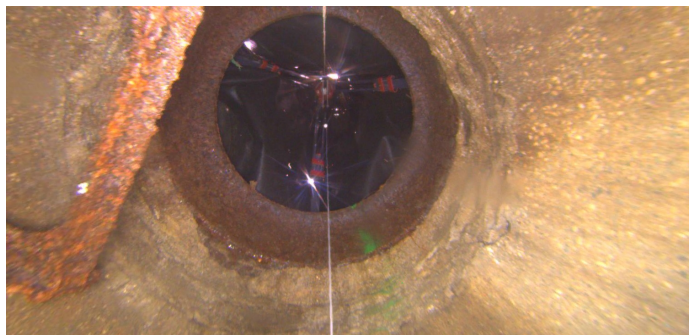
Code: **MGO**
Description: **General Observation**

Distance (ft): **2.3**
Structural Grade: **0**
O&M Grade: **0**
Clock Start/From:
Clock To:
1st Value:
2nd Value:
Value Percent:
Step: **NO**
Remarks: **underside of frame**

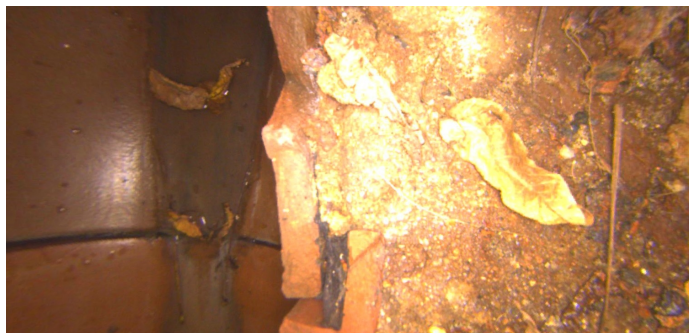
Code: **DSF**
Description: **Deposits Settled Fine**

Distance (ft): **8.2**
Structural Grade: **0**
O&M Grade: **2**
Clock Start/From: **12**
Clock To: **12**
1st Value:
2nd Value:
Value Percent: **5.000**
Step: **NO**
Remarks:

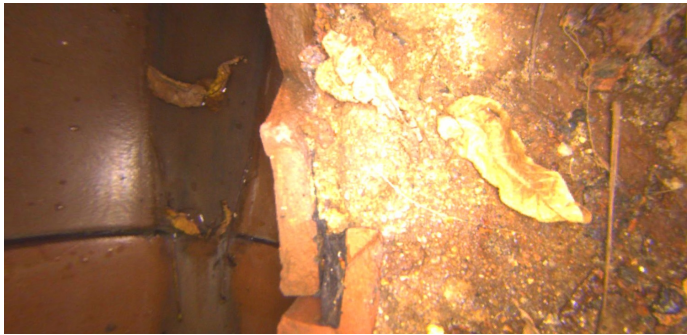
Code: **B**
Description: **Broken**

Distance (ft): **8.2**
Structural Grade: **5**
O&M Grade: **0**
Clock Start/From: **3**
Clock To: **5**
1st Value:
2nd Value:
Value Percent:
Step: **NO**
Remarks:

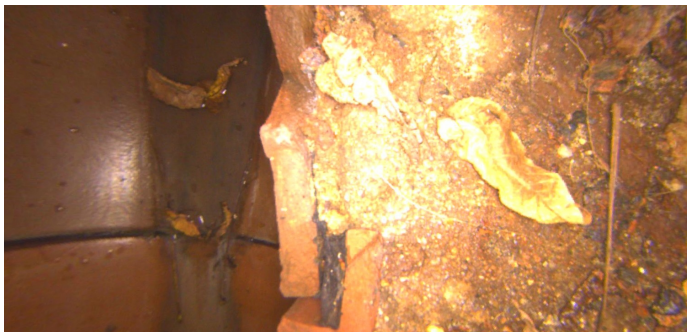
Code: **SAV**
Description: **Surface Aggregate Visible**

Distance (ft): **8.2**
Structural Grade: **3**
O&M Grade: **0**
Clock Start/From: **12**
Clock To: **12**
1st Value:
2nd Value:
Value Percent:
Step: **NO**
Remarks:

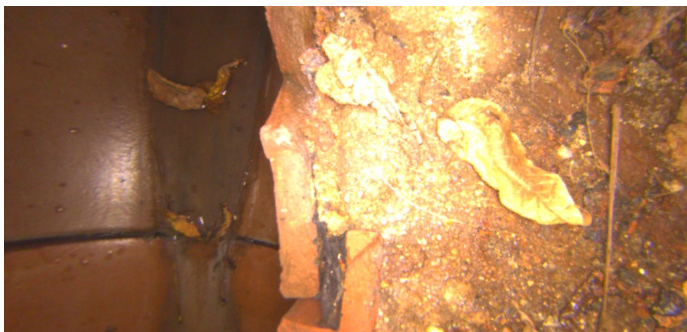
Code: **MGO**
Description: **General Observation**

Distance (ft): **8.2**
Structural Grade: **0**
O&M Grade: **0**
Clock Start/From:
Clock To:
1st Value:
2nd Value:
Value Percent:
Step: **NO**
Remarks: **end of survey**
