# Manhole Inspection Report

Date:	<b>03/28/2018</b>	Weather:		Coding:	<b>RZMACP</b>
MH#:	<b>M-803-008</b>	Owner:	<b>NA</b>	Len. Surveyed:	<b>13.8</b>
P.O.#:		Surveyor:	<b>John Kuglmaier</b>	Rim to Invert:	<b>15.1</b>
Customer:		Cert. #:	<b>U-1215-07002349</b>	Wall Material:	<b>Concrete (reinforced)</b>

Street:	<b>226' North of North St. 165' East of L</b>	Project:	<b>Hobart, IN</b>
City:	<b>Hobart, IN</b>	GPS Northing:	<b>0.0</b>
Location:		GPS Easting:	<b>0.0</b>
Drain Area:	<b>Northeast</b>	GPS Accuracy:	<b>Nearest Meter</b>
Cover Shape:	<b>Circular</b>	Evidence of Surcharge:	<b>No</b>
Cover Size:	<b>23.0</b>	Potential for Runoff:	<b>None</b>
Comments:

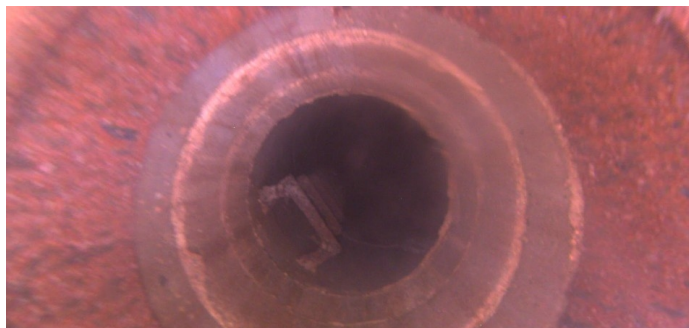
Code: **MGP**  
Description: **General Photo**

Distance (ft): **.0**  
Structural Grade: **0**  
O&M Grade: **0**  
Clock Start/From:  
Clock To:  
1st Value:  
2nd Value:  
Value Percent:  
Step: **NO**  
Remarks:

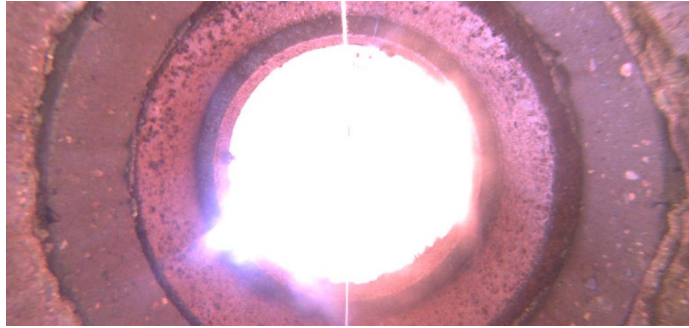
Code: **MGP**  
Description: **General Photo**

Distance (ft): **2.4**  
Structural Grade: **0**  
O&M Grade: **0**  
Clock Start/From:  
Clock To:  
1st Value:  
2nd Value:  
Value Percent:  
Step: **NO**  
Remarks:

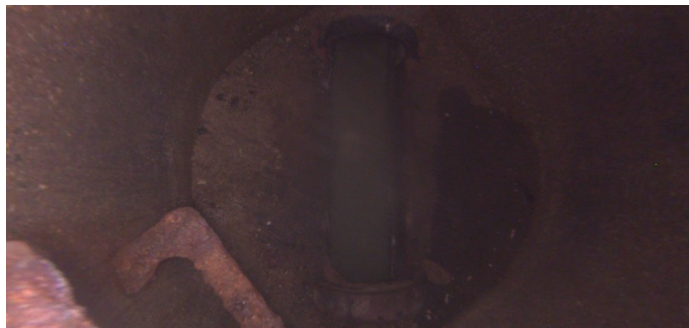
Code: **DAZ**  
Description: **Deposits Attached Other**

Distance (ft): **11.3**  
Structural Grade: **0**  
O&M Grade: **2**  
Clock Start/From: **12**  
Clock To: **12**  
1st Value:  
2nd Value:  
Value Percent: **5.000**  
Step: **NO**  
Remarks: **Mixed materials**

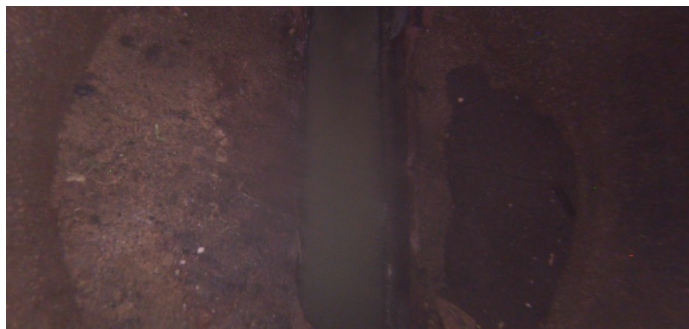
Code: **MGO**  
Description: **General Observation**

Distance (ft): **12.4**  
Structural Grade: **0**  
O&M Grade: **0**  
Clock Start/From:  
Clock To:  
1st Value:  
2nd Value:  
Value Percent:  
Step: **NO**  
Remarks: **Ins. Comp.**
