# Manhole Inspection Report

Date:	<b>03/28/2018</b>	Weather:		Coding:	<b>RZMACP</b>
MH#:	<b>M-803-011</b>	Owner:	<b>NA</b>	Len. Surveyed:	<b>10.9</b>
P.O.#:		Surveyor:	<b>John Kuglmaier</b>	Rim to Invert:	<b>12.3</b>
Customer:		Cert. #:	<b>U-1215-07002349</b>	Wall Material:	<b>Concrete (reinforced)</b>

Street:	<b>Rand St. 68' East of Lawrence St.</b>	Project:	<b>Hobart, IN</b>
City:	<b>Hobart, IN</b>	GPS Northing:	<b>0.0</b>
Location:		GPS Easting:	<b>0.0</b>
Drain Area:	<b>Northeast</b>	GPS Accuracy:	<b>Nearest Meter</b>
Cover Shape:	<b>Circular</b>	Evidence of Surcharge:	<b>No</b>
Cover Size:	<b>23.0</b>	Potential for Runoff:	<b>None</b>
Comments:

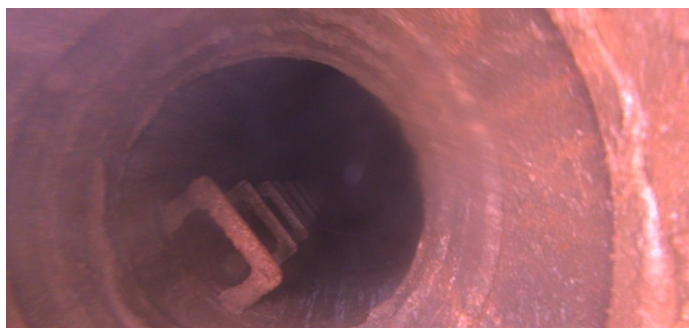
Code: **MGP**  
Description: **General Photo**

Distance (ft): **.0**  
Structural Grade: **0**  
O&M Grade: **0**  
Clock Start/From:  
Clock To:  
1st Value:  
2nd Value:  
Value Percent:  
Step: **NO**  
Remarks:

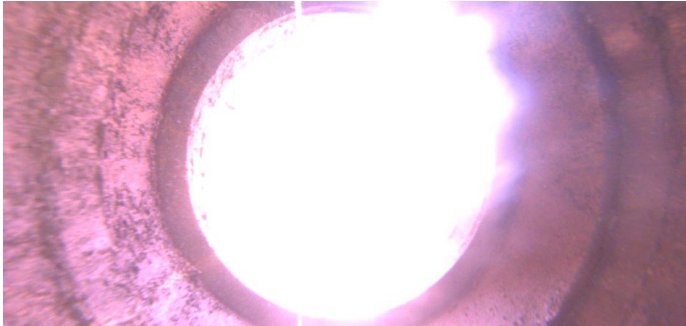
Code: **MGP**  
Description: **General Photo**

Distance (ft): **2.2**  
Structural Grade: **0**  
O&M Grade: **0**  
Clock Start/From:  
Clock To:  
1st Value:  
2nd Value:  
Value Percent:  
Step: **NO**  
Remarks:

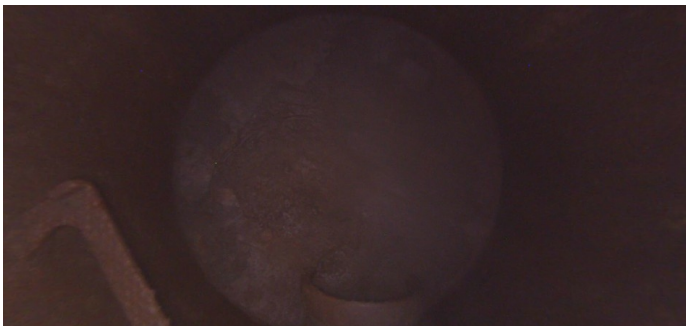
Code: **DAZ**  
Description: **Deposits Attached Other**

Distance (ft): **8.6**  
Structural Grade: **0**  
O&M Grade: **2**  
Clock Start/From: **12**  
Clock To: **12**  
1st Value:  
2nd Value:  
Value Percent: **10.000**  
Step: **NO**  
Remarks: **Mixed materials**

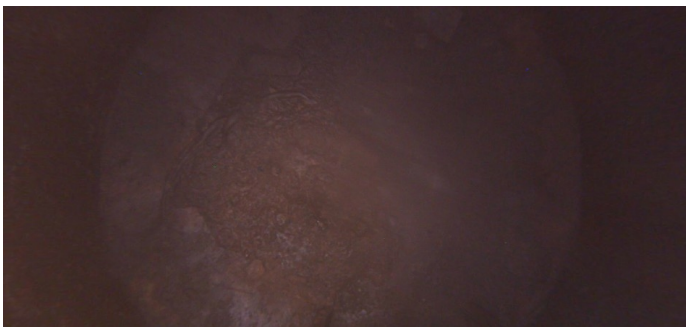
Code: **MGO**  
Description: **General Observation**

Distance (ft): **9.6**  
Structural Grade: **0**  
O&M Grade: **0**  
Clock Start/From:  
Clock To:  
1st Value:  
2nd Value:  
Value Percent:  
Step: **NO**  
Remarks: **Ins. Comp.**
