Manhole Inspection Report

| MH#: | M-803-012 | Owner: | NA | Len. Surveyed: | 11.4 |

| Street: | Rand St. 163' East of Lawrence St. | Project: | Hobart, IN |

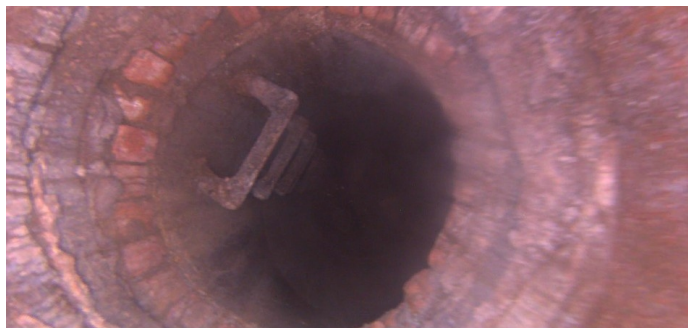
Code: **MGP**
Description: **General Photo**

Distance (ft): **.0**
Structural Grade: **0**
O&M Grade: **0**
Clock Start/From:
Clock To:
1st Value:
2nd Value:
Value Percent:
Step: **NO**
Remarks:

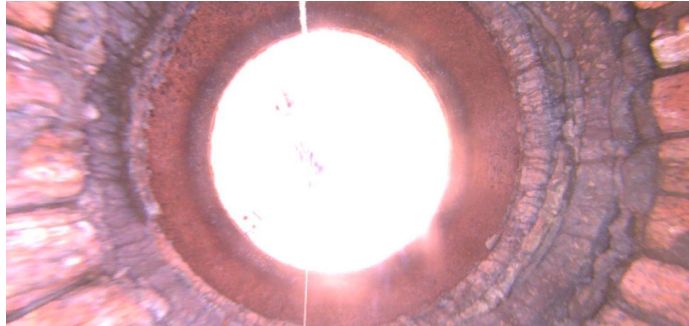
Code: **MGP**
Description: **General Photo**

Distance (ft): **2.2**
Structural Grade: **0**
O&M Grade: **0**
Clock Start/From:
Clock To:
1st Value:
2nd Value:
Value Percent:
Step: **NO**
Remarks:

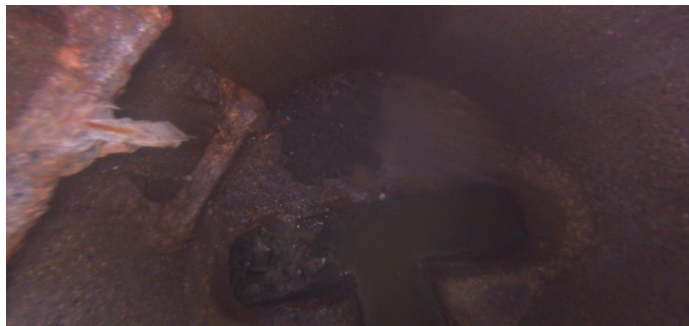
| | Position | Code | Observation | Video (sec) | Grade |
|--|---|---|---|---|---|
| | 9.3 | DSF | Deposits Settled Fine | 56 | M 2 |

Code: **DSF**
Description: **Deposits Settled Fine**

Distance (ft): **9.3**
Structural Grade: **0**
O&M Grade: **2**
Clock Start/From: **10**
Clock To: **12**
1st Value:
2nd Value:
Value Percent: **5.000**
Step: **NO**
Remarks:

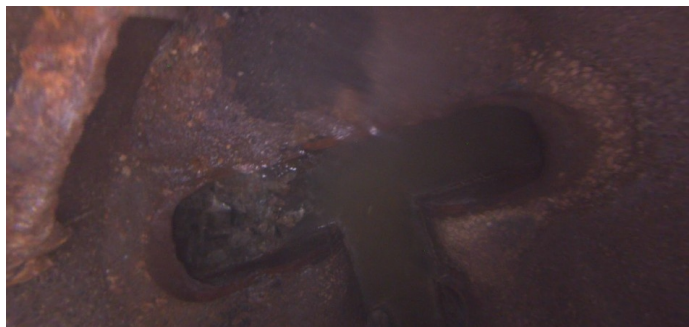
Code: **MGO**
Description: **General Observation**

Distance (ft): **10.0**
Structural Grade: **0**
O&M Grade: **0**
Clock Start/From:
Clock To:
1st Value:
2nd Value:
Value Percent:
Step: **NO**
Remarks: **Ins. Comp.**
