Manhole Inspection Report

Date:	10/08/2022	Weather:		Coding:	RZMACP
MH#:	M-803-014	Owner:	NA	Len. Surveyed:	9.7
P.O.#:		Surveyor:	Jen Costello	Rim to Invert:	10.6
Customer:		Cert. #:	U-907-5518	Wall Material:	Concrete (cast in place)

Street:	North St. 166' East of Liberty Pl.	Project:	Hobart, IN
City:	Hobart, IN	GPS Northing:	2293369.255
Location:	Other	GPS Easting:	2909213.379
Drain Area:	Northeast	GPS Accuracy:	Sub-Meter
Cover Shape:	Circular	Evidence of Surcharge:	Yes
Cover Size:	24.0	Potential for Runoff:	None
Comments:

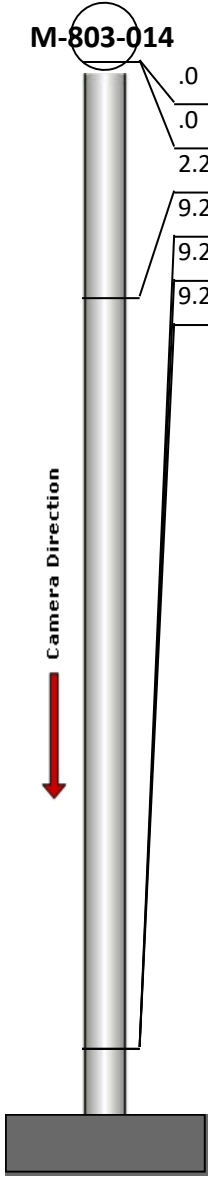
M-803-014				
	.0	MGO	General Observation	10	NA
	.0	SRI	Surface Roughness Increased	21	S 1
	2.2	MGO	General Observation	39	NA
	9.2	SAV	Surface Aggregate Visible	67	S 3
	9.2	SRI	Surface Roughness Increased	78	S 1
	9.2	MGO	General Observation	89	NA

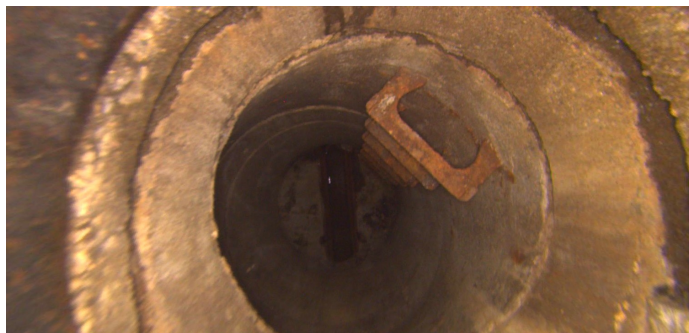
Code: **MGO**
Description: **General Observation**

Distance (ft): **.0**
Structural Grade: **0**
O&M Grade: **0**
Clock Start/From:
Clock To:
1st Value:
2nd Value:
Value Percent:
Step: **NO**
Remarks: **access mh**

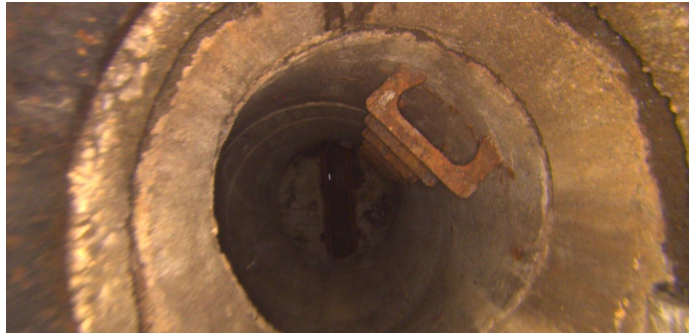
Code: **SRI**
Description: **Surface Roughness Increased**

Distance (ft): **.0**
Structural Grade: **1**
O&M Grade: **0**
Clock Start/From: **12**
Clock To: **12**
1st Value:
2nd Value:
Value Percent:
Step: **NO**
Remarks:

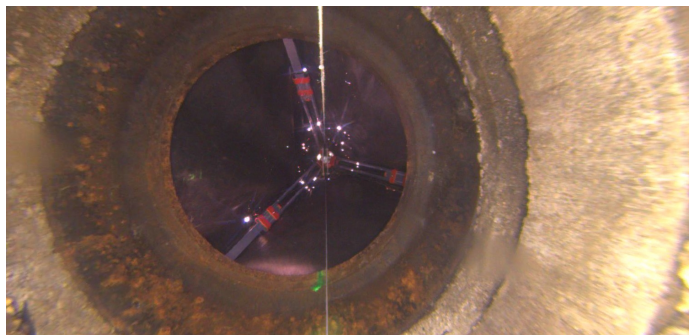
Code: **MGO**
Description: **General Observation**

Distance (ft): **2.2**
Structural Grade: **0**
O&M Grade: **0**
Clock Start/From:
Clock To:
1st Value:
2nd Value:
Value Percent:
Step: **NO**
Remarks: **underside of frame**

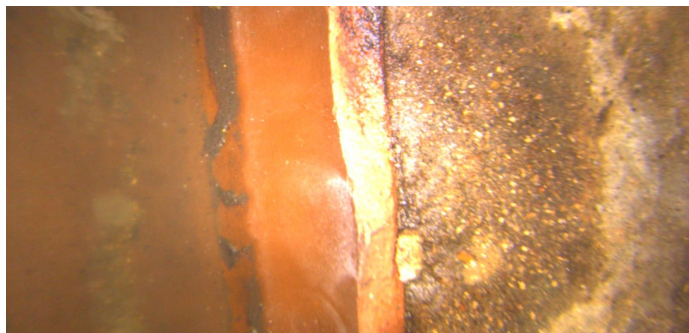
Code: **SAV**
Description: **Surface Aggregate Visible**

Distance (ft): **9.2**
Structural Grade: **3**
O&M Grade: **0**
Clock Start/From: **12**
Clock To: **12**
1st Value:
2nd Value:
Value Percent:
Step: **NO**
Remarks:

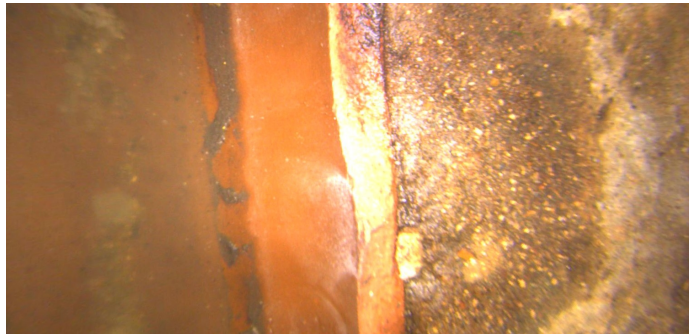
Code: **SRI**
Description: **Surface Roughness Increased**

Distance (ft): **9.2**
Structural Grade: **1**
O&M Grade: **0**
Clock Start/From: **12**
Clock To: **12**
1st Value:
2nd Value:
Value Percent:
Step: **NO**
Remarks:

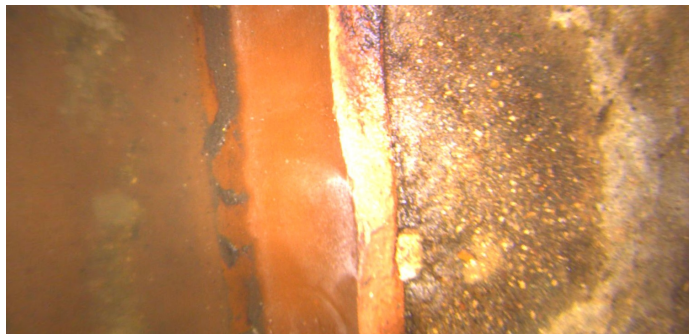
Code: **MGO**
Description: **General Observation**

Distance (ft): **9.2**
Structural Grade: **0**
O&M Grade: **0**
Clock Start/From:
Clock To:
1st Value:
2nd Value:
Value Percent:
Step: **NO**
Remarks: **end of survey**
