Manhole Inspection Report

Date:	10/07/2022	Weather:		Coding:	RZMACP
MH#:	M-803-017	Owner:	NA	Len. Surveyed:	7.3
P.O.#:		Surveyor:	Jen Costello	Rim to Invert:	8.7
Customer:		Cert. #:	U-907-5518	Wall Material:	Concrete (cast in place)

Street:	627' North of North St. 168' East of L	Project:	Hobart, IN
City:	Hobart, IN	GPS Northing:	2294007.238
Location:	Other	GPS Easting:	2909206.108
Drain Area:	Northeast	GPS Accuracy:	Sub-Meter
Cover Shape:	Circular	Evidence of Surcharge:	No
Cover Size:	24.0	Potential for Runoff:	None
Comments:

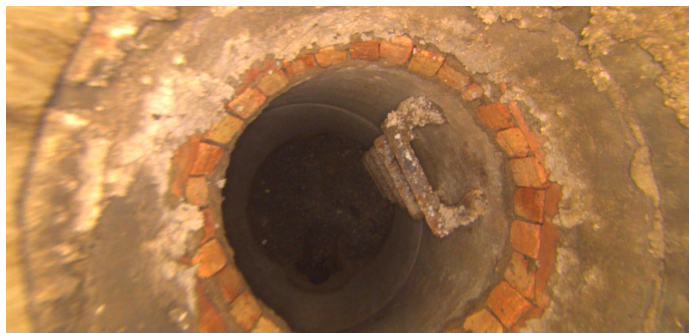
Code: **MGO**
Description: **General Observation**

Distance (ft): **.0**
Structural Grade: **0**
O&M Grade: **0**
Clock Start/From:
Clock To:
1st Value:
2nd Value:
Value Percent:
Step: **NO**
Remarks: **access mh**

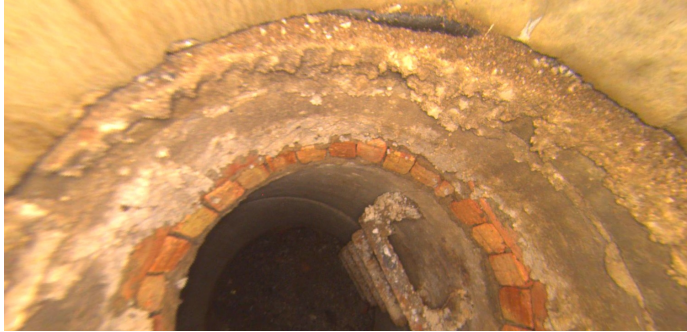
Code:	ISGT
Description:	Intruding Sealing Grout
Distance (ft):	.0
Structural Grade:	0
O&M Grade:	2
Clock Start/From:	12
Clock To:	12
1st Value:	
2nd Value:	
Value Percent:	5.000
Step:	NO
Remarks:

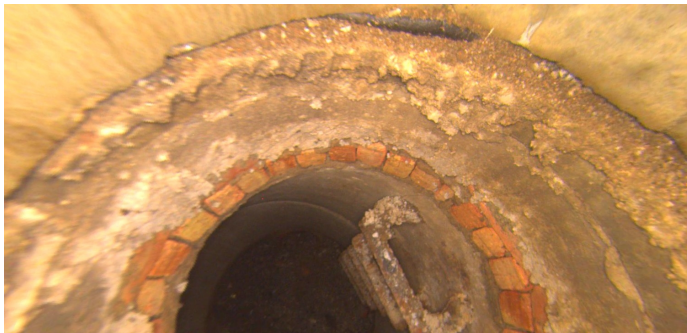
Code:	SRI
Description:	Surface Roughness Increased
Distance (ft):	.0
Structural Grade:	1
O&M Grade:	0
Clock Start/From:	12
Clock To:	12
1st Value:	
2nd Value:	
Value Percent:	
Step:	NO
Remarks:
