Manhole Inspection Report

Date:	10/08/2022	Weather:		Coding:	RZMACP
MH#:	M-803-020	Owner:	NA	Len. Surveyed:	8.3
P.O.#:		Surveyor:	Jen Costello	Rim to Invert:	9.6
Customer:		Cert. #:	U-907-5518	Wall Material:	Concrete (cast in place)

Street:	40th Ave. 162' East of Joliet St.	Project:	Hobart, IN
City:	Hobart, IN	GPS Northing:	2293720.203
Location:	Other	GPS Easting:	2908883.053
Drain Area:	Northeast	GPS Accuracy:	Sub-Meter
Cover Shape:	Circular	Evidence of Surcharge:	No
Cover Size:	24.0	Potential for Runoff:	None
Comments:

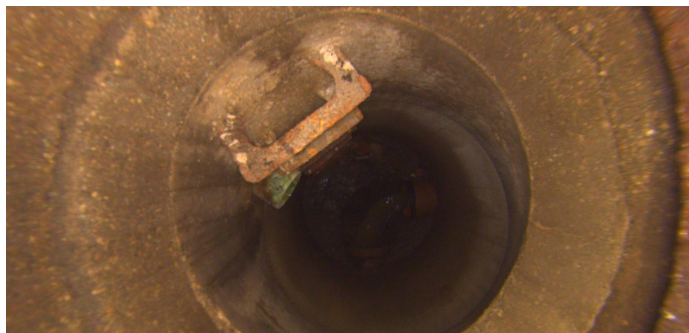
Code: **MGO**
Description: **General Observation**

Distance (ft): **.0**
Structural Grade: **0**
O&M Grade: **0**
Clock Start/From:
Clock To:
1st Value:
2nd Value:
Value Percent:
Step: **NO**
Remarks: **access mh**

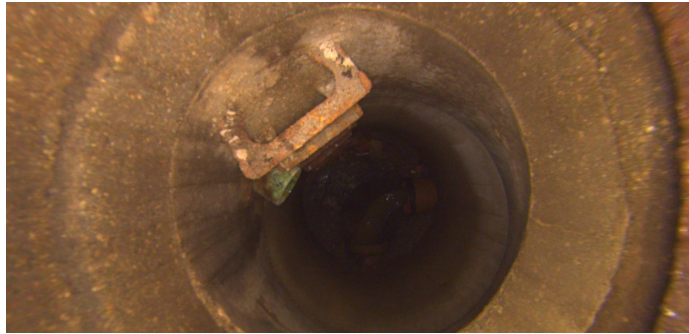
Code:	SAV
Description:	Surface Aggregate Visible
Distance (ft):	.0
Structural Grade:	3
O&M Grade:	0
Clock Start/From:	12
Clock To:	12
1st Value:	
2nd Value:	
Value Percent:	
Step:	NO
Remarks:

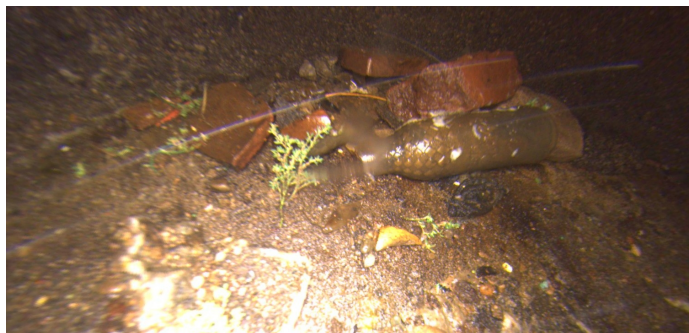
Code:	OBZ
Description:	Obstacle Other
Distance (ft):	7.9
Structural Grade:	0
O&M Grade:	2
Clock Start/From:	10
Clock To:	12
1st Value:	
2nd Value:	
Value Percent:	10.000
Step:	NO
Remarks:	misc

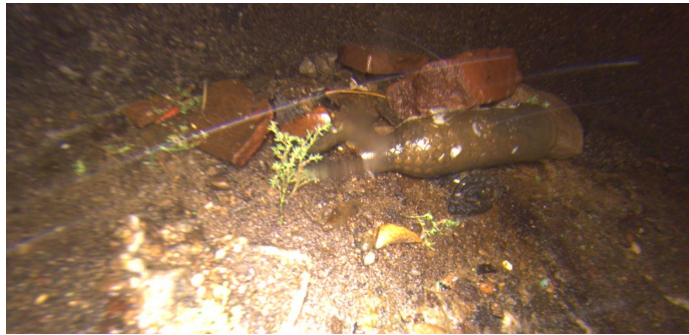
Code: **DSF**
Description: **Deposits Settled Fine**

Distance (ft): **7.9**
Structural Grade: **0**
O&M Grade: **2**
Clock Start/From: **12**
Clock To: **11**
1st Value:
2nd Value:
Value Percent: **5.000**
Step: **NO**
Remarks:

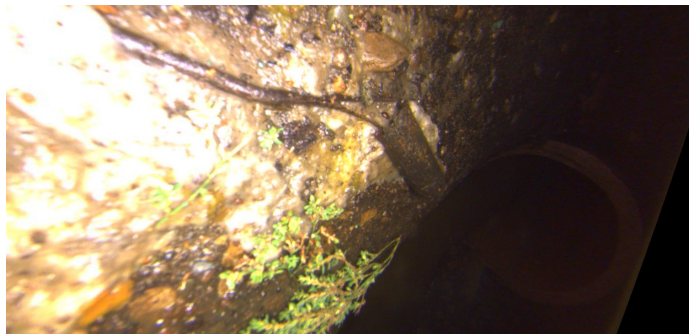
Code: **SAV**
Description: **Surface Aggregate Visible**

Distance (ft): **8.3**
Structural Grade: **3**
O&M Grade: **0**
Clock Start/From: **3**
Clock To: **9**
1st Value:
2nd Value:
Value Percent:
Step: **NO**
Remarks:

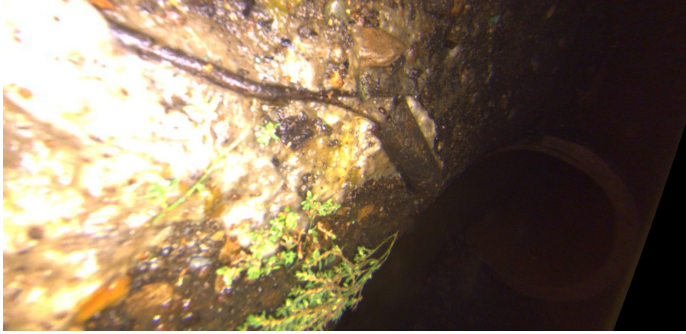
Code:	MGO
Description:	General Observation
Distance (ft):	8.3
Structural Grade:	0
O&M Grade:	0
Clock Start/From:	
Clock To:	
1st Value:	
2nd Value:	
Value Percent:	
Step:	NO
Remarks:	end of survey
