# Manhole Inspection Report

Date:	<b>03/28/2018</b>	Weather:		Coding:	<b>RZMACP</b>
MH#:	<b>M-803-028</b>	Owner:	<b>NA</b>	Len. Surveyed:	<b>10.9</b>
P.O.#:		Surveyor:	<b>John Kuglmaier</b>	Rim to Invert:	<b>12.2</b>
Customer:		Cert. #:	<b>U-1215-07002349</b>	Wall Material:	<b>Concrete (reinforced)</b>

Street:	<b>Intersection of Rand St. and Lawren</b>	Project:	<b>Hobart, IN</b>
City:	<b>Hobart, IN</b>	GPS Northing:	<b>0.0</b>
Location:		GPS Easting:	<b>0.0</b>
Drain Area:	<b>Northeast</b>	GPS Accuracy:	<b>Nearest Meter</b>
Cover Shape:	<b>Circular</b>	Evidence of Surcharge:	<b>No</b>
Cover Size:	<b>23.0</b>	Potential for Runoff:	<b>None</b>
Comments:

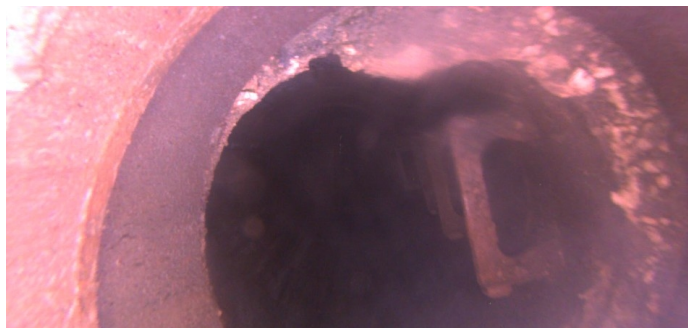
Code: **MGP**  
Description: **General Photo**

Distance (ft): **.0**  
Structural Grade: **0**  
O&M Grade: **0**  
Clock Start/From:  
Clock To:  
1st Value:  
2nd Value:  
Value Percent:  
Step: **NO**  
Remarks:

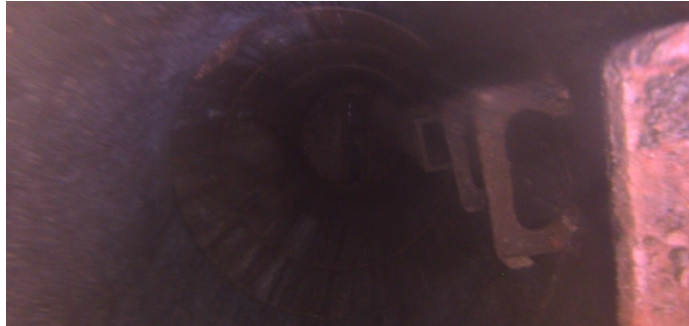
Code: **IS**  
Description: **Infil Stain**

Distance (ft): **1.1**  
Structural Grade: **0**  
O&M Grade: **0**  
Clock Start/From: **12**  
Clock To: **12**  
1st Value:  
2nd Value:  
Value Percent:  
Step: **NO**  
Remarks:

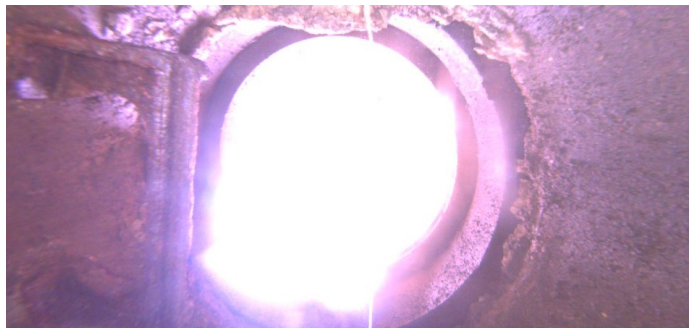
Code: **MGP**  
Description: **General Photo**

Distance (ft): **2.6**  
Structural Grade: **0**  
O&M Grade: **0**  
Clock Start/From:  
Clock To:  
1st Value:  
2nd Value:  
Value Percent:  
Step: **NO**  
Remarks:

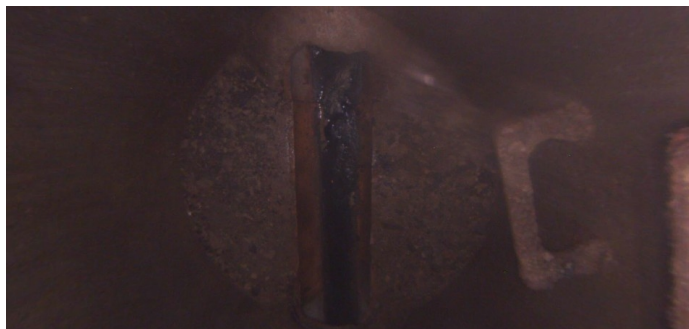
Code: **DSF**  
Description: **Deposits Settled Fine**

Distance (ft): **8.2**  
Structural Grade: **0**  
O&M Grade: **2**  
Clock Start/From: **12**  
Clock To: **12**  
1st Value:  
2nd Value:  
Value Percent: **10.000**  
Step: **NO**  
Remarks:

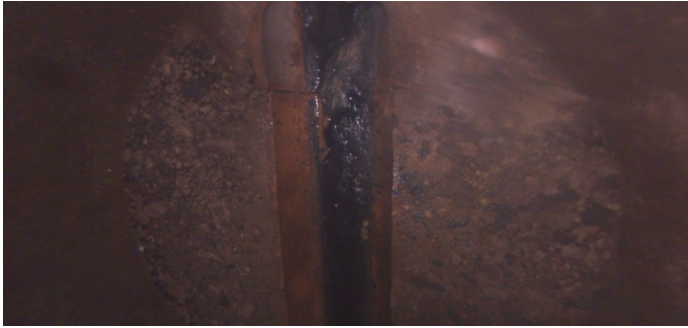
Code:	<b>MGO</b>
Description:	<b>General Observation</b>
Distance (ft):	<b>9.5</b>
Structural Grade:	<b>0</b>
O&M Grade:	<b>0</b>
Clock Start/From:	
Clock To:	
1st Value:	
2nd Value:	
Value Percent:	
Step:	<b>NO</b>
Remarks:	<b>Ins. Comp.</b>
