Manhole Inspection Report

Date:	03/28/2018	Weather:		Coding:	RZMACP
MH#:	M-803-029	Owner:	NA	Len. Surveyed:	10.5
P.O.#:		Surveyor:	John Kuglmaier	Rim to Invert:	12.5
Customer:		Cert. #:	U-1215-07002349	Wall Material:	Concrete (reinforced)

Street:	Rand St. 160' West of Liberty Ct.	Project:	Hobart, IN
City:	Hobart, IN	GPS Northing:	0.0
Location:		GPS Easting:	0.0
Drain Area:	Northeast	GPS Accuracy:	Nearest Meter
Cover Shape:	Circular	Evidence of Surcharge:	No
Cover Size:	23.0	Potential for Runoff:	None
Comments:

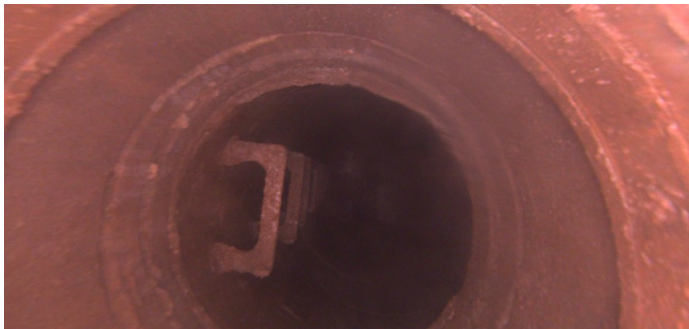
Code: **MGP**
Description: **General Photo**

Distance (ft): **.0**
Structural Grade: **0**
O&M Grade: **0**
Clock Start/From:
Clock To:
1st Value:
2nd Value:
Value Percent:
Step: **NO**
Remarks:

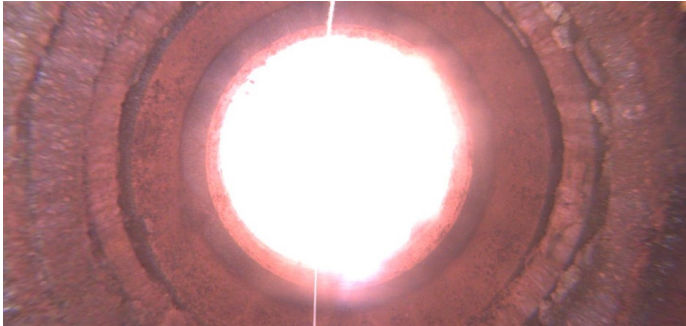
Code: **MGP**
Description: **General Photo**

Distance (ft): **2.5**
Structural Grade: **0**
O&M Grade: **0**
Clock Start/From:
Clock To:
1st Value:
2nd Value:
Value Percent:
Step: **NO**
Remarks:

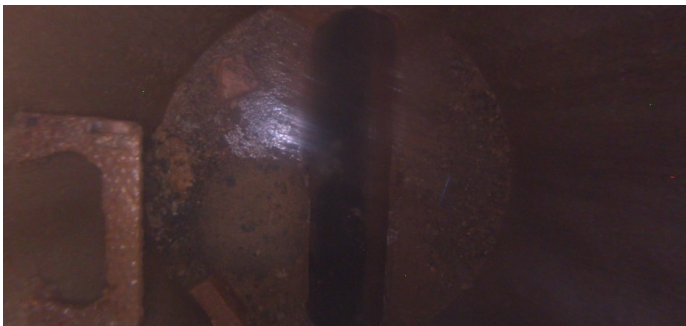
Code: **DSF**
Description: **Deposits Settled Fine**

Distance (ft): **8.7**
Structural Grade: **0**
O&M Grade: **2**
Clock Start/From: **12**
Clock To: **12**
1st Value:
2nd Value:
Value Percent: **5.000**
Step: **NO**
Remarks:

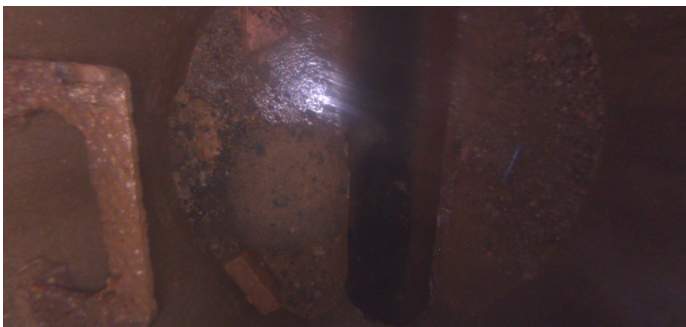
Code: **OBB**
Description: **Obstacle Brick**

Distance (ft): **9.2**
Structural Grade: **0**
O&M Grade: **2**
Clock Start/From: **7**
Clock To:
1st Value:
2nd Value:
Value Percent: **5.000**
Step: **NO**
Remarks:

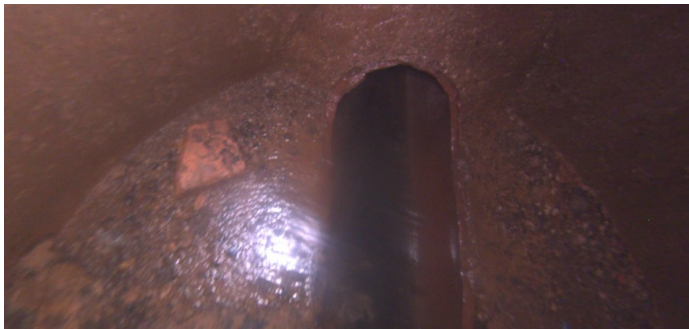
Code: **OBB**
Description: **Obstacle Brick**

Distance (ft): **10.0**
Structural Grade: **0**
O&M Grade: **2**
Clock Start/From: **11**
Clock To:
1st Value:
2nd Value:
Value Percent: **5.000**
Step: **NO**
Remarks:

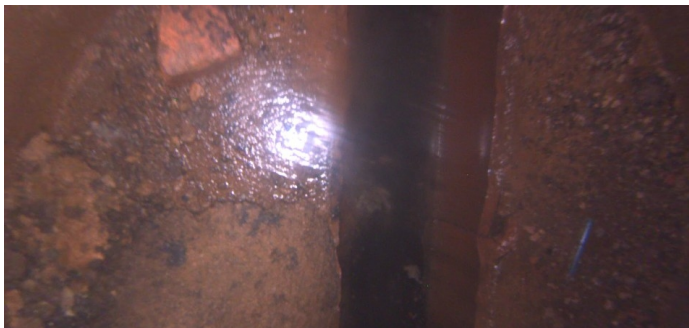
Code: **MGO**
Description: **General Observation**

Distance (ft): **10.2**
Structural Grade: **0**
O&M Grade: **0**
Clock Start/From:
Clock To:
1st Value:
2nd Value:
Value Percent:
Step: **NO**
Remarks: **Ins. Comp.**
