Manhole Inspection Report

Street:	Rand St. 164' East of Indiana St.	Project:	Hobart, IN
City:	Hobart, IN	GPS Northing:	2294382.563
Location:	Other	GPS Easting:	2908207.604
Drain Area:	Northeast	GPS Accuracy:	Sub-Meter
Cover Shape:	Circular	Evidence of Surcharge:	No
Cover Size:	24.0	Potential for Runoff:	None
Comments:

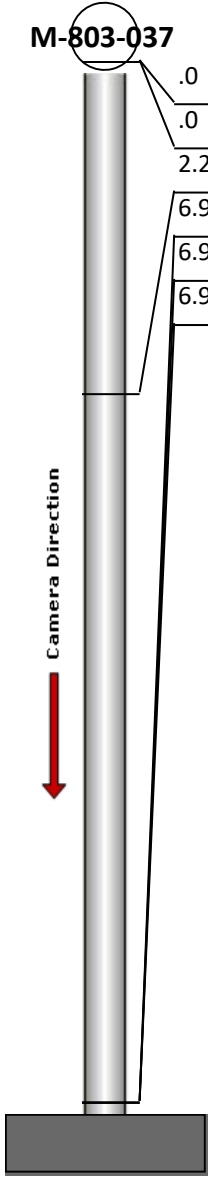
Position	Code	Observation	Video (sec)	Grade

.0	MGO	General Observation	10	NA
	.0	SAV	Surface Aggregate Visible	21	S 3
	2.2	MGO	General Observation	39	NA
	6.9	SAV	Surface Aggregate Visible	62	S 3
	6.9	MGO	General Observation	74	NA
	6.9	SAV	Surface Aggregate Visible	85	S 3

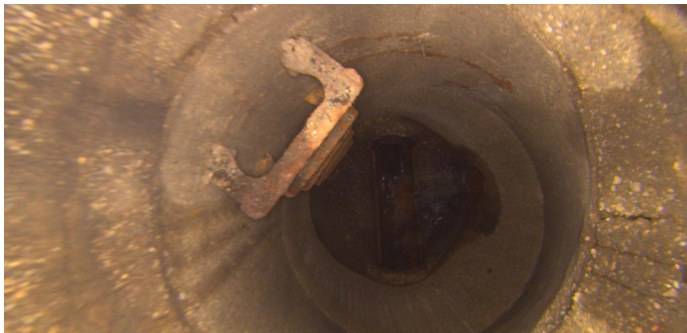
Code: **MGO**
Description: **General Observation**

Distance (ft): **.0**
Structural Grade: **0**
O&M Grade: **0**
Clock Start/From:
Clock To:
1st Value:
2nd Value:
Value Percent:
Step: **NO**
Remarks: **access mh**

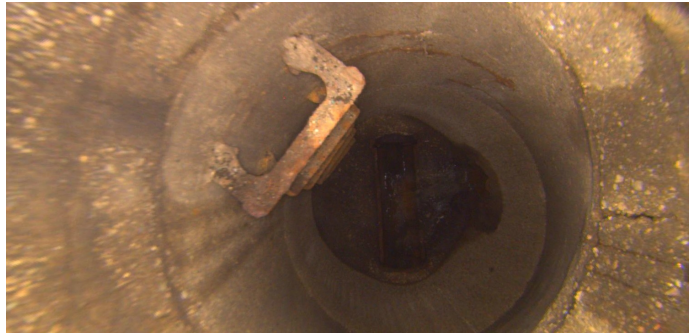
Code:	SAV
Description:	Surface Aggregate Visible
Distance (ft):	.0
Structural Grade:	3
O&M Grade:	0
Clock Start/From:	12
Clock To:	12
1st Value:	
2nd Value:	
Value Percent:	
Step:	NO
Remarks:

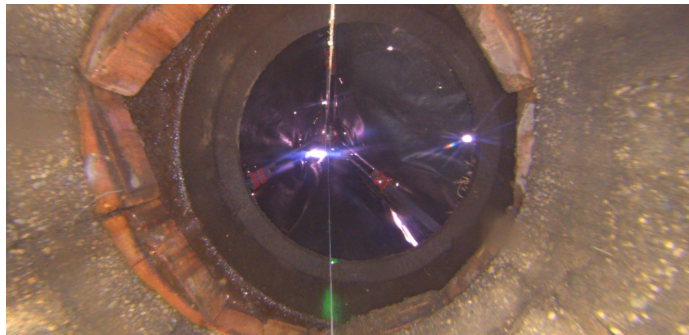
Code:	MGO
Description:	General Observation
Distance (ft):	2.2
Structural Grade:	0
O&M Grade:	0
Clock Start/From:	
Clock To:	
1st Value:	
2nd Value:	
Value Percent:	
Step:	NO
Remarks:	underside of frame

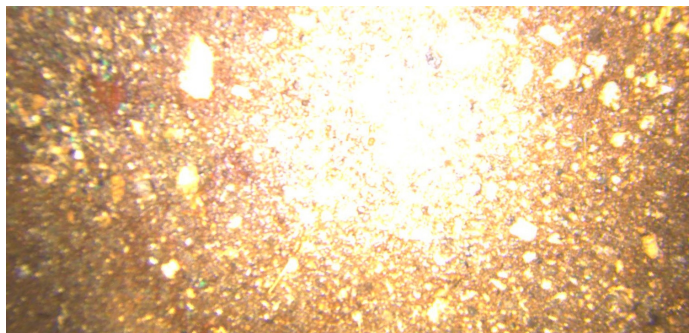
Code:	SAV
Description:	Surface Aggregate Visible
Distance (ft):	6.9
Structural Grade:	3
O&M Grade:	0
Clock Start/From:	12
Clock To:	12
1st Value:	
2nd Value:	
Value Percent:	
Step:	NO
Remarks:

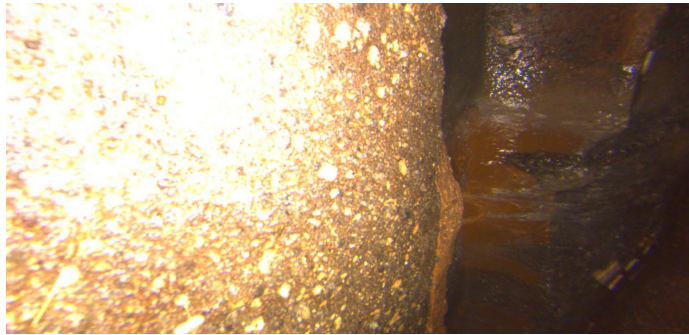
Code: **MGO**
Description: **General Observation**

Distance (ft): **6.9**
Structural Grade: **0**
O&M Grade: **0**
Clock Start/From:
Clock To:
1st Value:
2nd Value:
Value Percent:
Step: **NO**
Remarks: **end of survey**

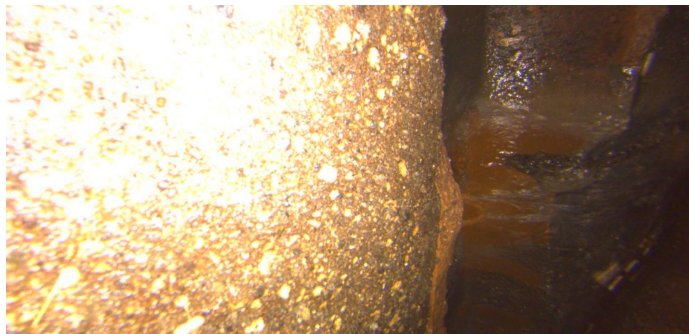
Code: **SAV**
Description: **Surface Aggregate Visible**

Distance (ft): **6.9**
Structural Grade: **3**
O&M Grade: **0**
Clock Start/From: **12**
Clock To: **12**
1st Value:
2nd Value:
Value Percent:
Step: **NO**
Remarks:
