# Manhole Inspection Report

Date:	<b>03/28/2018</b>	Weather:		Coding:	<b>RZMACP</b>
MH#:	<b>M-803-038</b>	Owner:	<b>NA</b>	Len. Surveyed:	<b>7.7</b>
P.O.#:		Surveyor:	<b>John Kuglmaier</b>	Rim to Invert:	<b>8.9</b>
Customer:		Cert. #:	<b>U-1215-07002349</b>	Wall Material:	<b>Concrete (reinforced)</b>

Street:	<b>Intersection of Rand St. and Indiana</b>	Project:	<b>Hobart, IN</b>
City:	<b>Hobart, IN</b>	GPS Northing:	<b>0.0</b>
Location:		GPS Easting:	<b>0.0</b>
Drain Area:	<b>Northeast</b>	GPS Accuracy:	<b>Nearest Meter</b>
Cover Shape:	<b>Circular</b>	Evidence of Surcharge:	<b>No</b>
Cover Size:	<b>23.0</b>	Potential for Runoff:	<b>None</b>
Comments:

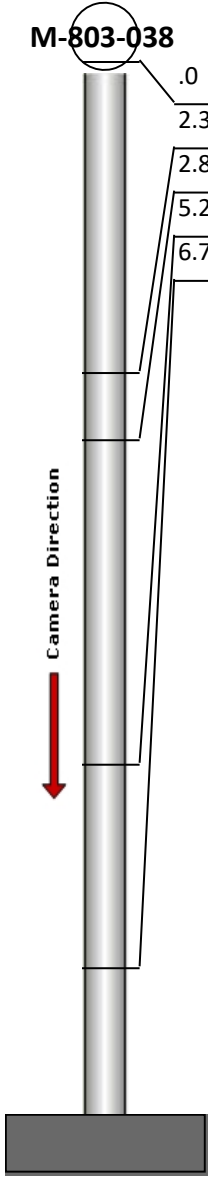
.0	MGP	General Photo	10	NA
	2.3	MGP	General Photo	28	NA
	2.8	IS	Infil Stain	43	NA
	5.2	DSF	Deposits Settled Fine	59	M 2
	6.7	MGO	General Observation	74	NA

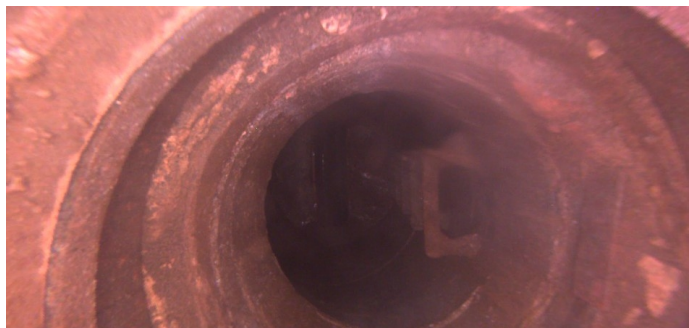
Code: **MGP**  
 Description: **General Photo**

Distance (ft): **.0**  
 Structural Grade: **0**  
 O&M Grade: **0**  
 Clock Start/From:  
 Clock To:  
 1st Value:  
 2nd Value:  
 Value Percent:  
 Step: **NO**  
 Remarks:

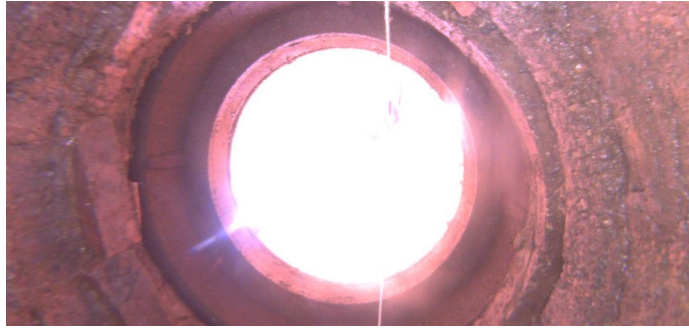
Code: **MGP**  
Description: **General Photo**

Distance (ft): **2.3**  
Structural Grade: **0**  
O&M Grade: **0**  
Clock Start/From:  
Clock To:  
1st Value:  
2nd Value:  
Value Percent:  
Step: **NO**  
Remarks:

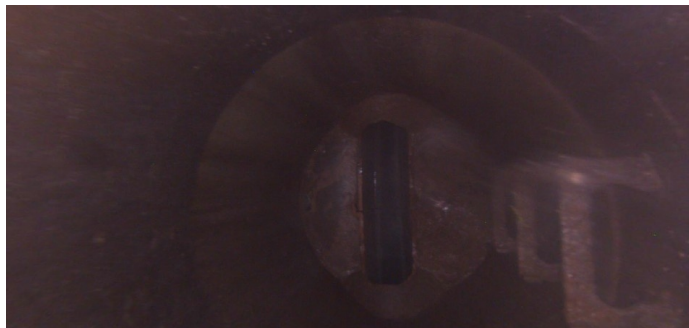
Code: **IS**  
Description: **Infil Stain**

Distance (ft): **2.8**  
Structural Grade: **0**  
O&M Grade: **0**  
Clock Start/From: **8**  
Clock To: **1**  
1st Value:  
2nd Value:  
Value Percent:  
Step: **NO**  
Remarks:

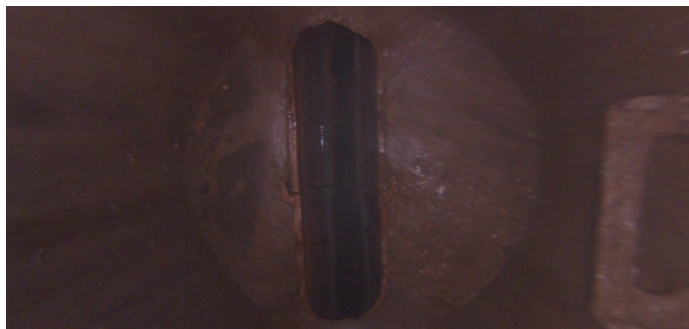
Code: **DSF**  
Description: **Deposits Settled Fine**

Distance (ft): **5.2**  
Structural Grade: **0**  
O&M Grade: **2**  
Clock Start/From: **12**  
Clock To: **12**  
1st Value:  
2nd Value:  
Value Percent: **5.000**  
Step: **NO**  
Remarks:

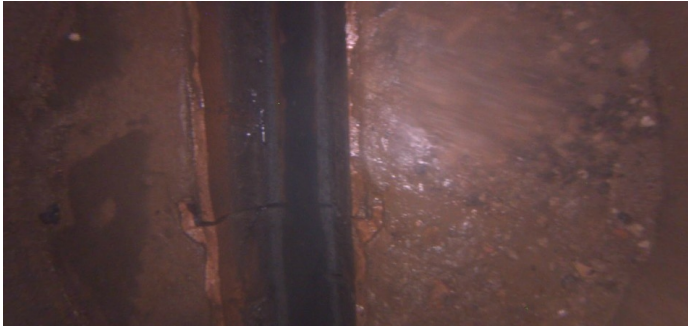
Code:	<b>MGO</b>
Description:	<b>General Observation</b>
Distance (ft):	<b>6.7</b>
Structural Grade:	<b>0</b>
O&M Grade:	<b>0</b>
Clock Start/From:	
Clock To:	
1st Value:	
2nd Value:	
Value Percent:	
Step:	<b>NO</b>
Remarks:	<b>Ins. Comp.</b>
