# Manhole Inspection Report

Date:	<b>03/29/2018</b>	Weather:		Coding:	<b>RZMACP</b>
MH#:	<b>M-803-043</b>	Owner:	<b>NA</b>	Len. Surveyed:	<b>12.0</b>
P.O.#:		Surveyor:	<b>John Kuglmaier</b>	Rim to Invert:	<b>13.5</b>
Customer:		Cert. #:	<b>U-1215-07002349</b>	Wall Material:	<b>Concrete (reinforced)</b>

Street:	<b>192' South of 40th Ave. 164' East of</b>	Project:	<b>Hobart, IN</b>
City:	<b>Hobart, IN</b>	GPS Northing:	<b>0.0</b>
Location:		GPS Easting:	<b>0.0</b>
Drain Area:	<b>Northeast</b>	GPS Accuracy:	<b>Nearest Meter</b>
Cover Shape:	<b>Circular</b>	Evidence of Surcharge:	<b>Yes</b>
Cover Size:	<b>23.0</b>	Potential for Runoff:	<b>None</b>
Comments:

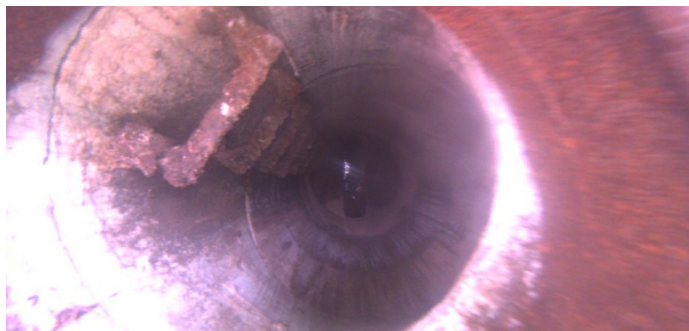
Code: **MGP**  
Description: **General Photo**

Distance (ft): **.0**  
Structural Grade: **0**  
O&M Grade: **0**  
Clock Start/From:  
Clock To:  
1st Value:  
2nd Value:  
Value Percent:  
Step: **NO**  
Remarks:

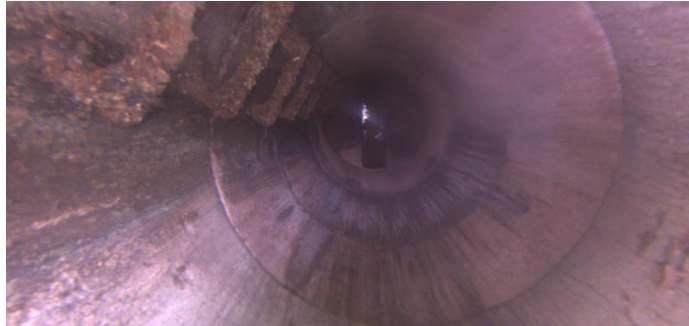
Code: **IS**  
Description: **Infil Stain**

Distance (ft): **1.5**  
Structural Grade: **0**  
O&M Grade: **0**  
Clock Start/From: **7**  
Clock To:  
1st Value:  
2nd Value:  
Value Percent:  
Step: **NO**  
Remarks:

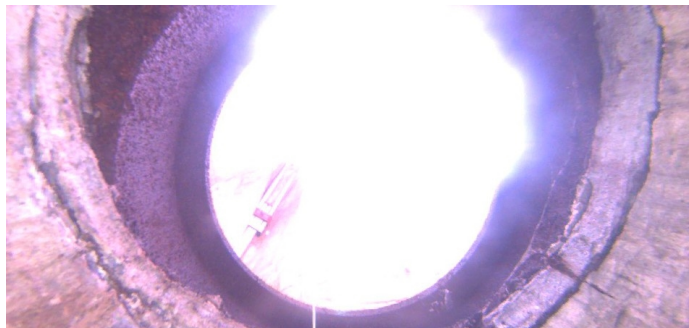
Code: **MGP**  
Description: **General Photo**

Distance (ft): **2.0**  
Structural Grade: **0**  
O&M Grade: **0**  
Clock Start/From:  
Clock To:  
1st Value:  
2nd Value:  
Value Percent:  
Step: **NO**  
Remarks:

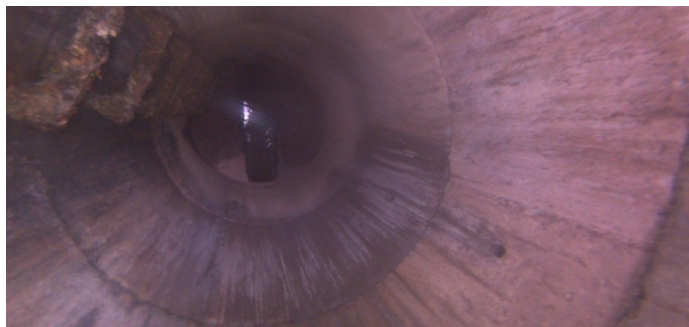
Code: **IS**  
Description: **Infil Stain**

Distance (ft): **3.3**  
Structural Grade: **0**  
O&M Grade: **0**  
Clock Start/From: **4**  
Clock To:  
1st Value:  
2nd Value:  
Value Percent:  
Step: **NO**  
Remarks:

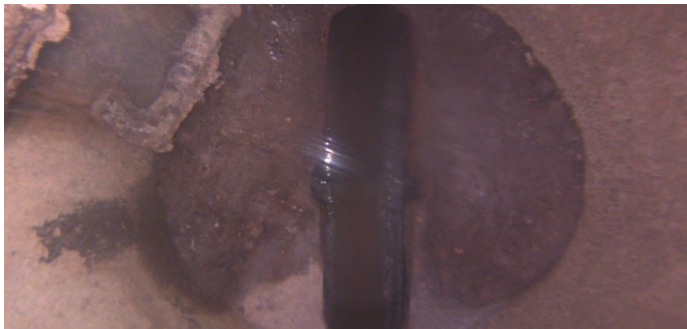
Code: **DSF**  
Description: **Deposits Settled Fine**

Distance (ft): **9.7**  
Structural Grade: **0**  
O&M Grade: **2**  
Clock Start/From: **12**  
Clock To: **12**  
1st Value:  
2nd Value:  
Value Percent: **10.000**  
Step: **NO**  
Remarks:

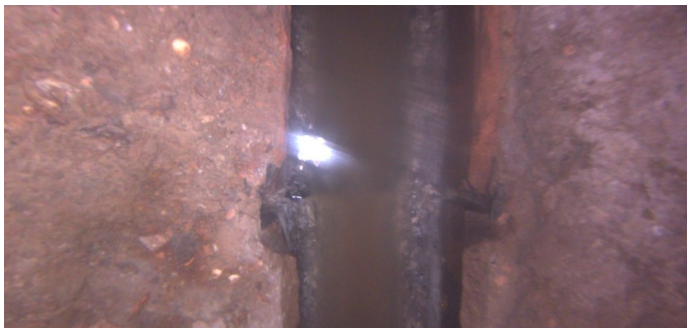
Code: **MGO**  
Description: **General Observation**

Distance (ft): **11.3**  
Structural Grade: **0**  
O&M Grade: **0**  
Clock Start/From:  
Clock To:  
1st Value:  
2nd Value:  
Value Percent:  
Step: **NO**  
Remarks: **Ins. Comp.**
