Manhole Inspection Report

| MH#: | M-803-044 | Owner: | NA | Len. Surveyed: | 13.0 |

| Street: | 234' North of High St. 163' East of K | Project: | Hobart, IN |

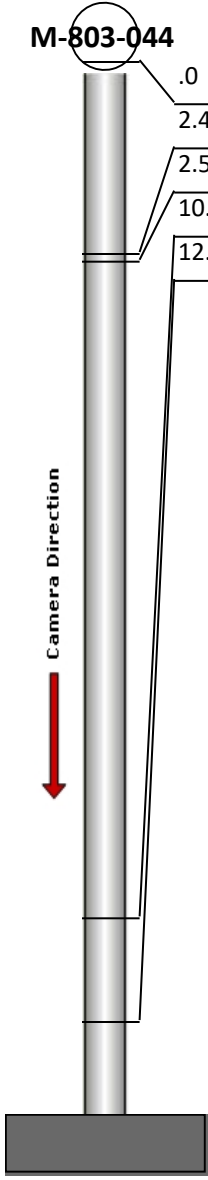
| | Position | Code | Observation | Video (sec) | Grade |
|--|---|---|---|---|---|
| | M-803-044 | | | | |

| | Position | Code | Observation | Video (sec) | Grade |
|--|---|---|---|---|---|
| | .0 | MGP | General Photo | 10 | NA |
| | 2.4 | MGP | General Photo | 29 | NA |
| | 2.5 | IS | Infil Stain | 42 | NA |
| | 10.7 | DSF | Deposits Settled Fine | 70 | M 2 |
| | 12.0 | MGO | General Observation | 84 | NA |

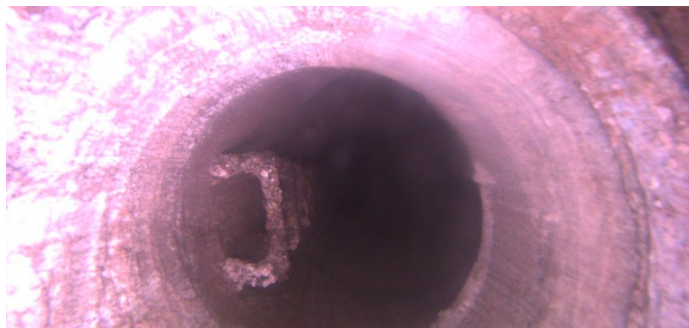
Code: **MGP**
Description: **General Photo**

Distance (ft): **.0**
Structural Grade: **0**
O&M Grade: **0**
Clock Start/From:
Clock To:
1st Value:
2nd Value:
Value Percent:
Step: **NO**
Remarks:

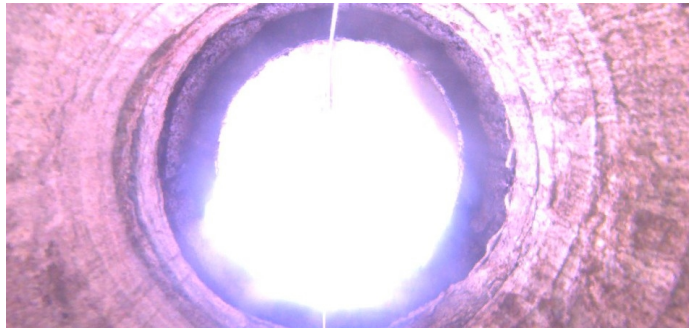
Code: **MGP**
Description: **General Photo**

Distance (ft): **2.4**
Structural Grade: **0**
O&M Grade: **0**
Clock Start/From:
Clock To:
1st Value:
2nd Value:
Value Percent:
Step: **NO**
Remarks:

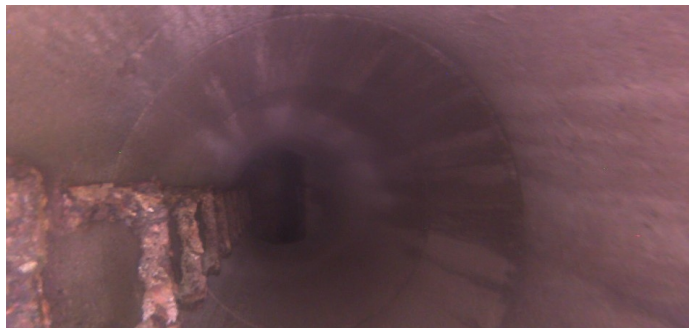
Code: **IS**
Description: **Infil Stain**

Distance (ft): **2.5**
Structural Grade: **0**
O&M Grade: **0**
Clock Start/From: **10**
Clock To: **4**
1st Value:
2nd Value:
Value Percent:
Step: **NO**
Remarks:

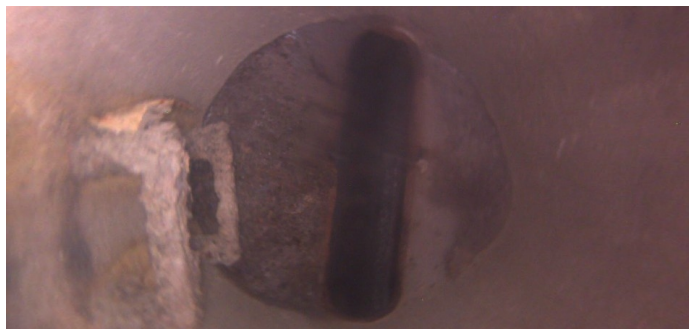
Code: **DSF**
Description: **Deposits Settled Fine**

Distance (ft): **10.7**
Structural Grade: **0**
O&M Grade: **2**
Clock Start/From: **12**
Clock To: **12**
1st Value:
2nd Value:
Value Percent: **10.000**
Step: **NO**
Remarks:

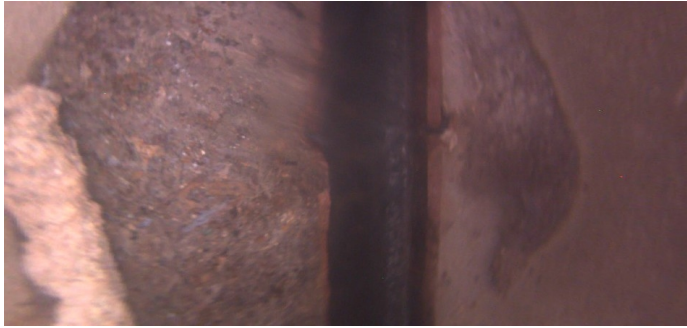
| Code: | MGO |
| Description: | General Observation |
| Distance (ft): | 12.0 |
| Remarks: | Ins. Comp. |
