Manhole Inspection Report

Street:	Rand St. 165' West of Indiana St.	Project:	Hobart, IN
City:	Hobart, IN	GPS Northing:	0.0
Location:		GPS Easting:	0.0
Drain Area:	Northeast	GPS Accuracy:	Nearest Meter
Cover Shape:	Circular	Evidence of Surcharge:	Yes
Cover Size:	23.0	Potential for Runoff:	None
Comments:

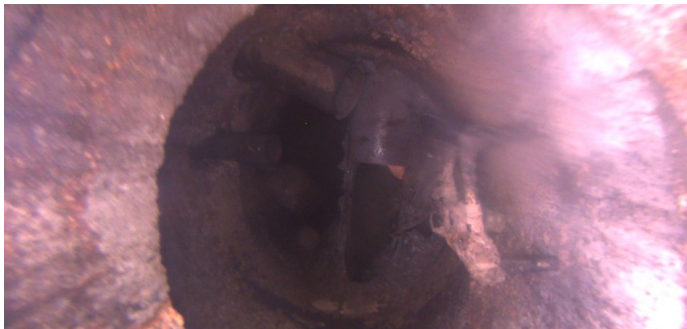
Code:	MGP
Description:	General Photo

Distance (ft):	.0
Structural Grade:	0
O&M Grade:	0
Clock Start/From:	
Clock To:	
1st Value:	
2nd Value:	
Value Percent:	
Step:	NO
Remarks:

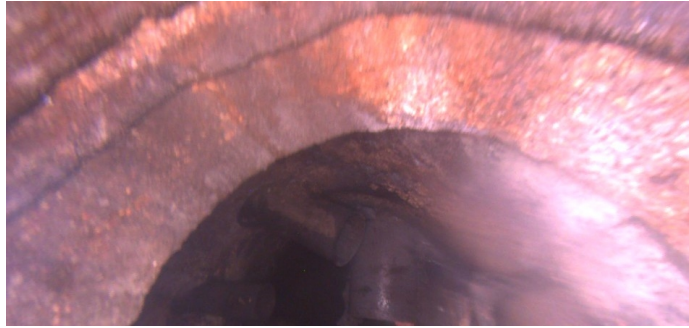
Code:	DAZ
Description:	Deposits Attached Other
Distance (ft):	.0
Structural Grade:	0
O&M Grade:	2
Clock Start/From:	12
Clock To:	12
1st Value:	
2nd Value:	
Value Percent:	5.000
Step:	NO
Remarks:	Mixed materials

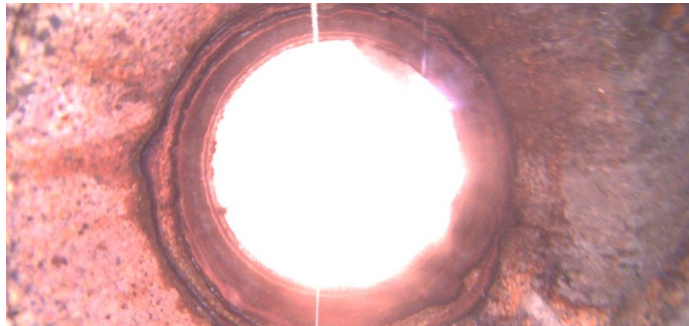
Code:	MGP
Description:	General Photo
Distance (ft):	2.0
Structural Grade:	0
O&M Grade:	0
Clock Start/From:	
Clock To:	
1st Value:	
2nd Value:	
Value Percent:	
Step:	NO
Remarks:

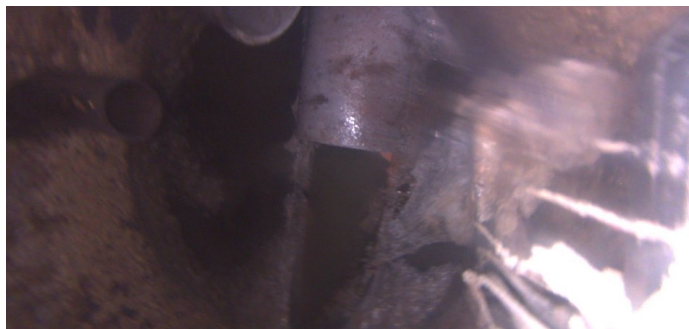
Code:	MGO
Description:	General Observation
Distance (ft):	2.4
Structural Grade:	0
O&M Grade:	0
Clock Start/From:	
Clock To:	
1st Value:	
2nd Value:	
Value Percent:	
Step:	NO
Remarks:	Surcharge

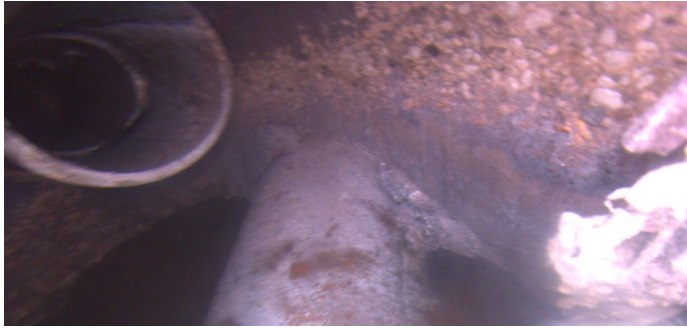
Code:	DAZ
Description:	Deposits Attached Other
Distance (ft):	3.9
Structural Grade:	0
O&M Grade:	2
Clock Start/From:	12
Clock To:	12
1st Value:	
2nd Value:	
Value Percent:	5.000
Step:	NO
Remarks:	Mixed materials

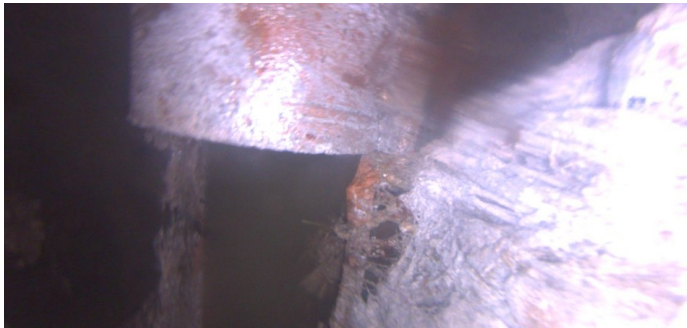
Code:	MGO
Description:	General Observation
Distance (ft):	4.2
Structural Grade:	0
O&M Grade:	0
Clock Start/From:	
Clock To:	
1st Value:	
2nd Value:	
Value Percent:	
Step:	NO
Remarks:	Ins. Comp.
