Manhole Inspection Report

Date:	10/07/2022	Weather:		Coding:	RZMACP
MH#:	M-803-065	Owner:	NA	Len. Surveyed:	4.3
P.O.#:		Surveyor:	Jen Costello	Rim to Invert:	5.5
Customer:		Cert. #:	U-907-5518	Wall Material:	Concrete (cast in place)

Street:	The West Side of Hwy 51. 543' Sout	Project:	Hobart, IN
City:	Hobart, IN	GPS Northing:	2295151.147
Location:	Other	GPS Easting:	2909656.165
Drain Area:	Northeast	GPS Accuracy:	Sub-Meter
Cover Shape:	Circular	Evidence of Surcharge:	No
Cover Size:	24.0	Potential for Runoff:	None
Comments:

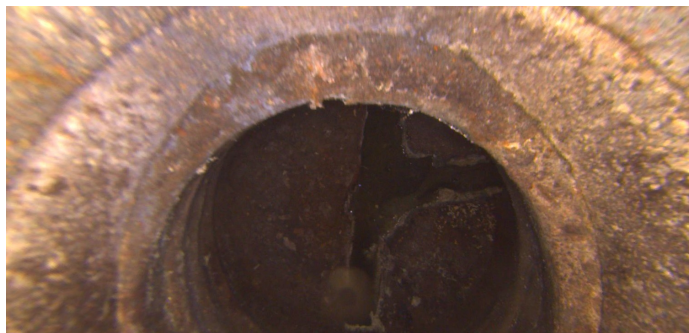
Code: **MGO**
Description: **General Observation**

Distance (ft): **.0**
Structural Grade: **0**
O&M Grade: **0**
Clock Start/From:
Clock To:
1st Value:
2nd Value:
Value Percent:
Step: **NO**
Remarks: **access mh**

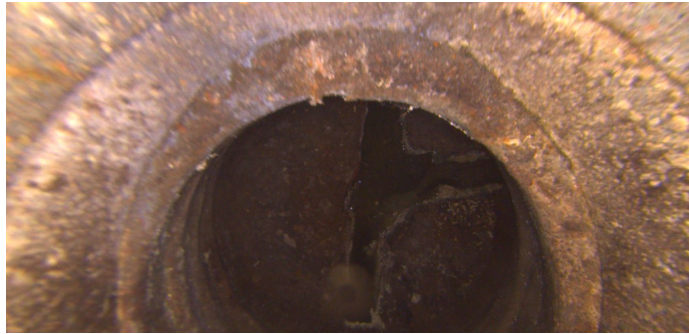
Code: **SRI**
Description: **Surface Roughness Increased**

Distance (ft): **.0**
Structural Grade: **1**
O&M Grade: **0**
Clock Start/From: **12**
Clock To: **12**
1st Value:
2nd Value:
Value Percent:
Step: **NO**
Remarks:

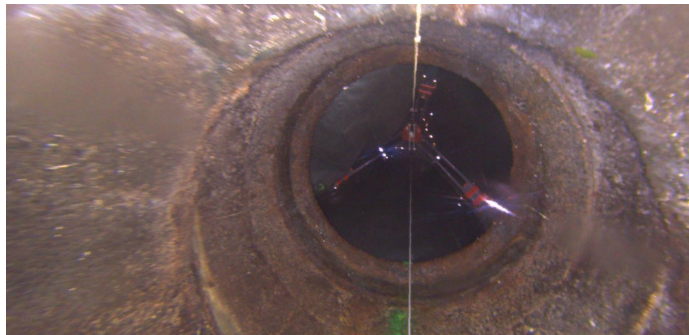
Code: **MGO**
Description: **General Observation**

Distance (ft): **2.5**
Structural Grade: **0**
O&M Grade: **0**
Clock Start/From:
Clock To:
1st Value:
2nd Value:
Value Percent:
Step: **NO**
Remarks: **underside of frame**

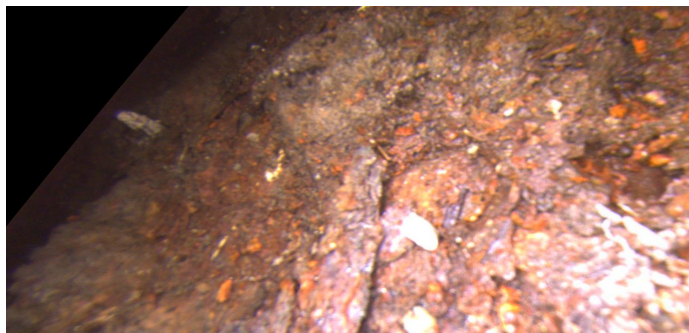
Code: **DSC**
Description: **Deposits Settled Compacted**

Distance (ft): **4.2**
Structural Grade: **0**
O&M Grade: **2**
Clock Start/From: **12**
Clock To: **12**
1st Value:
2nd Value:
Value Percent: **10.000**
Step: **NO**
Remarks:

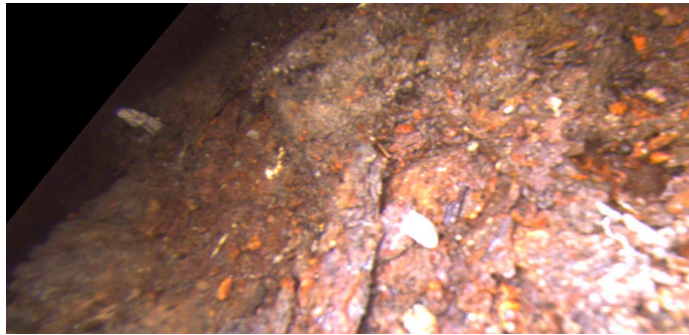
Code: **MGO**
Description: **General Observation**

Distance (ft): **4.2**
Structural Grade: **0**
O&M Grade: **0**
Clock Start/From:
Clock To:
1st Value:
2nd Value:
Value Percent:
Step: **NO**
Remarks: **end of survey**

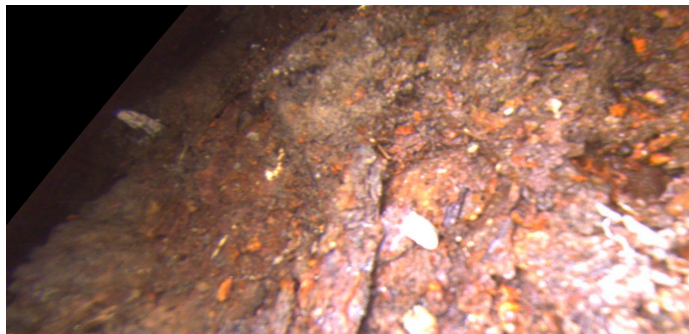
Code: **SRI**
Description: **Surface Roughness Increased**

Distance (ft): **4.2**
Structural Grade: **1**
O&M Grade: **0**
Clock Start/From: **12**
Clock To: **12**
1st Value:
2nd Value:
Value Percent:
Step: **NO**
Remarks:
