# Manhole Inspection Report

Date:	<b>05/07/2018</b>	Weather:		Coding:	<b>RZMACP</b>
MH#:	<b>M-804-002</b>	Owner:	<b>NA</b>	Len. Surveyed:	<b>6.7</b>
P.O.#:		Surveyor:	<b>Jen Costello</b>	Rim to Invert:	<b>7.2</b>
Customer:		Cert. #:	<b>U-907-5518</b>	Wall Material:	<b>Concrete (reinforced)</b>

Street:	<b>Intersection of Liberty St. and Clevel</b>	Project:	<b>Hobart, IN</b>
City:	<b>Hobart, IN</b>	GPS Northing:	<b>2909089.731</b>
Location:		GPS Easting:	<b>2909089.731</b>
Drain Area:	<b>South</b>	GPS Accuracy:	<b>Sub-Meter</b>
Cover Shape:	<b>Circular</b>	Evidence of Surcharge:	<b>No</b>
Cover Size:	<b>22.5</b>	Potential for Runoff:	<b>None</b>
Comments:

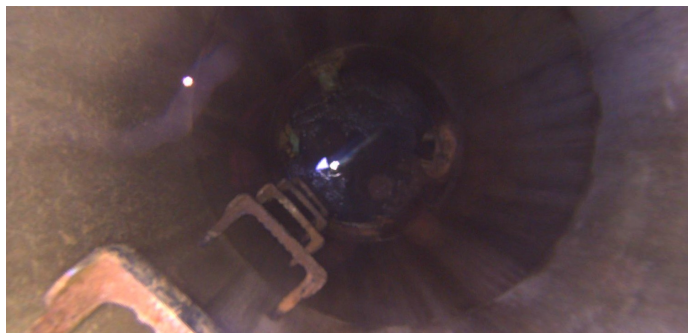
Code: **MGP**  
Description: **General Photo**

Distance (ft): **.0**  
Structural Grade: **0**  
O&M Grade: **0**  
Clock Start/From:  
Clock To:  
1st Value:  
2nd Value:  
Value Percent:  
Step: **NO**  
Remarks: **ACCESS MH**

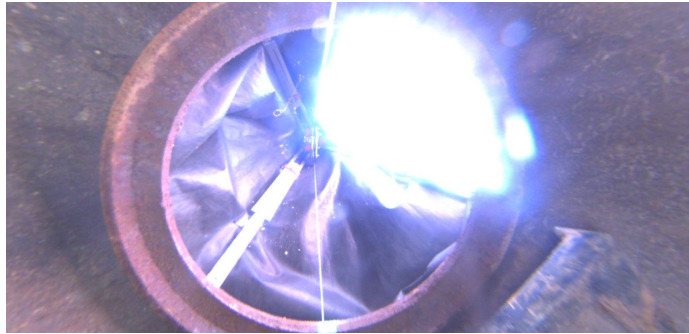
Code: **MGO**  
Description: **General Observation**

Distance (ft): **1.5**  
Structural Grade: **0**  
O&M Grade: **0**  
Clock Start/From:  
Clock To:  
1st Value:  
2nd Value:  
Value Percent:  
Step: **NO**  
Remarks: **UNDERSIDE OF FRAME**

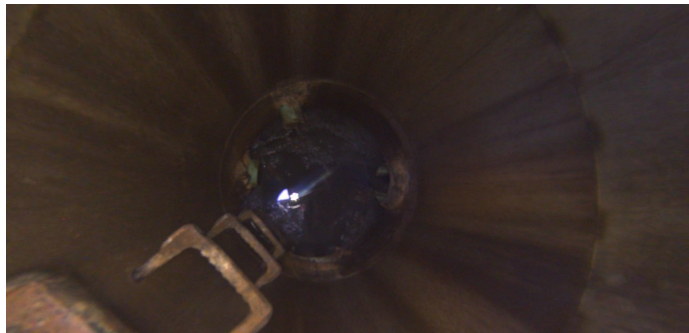
Code: **IS**  
Description: **Infil Stain**

Distance (ft): **1.5**  
Structural Grade: **0**  
O&M Grade: **0**  
Clock Start/From: **12**  
Clock To: **12**  
1st Value:  
2nd Value:  
Value Percent:  
Step: **NO**  
Remarks:

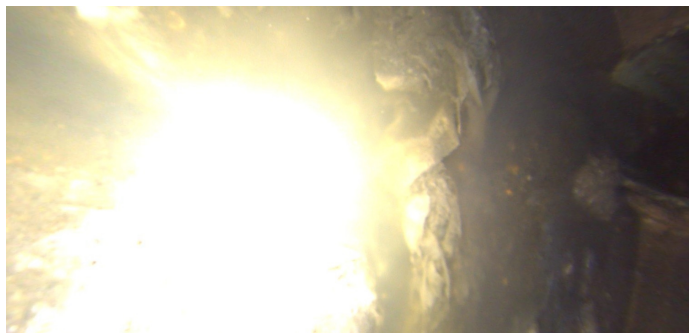
Code: **MGO**  
Description: **General Observation**

Distance (ft): **6.7**  
Structural Grade: **0**  
O&M Grade: **0**  
Clock Start/From:  
Clock To:  
1st Value:  
2nd Value:  
Value Percent:  
Step: **NO**  
Remarks: **end survey**
