Manhole Inspection Report

| MH#: | M-804-016 | Owner: | NA | Len. Surveyed: | 9.7 |

| Street: | Home Ave. 158' West of Illinois St. | Project: | Hobart, IN |

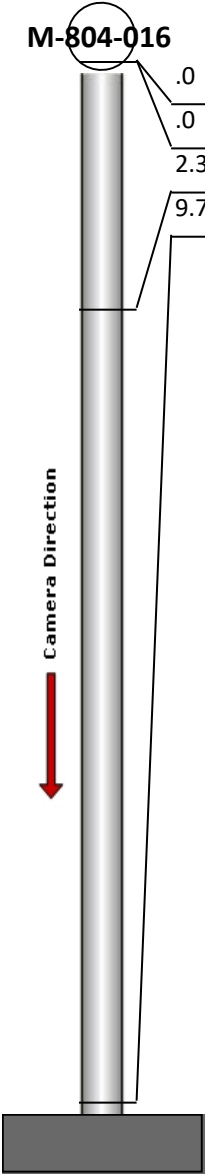
| | Position | Code | Observation | Video (sec) | Grade |
|--|---|---|---|---|---|
| | M-804-016 | | | | |

| | Position | Code | Observation | Video (sec) | Grade |
|--|---|---|---|---|---|
| | .0 | MGP | General Photo | 10 | NA |
| | .0 | ISSR | Intruding Sealing Ring | 21 | M 2 |
| | 2.3 | MGO | General Observation | 40 | NA |
| | 9.7 | MGO | General Observation | 68 | NA |

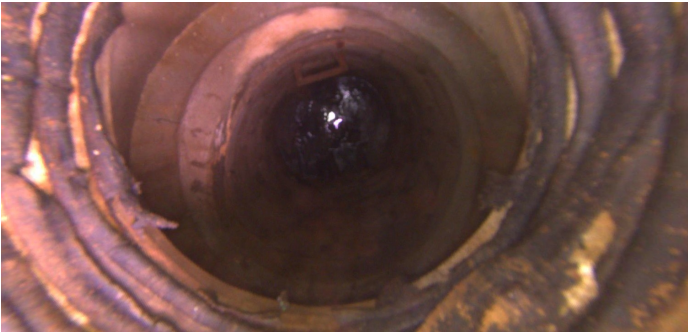
| Code: | MGP |
| Description: | General Photo |
| Distance (ft): | .0 |
| Remarks: | access mh |

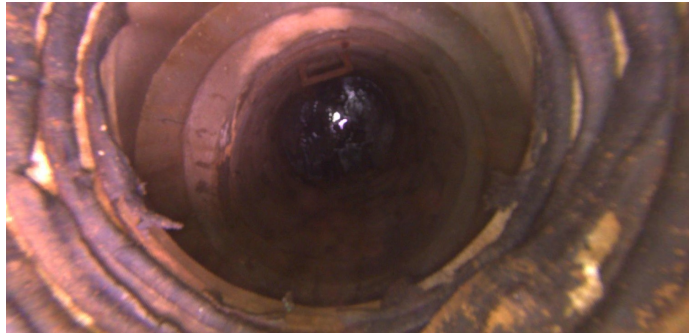
Code: **ISSR**
Description: **Intruding Sealing Ring**

Distance (ft): **.0**
Structural Grade: **0**
O&M Grade: **2**
Clock Start/From: **12**
Clock To: **12**
1st Value:
2nd Value:
Value Percent: **5.000**
Step: **NO**
Remarks:

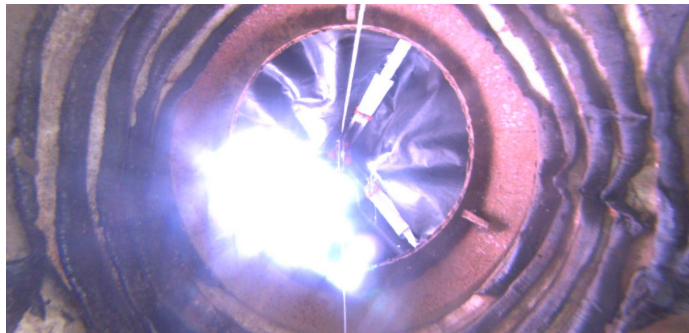
Code: **MGO**
Description: **General Observation**

Distance (ft): **2.3**
Structural Grade: **0**
O&M Grade: **0**
Clock Start/From:
Clock To:
1st Value:
2nd Value:
Value Percent:
Step: **NO**
Remarks: **underside of frame**

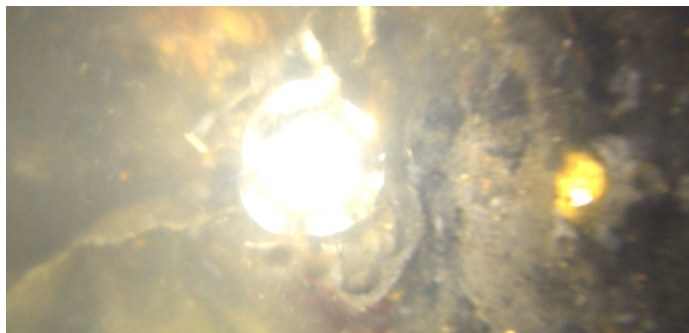
Code: **MGO**
Description: **General Observation**

Distance (ft): **9.7**
Structural Grade: **0**
O&M Grade: **0**
Clock Start/From:
Clock To:
1st Value:
2nd Value:
Value Percent:
Step: **NO**
Remarks: **end survey**
