Manhole Inspection Report

Date:	05/16/2018	Weather:		Coding:	RZMACP
MH#:	M-804-021	Owner:	NA	Len. Surveyed:	4.8
P.O.#:		Surveyor:	Jen Costello	Rim to Invert:	5.2
Customer:		Cert. #:	U-907-5518	Wall Material:	Brick

Street:	Hickey St. 165' West of Illinois St.	Project:	Hobart, IN
City:	Hobart, IN	GPS Northing:	2907259.659
Location:		GPS Easting:	2907259.659
Drain Area:	Northeast	GPS Accuracy:	Sub-Meter
Cover Shape:	Circular	Evidence of Surcharge:	No
Cover Size:	22.5	Potential for Runoff:	None
Comments:

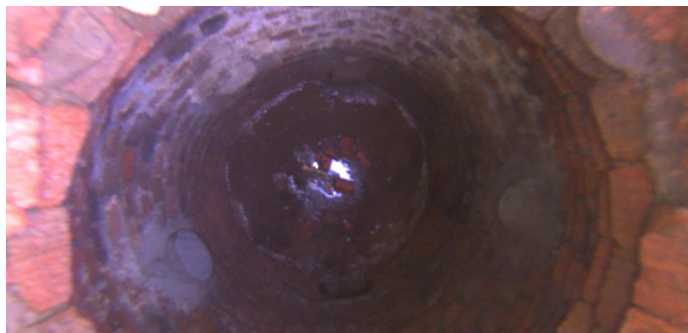
Code: **MGO**
Description: **General Observation**

Distance (ft): **.0**
Structural Grade: **0**
O&M Grade: **0**
Clock Start/From:
Clock To:
1st Value:
2nd Value:
Value Percent:
Step: **NO**
Remarks: **access mh**

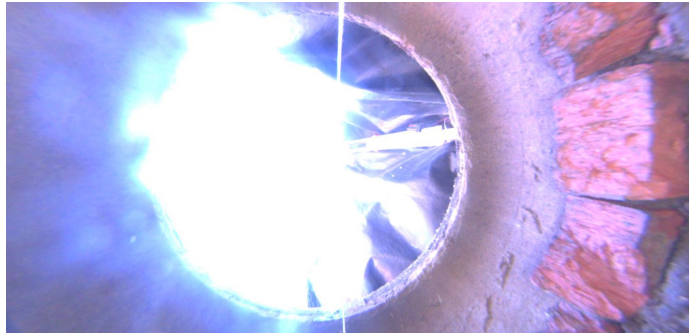
Code: **MGO**
Description: **General Observation**

Distance (ft): **1.3**
Structural Grade: **0**
O&M Grade: **0**
Clock Start/From:
Clock To:
1st Value:
2nd Value:
Value Percent:
Step: **NO**
Remarks: **underside of frame**

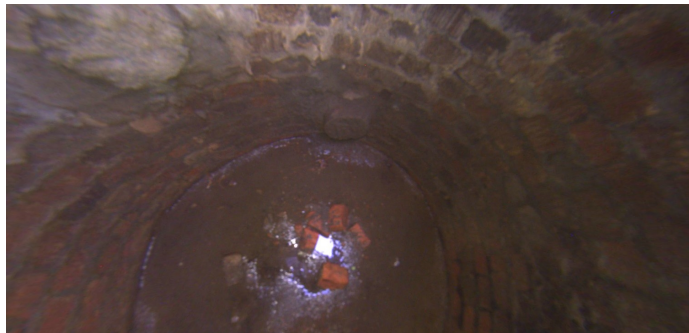
Code: **DAE**
Description: **Deposits Attached Encrustation**

Distance (ft): **2.7**
Structural Grade: **0**
O&M Grade: **2**
Clock Start/From: **11**
Clock To:
1st Value:
2nd Value:
Value Percent: **5.000**
Step: **NO**
Remarks:

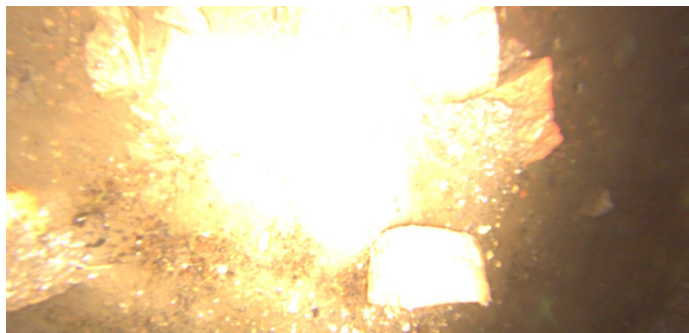
Code: **MGO**
Description: **General Observation**

Distance (ft): **4.8**
Structural Grade: **0**
O&M Grade: **0**
Clock Start/From:
Clock To:
1st Value:
2nd Value:
Value Percent:
Step: **NO**
Remarks: **end survey**

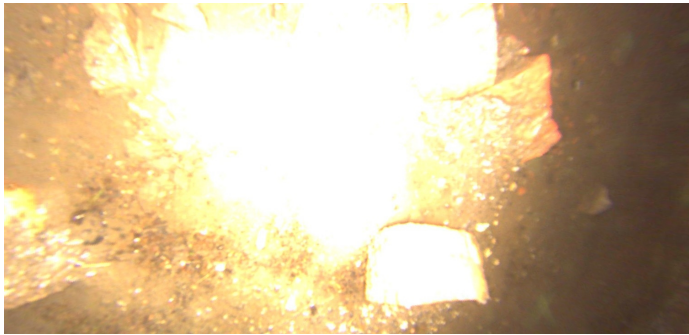
Code:	DSF
Description:	Deposits Settled Fine
Distance (ft):	4.8
Structural Grade:	0
O&M Grade:	2
Clock Start/From:	12
Clock To:	12
1st Value:	
2nd Value:	
Value Percent:	5.000
Step:	NO
Remarks:

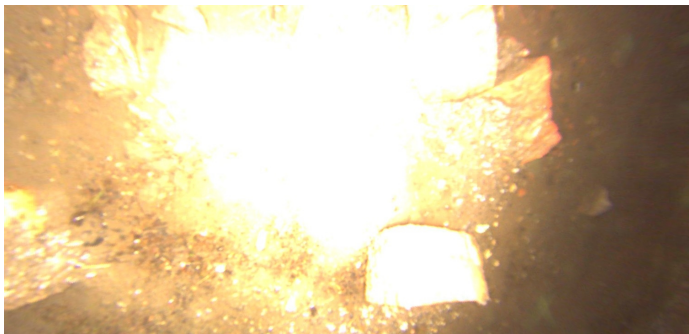
Code:	OBB
Description:	Obstacle Brick
Distance (ft):	4.8
Structural Grade:	0
O&M Grade:	2
Clock Start/From:	12
Clock To:	12
1st Value:	
2nd Value:	
Value Percent:	5.000
Step:	NO
Remarks:
