Manhole Inspection Report

Date:	10/11/2022	Weather:		Coding:	RZMACP
MH#:	M-804-023	Owner:	NA	Len. Surveyed:	15.4
P.O.#:		Surveyor:	Jen Costello	Rim to Invert:	21.3
Customer:		Cert. #:	U-907-5518	Wall Material:	Other

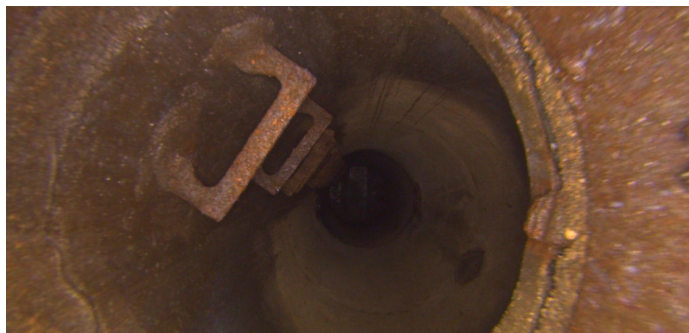
Code: **MGO**
Description: **General Observation**

Distance (ft): **.0**
Structural Grade: **0**
O&M Grade: **0**
Clock Start/From:
Clock To:
1st Value:
2nd Value:
Value Percent:
Step: **NO**
Remarks: **access mh**

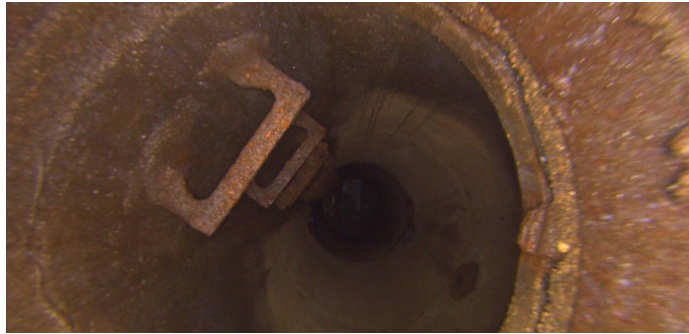
Code: **SAV**
Description: **Surface Aggregate Visible**

Distance (ft): **.0**
Structural Grade: **3**
O&M Grade: **0**
Clock Start/From: **12**
Clock To: **12**
1st Value:
2nd Value:
Value Percent:
Step: **NO**
Remarks:

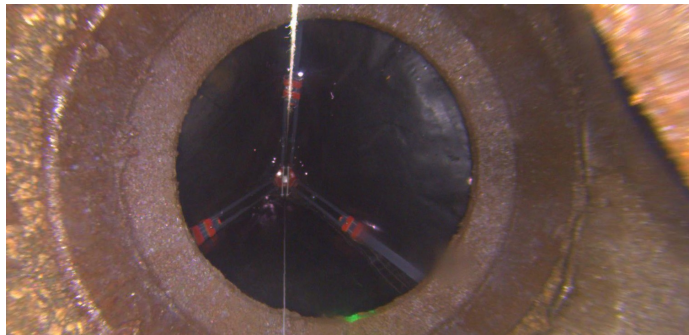
Code: **MGO**
Description: **General Observation**

Distance (ft): **2.0**
Structural Grade: **0**
O&M Grade: **0**
Clock Start/From:
Clock To:
1st Value:
2nd Value:
Value Percent:
Step: **NO**
Remarks: **underside of frame**

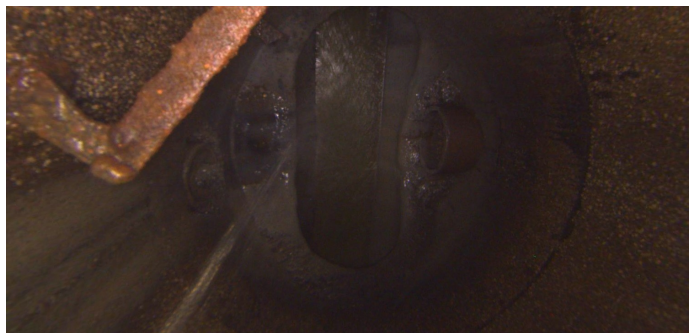
Code: **MGO**
Description: **General Observation**

Distance (ft): **15.4**
Structural Grade: **0**
O&M Grade: **0**
Clock Start/From:
Clock To:
1st Value:
2nd Value:
Value Percent:
Step: **NO**
Remarks: **end of survey**

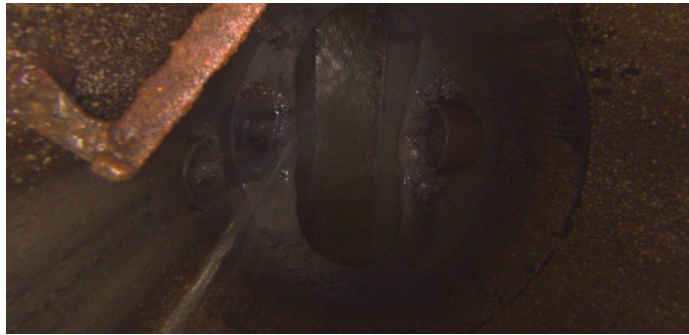
Code:	SAV
Description:	Surface Aggregate Visible
Distance (ft):	15.4
Structural Grade:	3
O&M Grade:	0
Clock Start/From:	12
Clock To:	12
1st Value:	
2nd Value:	
Value Percent:	
Step:	NO
Remarks:

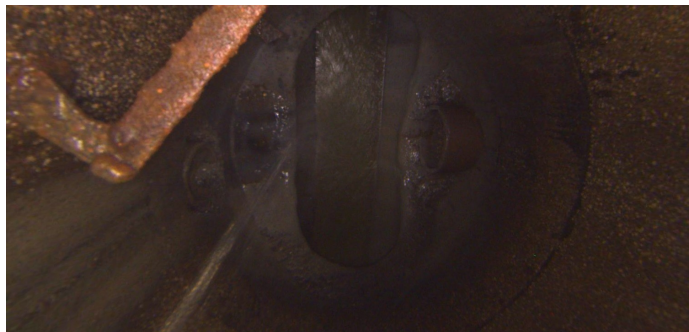
Code:	MGO
Description:	General Observation
Distance (ft):	15.4
Structural Grade:	0
O&M Grade:	0
Clock Start/From:	
Clock To:	
1st Value:	
2nd Value:	
Value Percent:	
Step:	NO
Remarks:	doesnt reach bottom
