Manhole Inspection Report

Date:	05/16/2018	Weather:		Coding:	RZMACP
MH#:	M-804-024	Owner:	NA	Len. Surveyed:	9.5
P.O.#:		Surveyor:	Jen Costello	Rim to Invert:	10.2
Customer:		Cert. #:	U-907-5518	Wall Material:	Brick

Street:	Kelly St. 291' South of Hickey St.	Project:	Hobart, IN
City:	NA	GPS Northing:	2907755.7
Location:		GPS Easting:	2907755.7
Drain Area:	Northeast	GPS Accuracy:	Sub-Meter
Cover Shape:	Circular	Evidence of Surcharge:	No
Cover Size:	22.5	Potential for Runoff:	None
Comments:

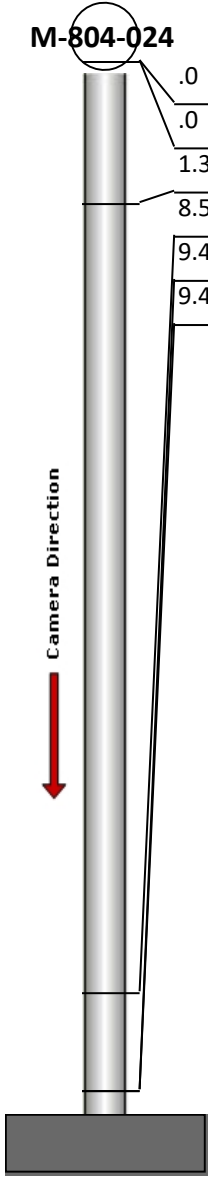
.0	MGP	General Photo	10	NA
	.0	SAP	Surface Aggregate Projecting	21	S 3
	1.3	MGO	General Observation	37	NA
	8.5	DSGV	Deposits Settled Gravel	64	M 2
	9.4	MGO	General Observation	77	NA
	9.4	OBR	Obstacle Rocks	89	M 2

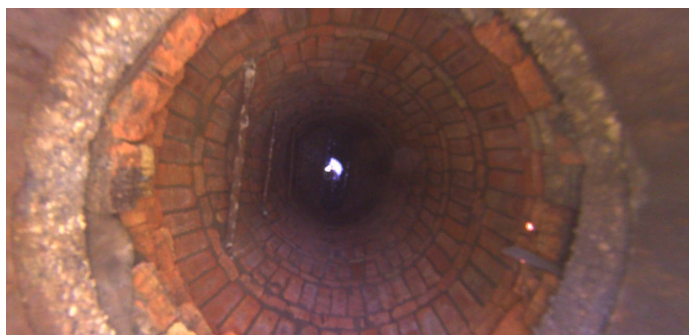
Code: **MGP**
Description: **General Photo**

Distance (ft): **.0**
Structural Grade: **0**
O&M Grade: **0**
Clock Start/From:
Clock To:
1st Value:
2nd Value:
Value Percent:
Step: **NO**
Remarks: **ACCESS**

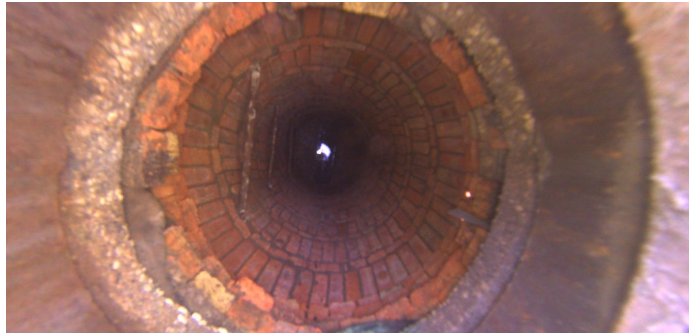
Code: **SAP**
Description: **Surface Aggregate Projecting**

Distance (ft): **.0**
Structural Grade: **3**
O&M Grade: **0**
Clock Start/From: **12**
Clock To: **12**
1st Value:
2nd Value:
Value Percent:
Step: **NO**
Remarks:

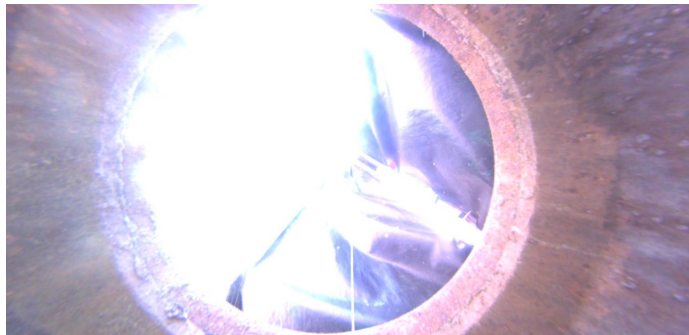
Code: **MGO**
Description: **General Observation**

Distance (ft): **1.3**
Structural Grade: **0**
O&M Grade: **0**
Clock Start/From:
Clock To:
1st Value:
2nd Value:
Value Percent:
Step: **NO**
Remarks: **UNDERSIDE OF FRAME**

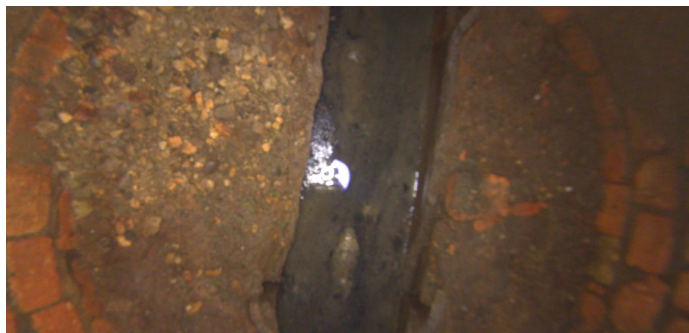
Code: **DSGV**
Description: **Deposits Settled Gravel**

Distance (ft): **8.5**
Structural Grade: **0**
O&M Grade: **2**
Clock Start/From: **12**
Clock To: **12**
1st Value:
2nd Value:
Value Percent: **5.000**
Step: **NO**
Remarks:

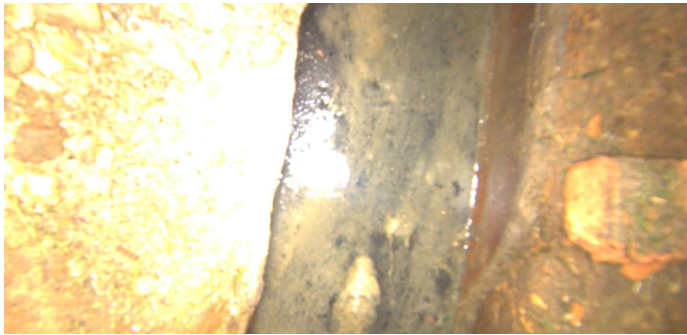
Code: **MGO**
Description: **General Observation**

Distance (ft): **9.4**
Structural Grade: **0**
O&M Grade: **0**
Clock Start/From:
Clock To:
1st Value:
2nd Value:
Value Percent:
Step: **NO**
Remarks: **END SURVEY**

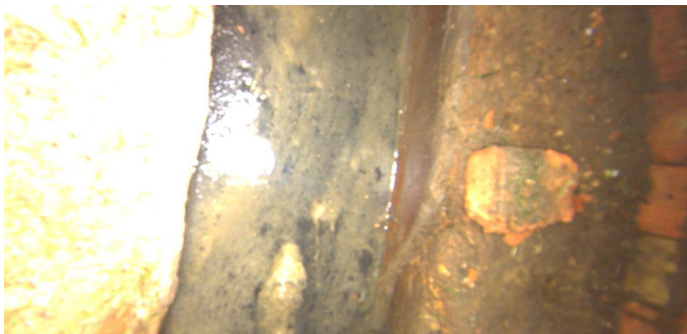
Code: **OBR**
Description: **Obstacle Rocks**

Distance (ft): **9.4**
Structural Grade: **0**
O&M Grade: **2**
Clock Start/From: **3**
Clock To:
1st Value:
2nd Value:
Value Percent: **5.000**
Step: **NO**
Remarks:
