Manhole Inspection Report

Date:	05/15/2018	Weather:		Coding:	RZMACP
MH#:	M-804-025	Owner:	NA	Len. Surveyed:	17.5
P.O.#:		Surveyor:	Jen Costello	Rim to Invert:	17.6
Customer:		Cert. #:	U-907-5518	Wall Material:	Concrete (reinforced)

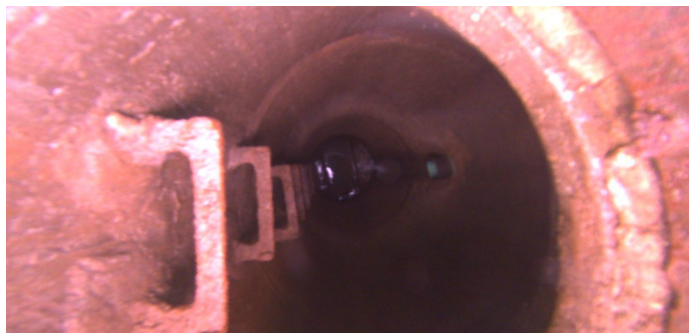
Code: **MGP**
Description: **General Photo**

Distance (ft): **.0**
Structural Grade: **0**
O&M Grade: **0**
Clock Start/From:
Clock To:
1st Value:
2nd Value:
Value Percent:
Step: **NO**
Remarks: **ACCESS MH**

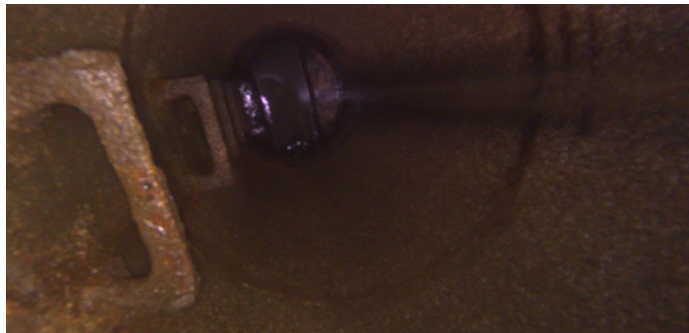
Code:	SAV
Description:	Surface Aggregate Visible
Distance (ft):	7.3
Structural Grade:	3
O&M Grade:	0
Clock Start/From:	12
Clock To:	12
1st Value:	
2nd Value:	
Value Percent:	
Step:	NO
Remarks:

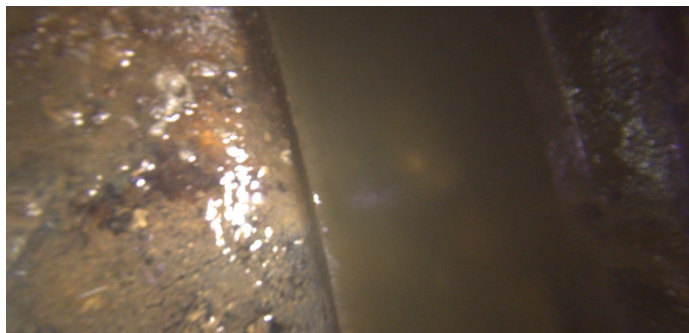
Code:	MGO
Description:	General Observation
Distance (ft):	17.5
Structural Grade:	0
O&M Grade:	0
Clock Start/From:	
Clock To:	
1st Value:	
2nd Value:	
Value Percent:	
Step:	NO
Remarks:	END SURVEY
