# Manhole Inspection Report

Date:	05/15/2018	Weather:		Coding:	RZMACP
MH#:	M-804-030	Owner:	NA	Len. Surveyed:	9.9
P.O.#:		Surveyor:	Jen Costello	Rim to Invert:	14.3
Customer:		Cert. #:	U-907-5518	Wall Material:	Concrete (reinforced)

Street:	Hickey St. 194' West of Hwy 51.	Project:	Hobart, IN
City:	Hobart, IN	GPS Northing:	2909544.981
Location:		GPS Easting:	2909544.981
Drain Area:	Northeast	GPS Accuracy:	Sub-Meter
Cover Shape:	Circular	Evidence of Surcharge:	No
Cover Size:	22.5	Potential for Runoff:	None
Comments:

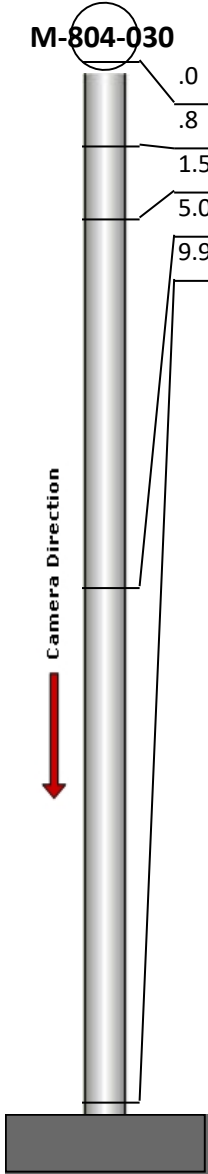
M-804-030				
	.0	MGP	General Photo	10	NA
	.8	DB	Displaced Brick	23	S 3
	1.5	MGO	General Observation	38	NA
	5.0	SAV	Surface Aggregate Visible	58	S 3
	9.9	MGO	General Observation	80	NA

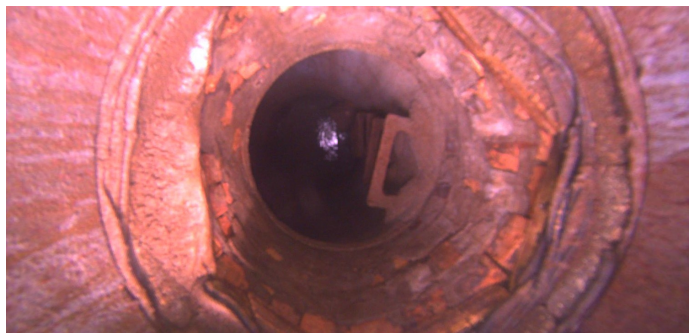
Code: **MGP**  
Description: **General Photo**

Distance (ft): **.0**  
Structural Grade: **0**  
O&M Grade: **0**  
Clock Start/From:  
Clock To:  
1st Value:  
2nd Value:  
Value Percent:  
Step: **NO**  
Remarks: **ACCESS MH**

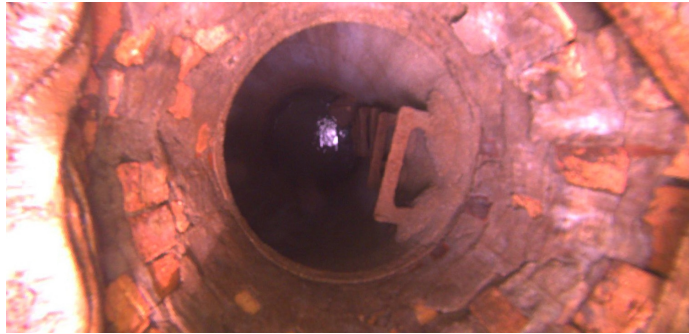
Code: **DB**  
Description: **Displaced Brick**

Distance (ft): **.8**  
Structural Grade: **3**  
O&M Grade: **0**  
Clock Start/From: **12**  
Clock To: **12**  
1st Value:  
2nd Value:  
Value Percent:  
Step: **NO**  
Remarks:

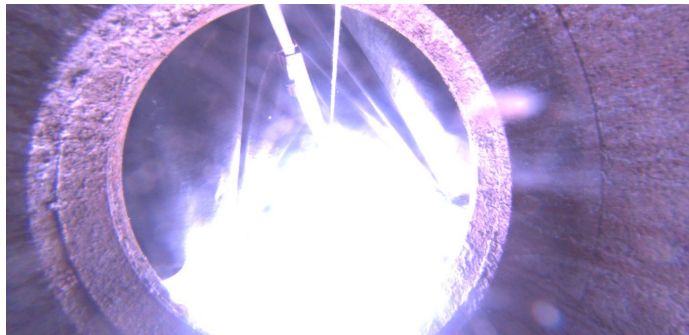
Code: **MGO**  
Description: **General Observation**

Distance (ft): **1.5**  
Structural Grade: **0**  
O&M Grade: **0**  
Clock Start/From:  
Clock To:  
1st Value:  
2nd Value:  
Value Percent:  
Step: **NO**  
Remarks: **UNDERSIDE OF FRAME**

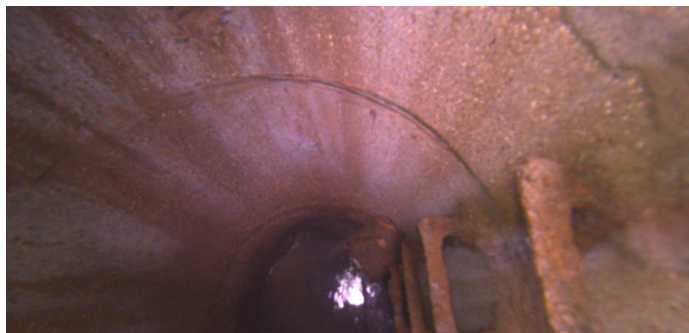
Code: **SAV**  
Description: **Surface Aggregate Visible**

Distance (ft): **5.0**  
Structural Grade: **3**  
O&M Grade: **0**  
Clock Start/From: **12**  
Clock To: **12**  
1st Value:  
2nd Value:  
Value Percent:  
Step: **NO**  
Remarks:

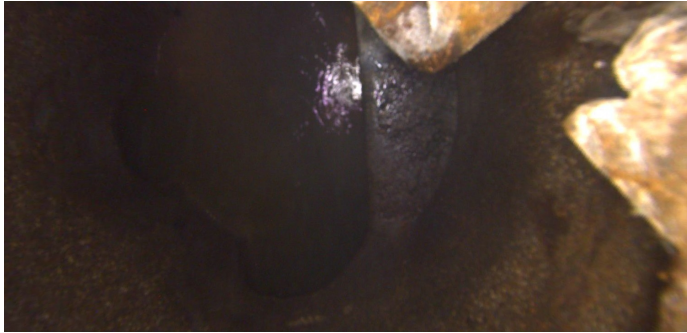
Code:	<b>MGO</b>
Description:	<b>General Observation</b>
Distance (ft):	<b>9.9</b>
Structural Grade:	<b>0</b>
O&M Grade:	<b>0</b>
Clock Start/From:	
Clock To:	
1st Value:	
2nd Value:	
Value Percent:	
Step:	<b>NO</b>
Remarks:	<b>END SURVEY</b>
