Manhole Inspection Report

O&M Index:	2.00	O&M Quick:	2100	O&M Rating:	2.00
Structural Index:	2.50	Structural Quick:	3121	Structural Rating:	5.00
Overall Index:	2.33	Overall Quick:	3122	Overall Rating:	7.00

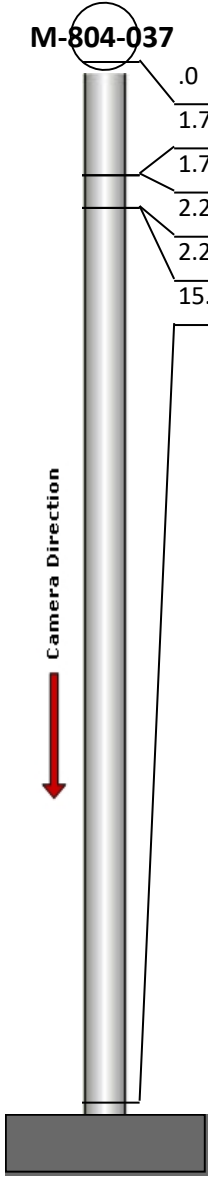
.0	MGP	General Photo	10	NA
	1.7	MGO	General Observation	27	NA
	1.7	SAV	Surface Aggregate Visible	40	S 3
	2.2	SSS	Surface Spalling	53	S 2
	2.2	IW	Infil Weeper	65	M 2
	15.6	MGO	General Observation	103	NA

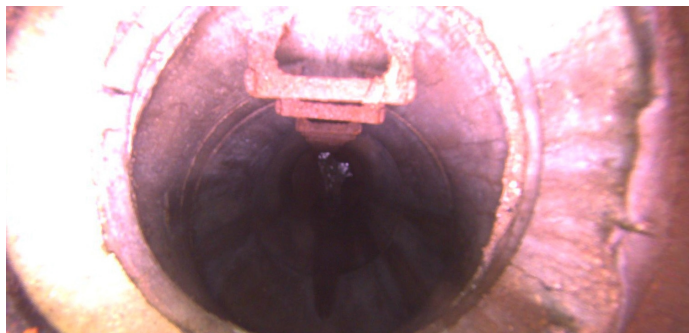
Code: **MGP**
Description: **General Photo**

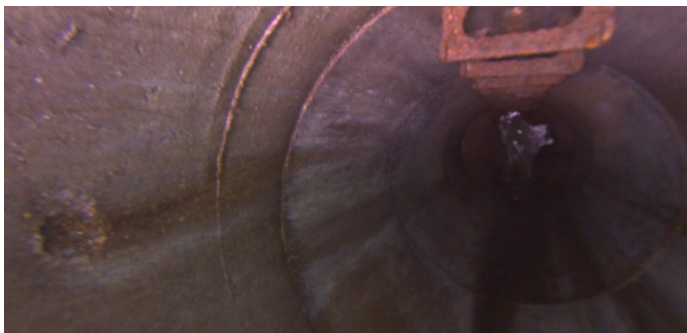
Code:	SSS
Description:	Surface Spalling
Distance (ft):	2.2
Structural Grade:	2
O&M Grade:	0
Clock Start/From:	9
Clock To:	
1st Value:	
2nd Value:	
Value Percent:	
Step:	NO
Remarks:

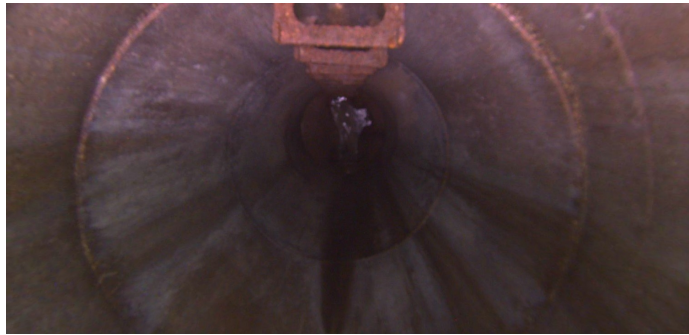
Code: **IW**
Description: **Infil Weeper**
