Manhole Inspection Report

Date:	05/15/2018	Weather:		Coding:	RZMACP
MH#:	M-804-038	Owner:	NA	Len. Surveyed:	13.6
P.O.#:		Surveyor:	Jen Costello	Rim to Invert:	14.3
Customer:		Cert. #:	U-907-5518	Wall Material:	Concrete (reinforced)

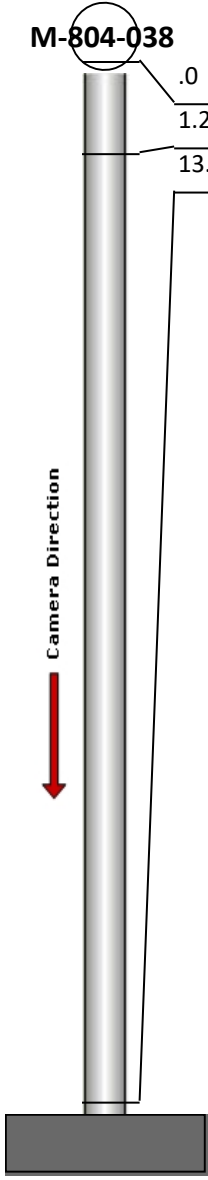
M-804-038				
	.0	MGO	General Observation	10	NA
	1.2	SAV	Surface Aggregate Visible	24	S 3
	13.6	MGO	General Observation	61	NA

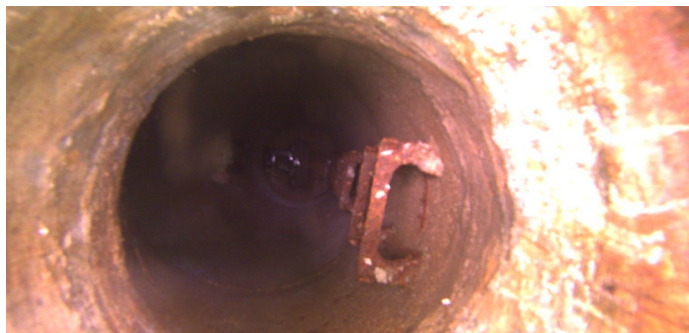
Code: **MGO**
 Description: **General Observation**

Distance (ft): **.0**
 Structural Grade: **0**
 O&M Grade: **0**
 Clock Start/From:
 Clock To:
 1st Value:
 2nd Value:
 Value Percent:
 Step: **NO**
 Remarks: **ACCESS MH**

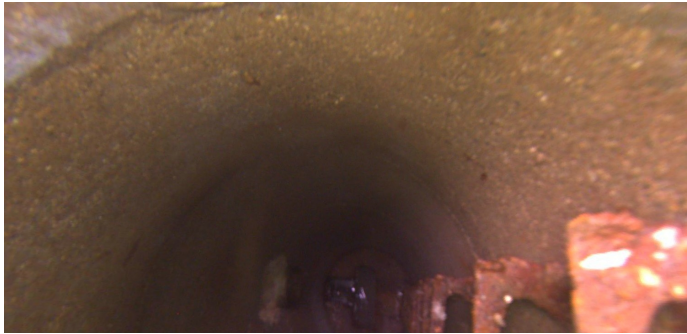
Code:	SAV
Description:	Surface Aggregate Visible
Distance (ft):	1.2
Structural Grade:	3
O&M Grade:	0
Clock Start/From:	12
Clock To:	12
1st Value:	
2nd Value:	
Value Percent:	
Step:	NO
Remarks:

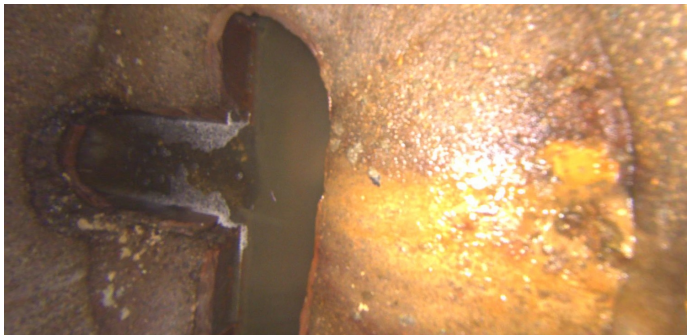
Code:	MGO
Description:	General Observation
Distance (ft):	13.6
Structural Grade:	0
O&M Grade:	0
Clock Start/From:	
Clock To:	
1st Value:	
2nd Value:	
Value Percent:	
Step:	NO
Remarks:	END SURVEY
