Manhole Inspection Report

Date:	05/15/2018	Weather:		Coding:	RZMACP
MH#:	M-804-041	Owner:	NA	Len. Surveyed:	13.2
P.O.#:		Surveyor:	Jen Costello	Rim to Invert:	15.3
Customer:		Cert. #:	U-907-5518	Wall Material:	Concrete (reinforced)

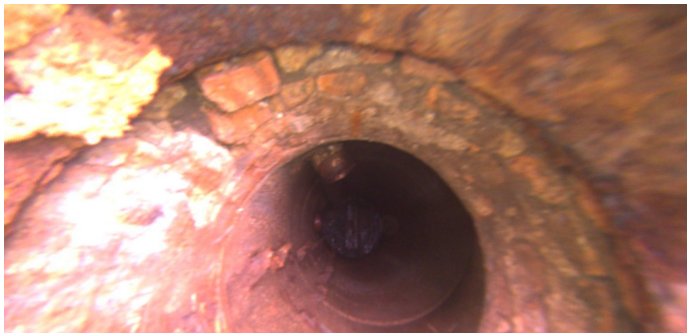
Code: **DB**
Description: **Displaced Brick**

Distance (ft): **.0**
Structural Grade: **3**
O&M Grade: **0**
Clock Start/From: **11**
Clock To:
1st Value:
2nd Value:
Value Percent:
Step: **NO**
Remarks:

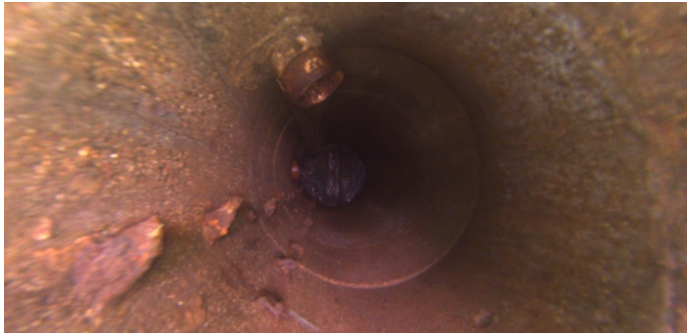
Code: **SAV**
Description: **Surface Aggregate Visible**

Distance (ft): **1.3**
Structural Grade: **3**
O&M Grade: **0**
Clock Start/From: **12**
Clock To: **12**
1st Value:
2nd Value:
Value Percent:
Step: **NO**
Remarks:

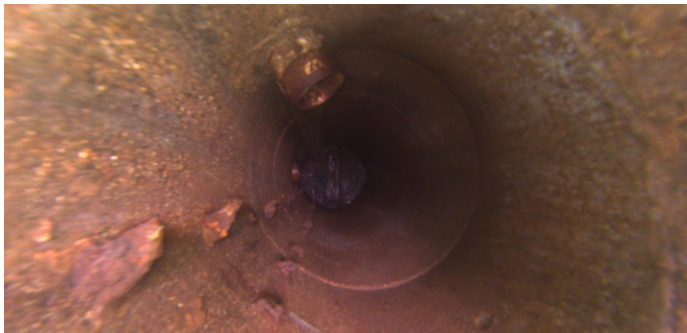
Code: **MGO**
Description: **General Observation**

Distance (ft): **1.3**
Structural Grade: **0**
O&M Grade: **0**
Clock Start/From:
Clock To:
1st Value:
2nd Value:
Value Percent:
Step: **NO**
Remarks: **broken steps**

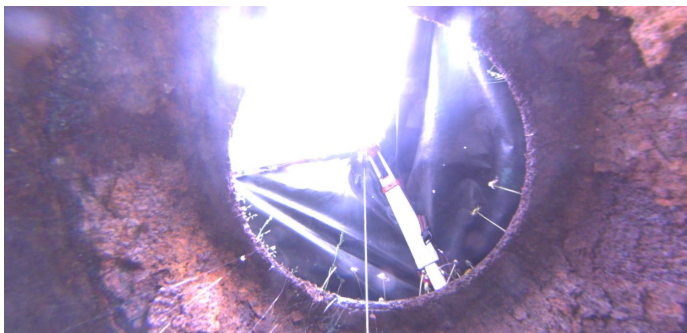
Code: **MGO**
Description: **General Observation**

Distance (ft): **1.3**
Structural Grade: **0**
O&M Grade: **0**
Clock Start/From:
Clock To:
1st Value:
2nd Value:
Value Percent:
Step: **NO**
Remarks: **underside of frame**

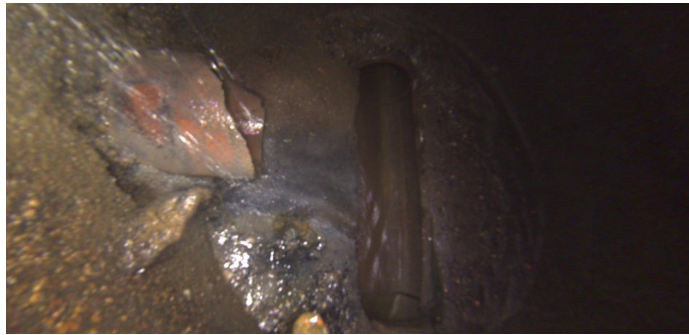
Code:	SAV
Description:	Surface Aggregate Visible
Distance (ft):	13.2
Structural Grade:	3
O&M Grade:	0
Clock Start/From:	12
Clock To:	12
1st Value:	
2nd Value:	
Value Percent:	
Step:	NO
Remarks:

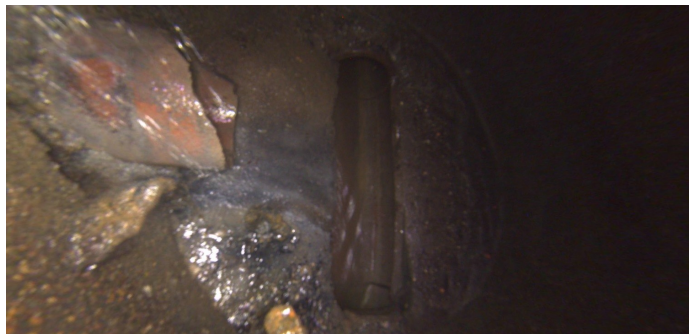
Code:	MGO
Description:	General Observation
Distance (ft):	13.2
Structural Grade:	0
O&M Grade:	0
Clock Start/From:	
Clock To:	
1st Value:	
2nd Value:	
Value Percent:	
Step:	NO
Remarks:	end sruvey
